APOLLO 15 MISSION REPORT

MSC-05161

Mission Evaluation Team

NATIONAL AERONAUTICS AND SPACE ADMINISTRATION
MANNED SPACECRAFT CENTER
HOUSTON, TEXAS
December 1971

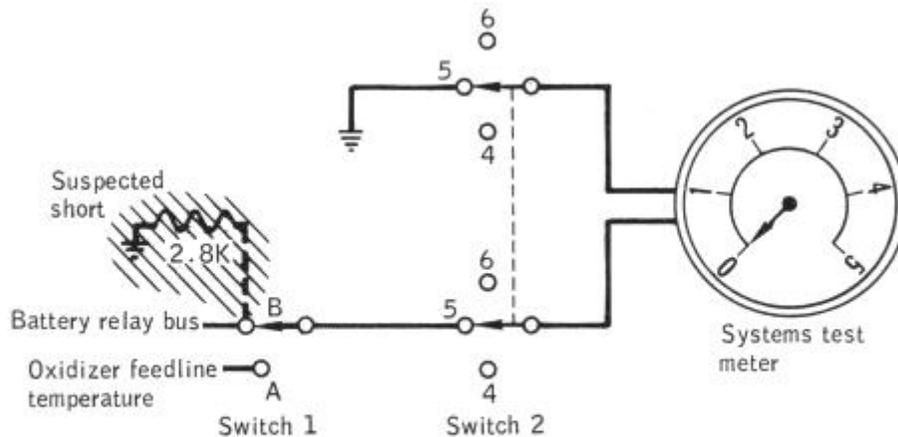
Figure 14-6.- Systems test meter switch.

Postflight testing of the vehicle and all of the involved components revealed no anomalous condition which could have caused the problem but did isolate the problem to the instrumentation circuitry and verify that the functional operation of the bus was not impaired. Analysis indicates that the only way to duplicate the flight problem would be to connect a resistance of 2800 ohms from ground to the battery relay bus measurement circuit (**Fig. 14-6**). No resistance near this magnitude was measured during postflight testing. The most probable cause of the anomaly was that insulation resistance at the output terminal of the switch was lowered because of humidity.

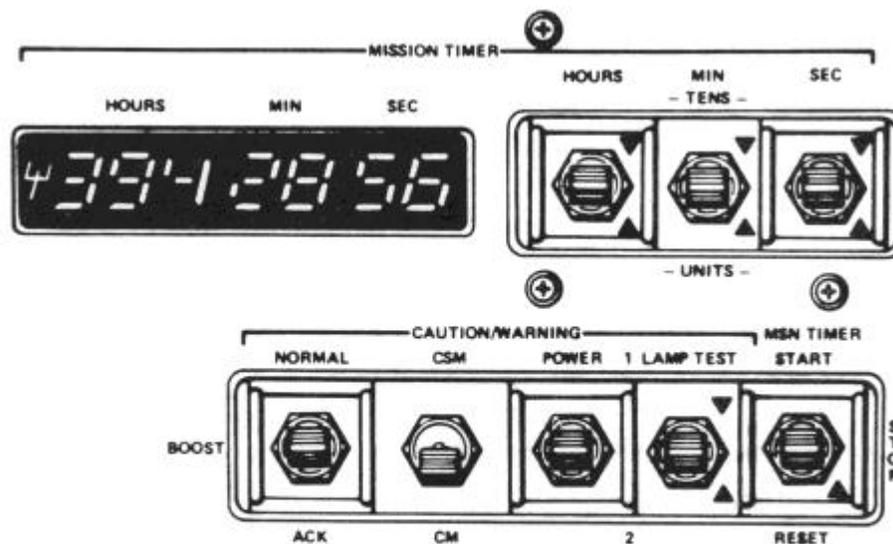
Figure 14-10.- Mission timer.

The panel 2 mission timer stopped at 124:47:37. Several attempts to start the clock by cycling the start /stop/reset switch from the stop to the start position failed (**Fig. 14-10**). The timer was reset to 124:59:00 using the hours, minutes, and seconds switches, and the timer again failed to start when the switch was cycled. The switch was then placed in the reset position. The timer reset to all zeros and started to count when the switch was placed in the start position. The timer was then set to the proper mission time using the hours, minutes, and seconds switches and operated properly for the remainder of the mission.

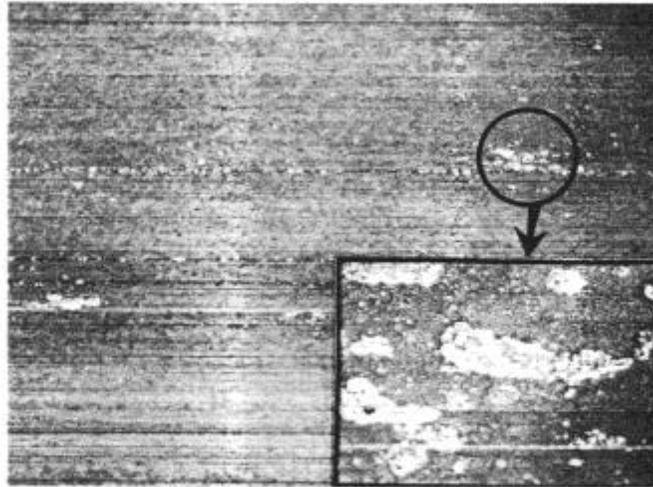
Figure 14-14.- Recording tape photographed under 50 power and 400 power magnification showing silver oxide deposits.

The first 30 feet of tape was scanned under magnifications ranging from 50X to 400X. Under 50X magnification, a distinct pattern of embedded particles could be observed (**Fig. 14-14**). The deposits were quite heavy over the first 12 feet of tape, and gradually tapered out so that, at 20 feet, very few particles could be observed. Under 400X magnification, individual flakes of deposited material were observed. The portion of **Fig. 14-14** at 400X magnification shows a typical cluster of particles on the beginning portions of the tape.

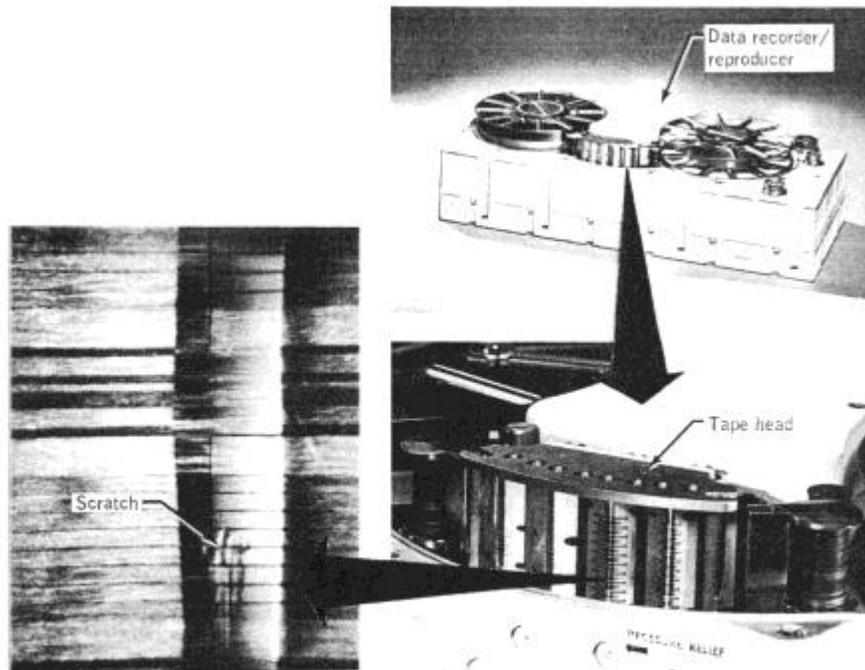
Figure 14-15.- Data recorder/reproducer and scratches on head.

Inspection on the magnetic heads under 20X magnification disclosed four scratches, one of which is shown in **Fig. 14-15**. An overlay was made of the scratches with respect to the accumulation of silver oxide on the tape; two of the four scratches aligned perfectly with the silver oxide accumulation. The scratches must have scraped loose the silver oxide on the leader. Operation of the recorder would then distribute the silver oxide particles along the tape. During the manufacture of the Apollo 16 recorder, it was discovered that the heads were being scratched by handling. The Apollo 15 recorder heads were probably also scratched during manufacture. The scratches would not have been detected during acceptance inspection since they are not visible at the 7X magnification used during that inspection.
