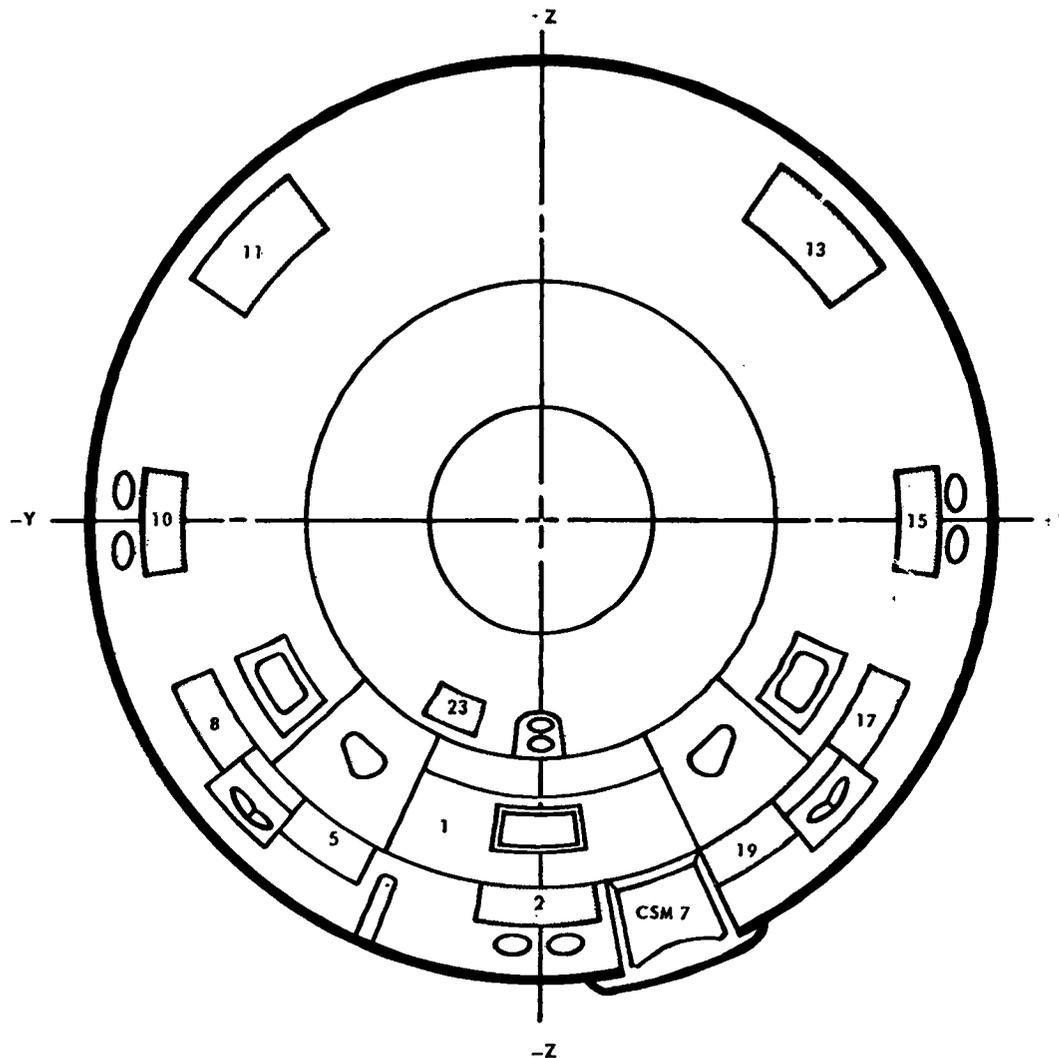
ENCLOSURE 10-3

NOTE: SHADED PANELS REPRESENT AREAS OPEN AT THE TIME OF THE ACCIDENT

HEATSHIELD ACCESS PANELS

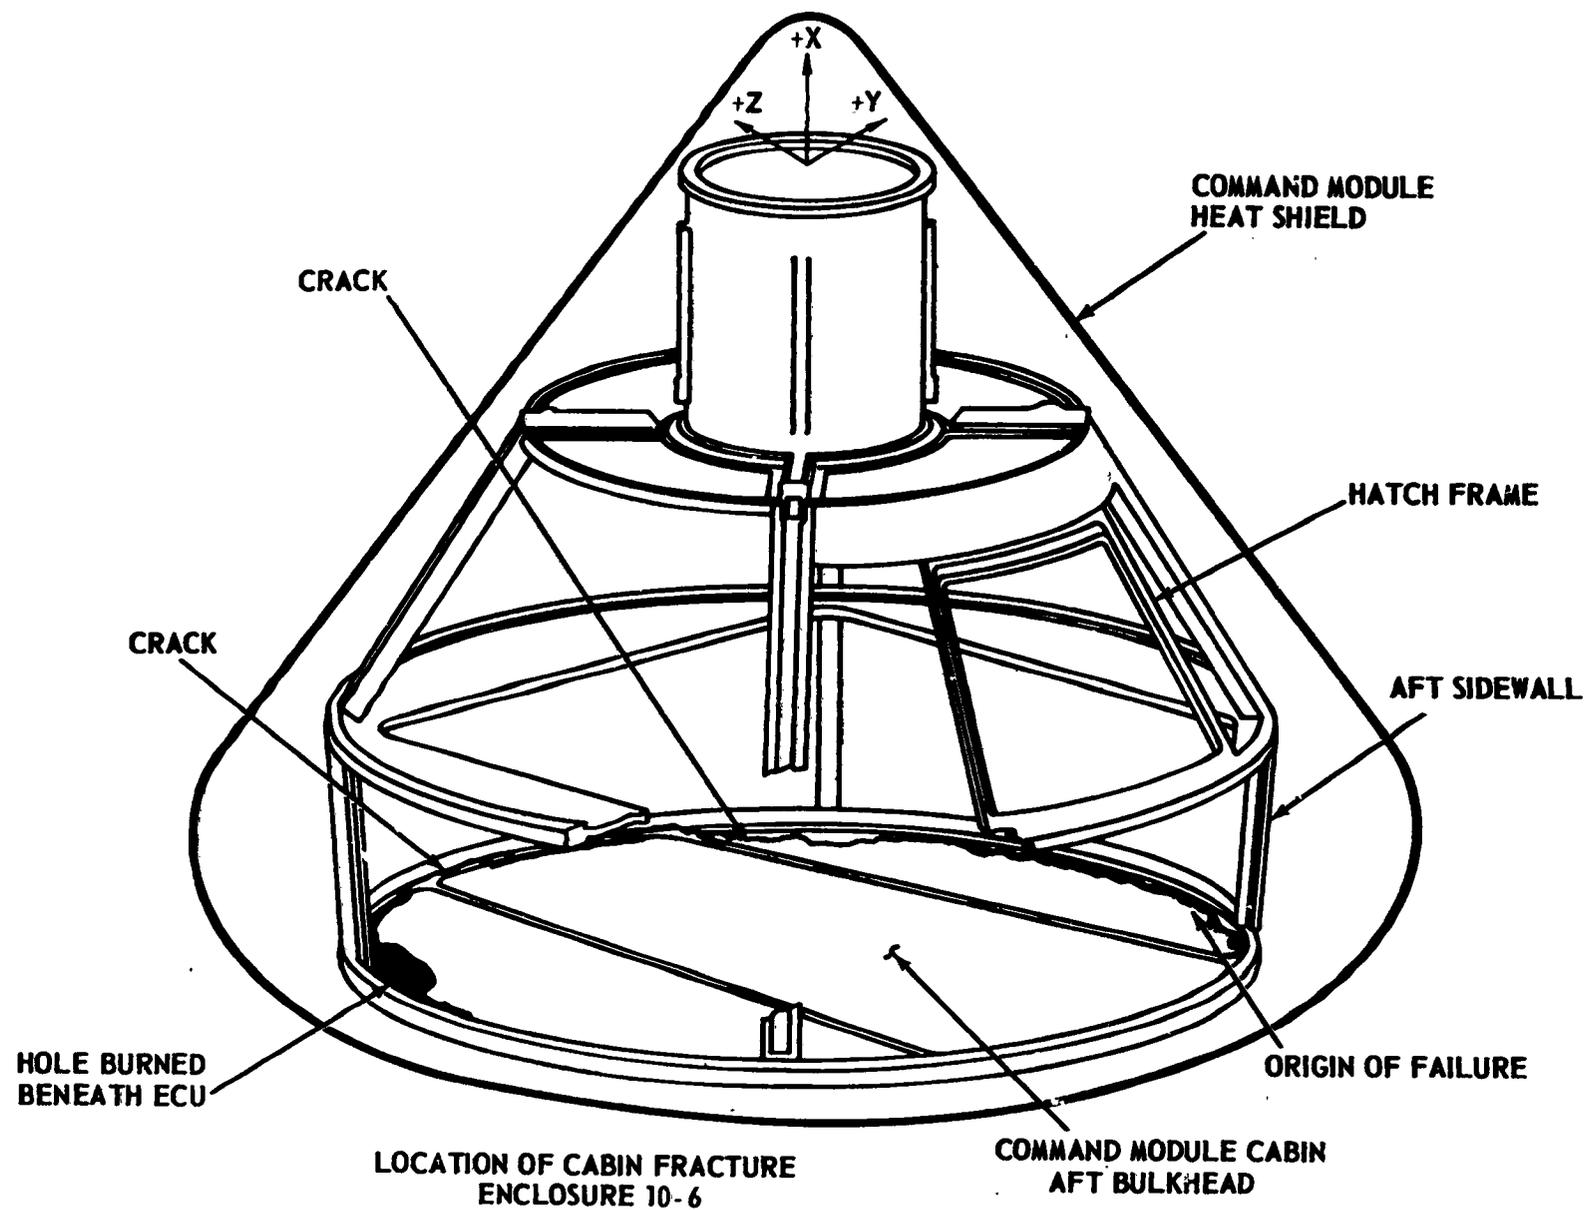
LOCATION OF CABIN FRACTURE
ENCLOSURE 10-6

LOCATION OF CABIN FRACTURE

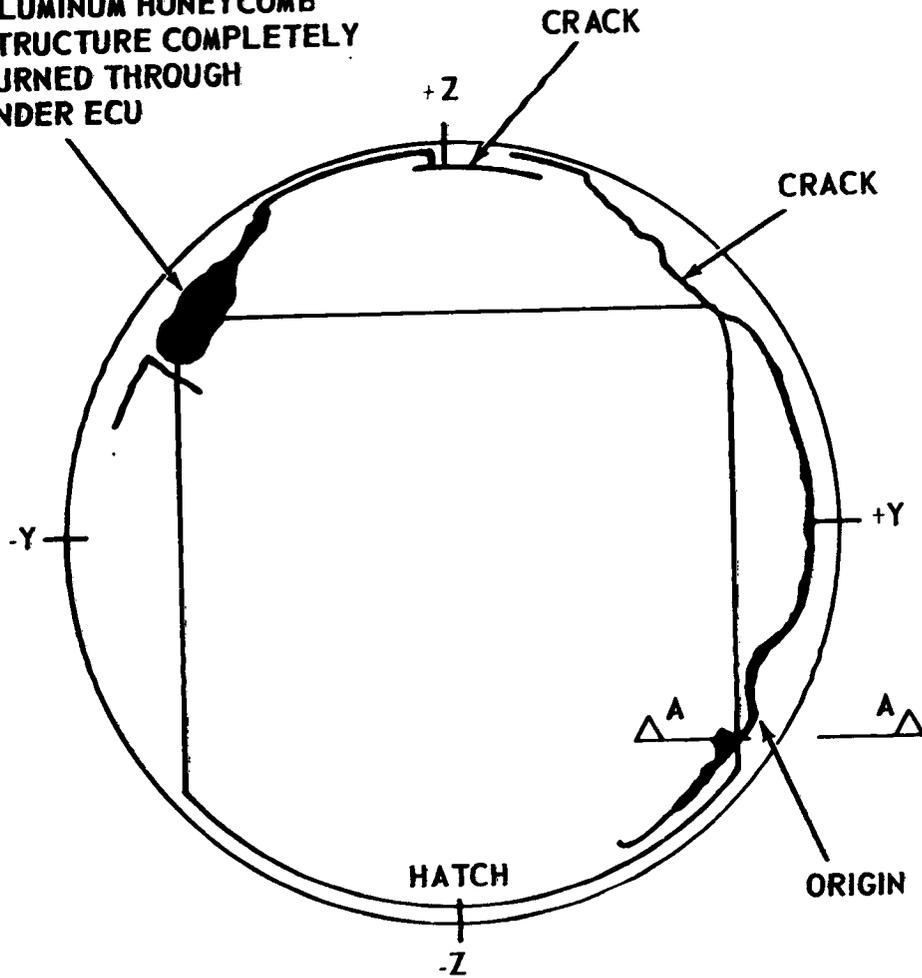
ENCLOSURE 10-7

AFT BULKHEAD
ALUMINUM HONEYCOMB
STRUCTURE COMPLETELY
BURNED THROUGH
UNDER ECU

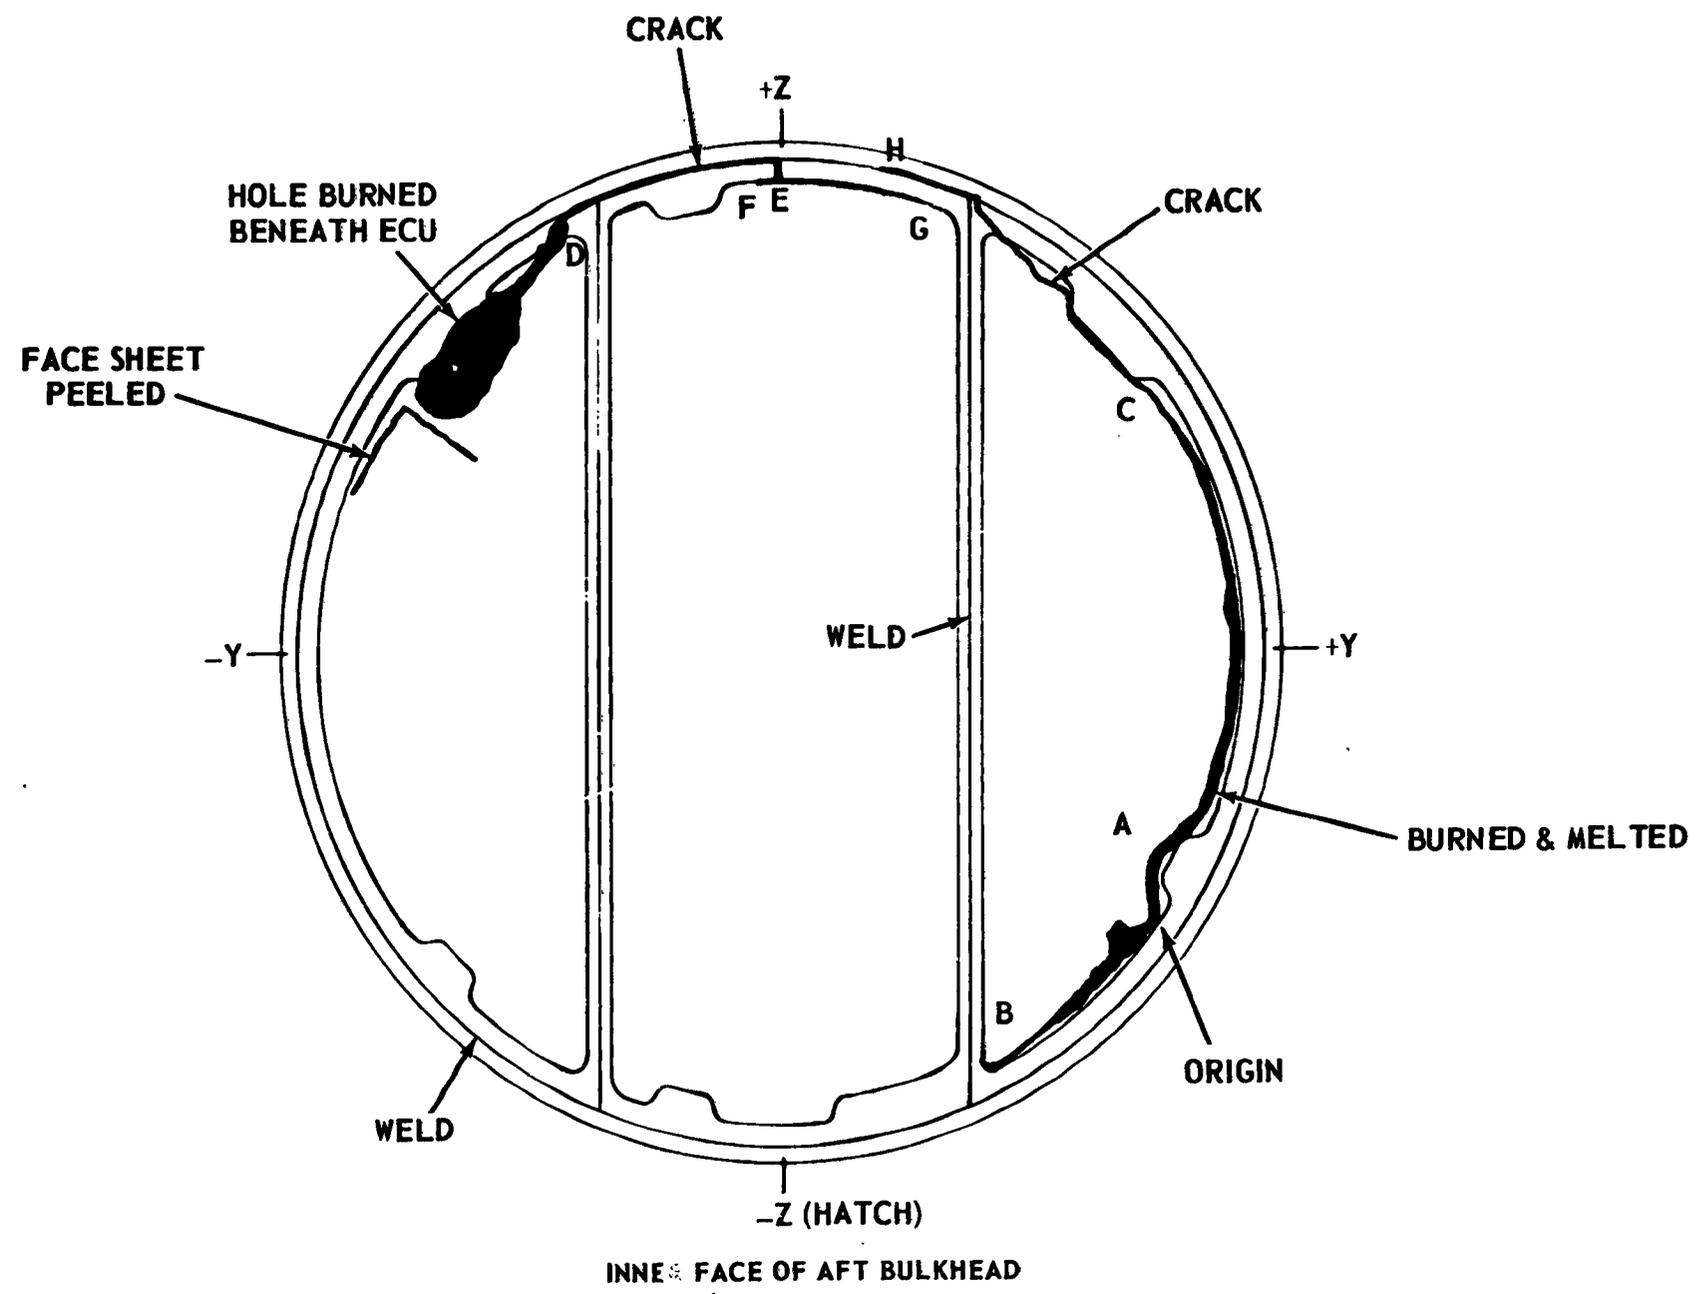
INNER FACE OF AFT BULKHEAD

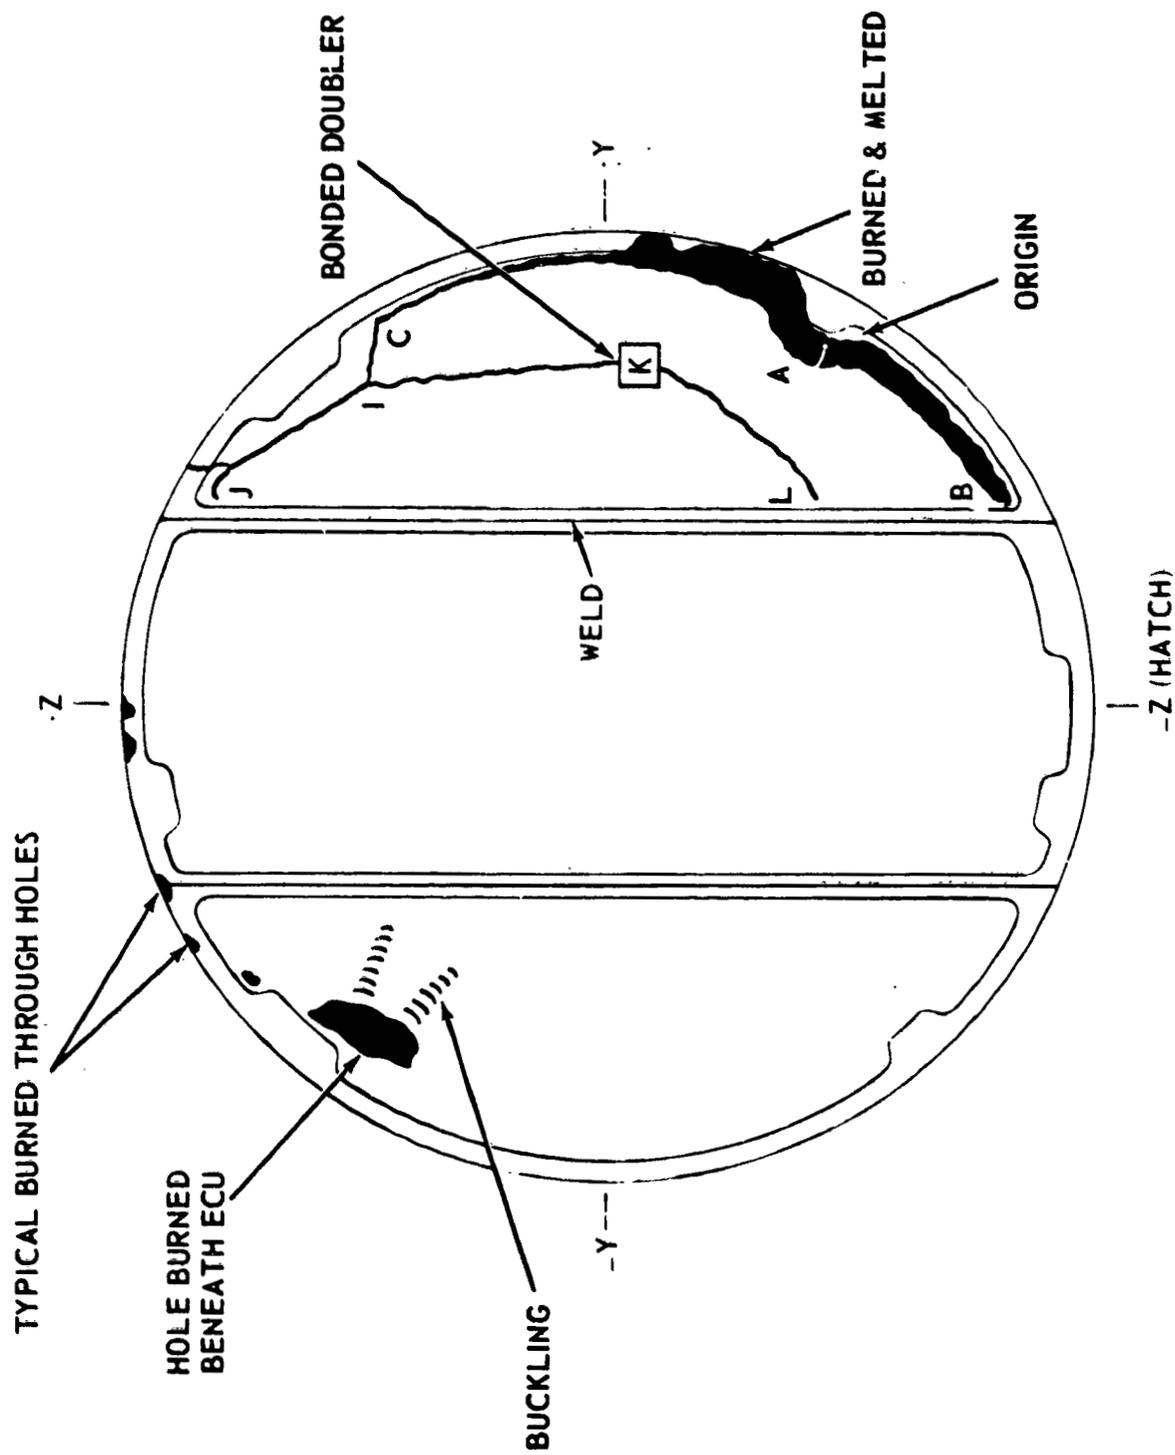
OUTER FACE SHEET OF AFT BULKHEAD
