NATIONAL AERONAUTICS AND SPACE ADMINISTRATION

APOLLO 12 MISSION REPORT

HOUSTON, TEXAS
MARCH 1970

Mission Evaluation Team

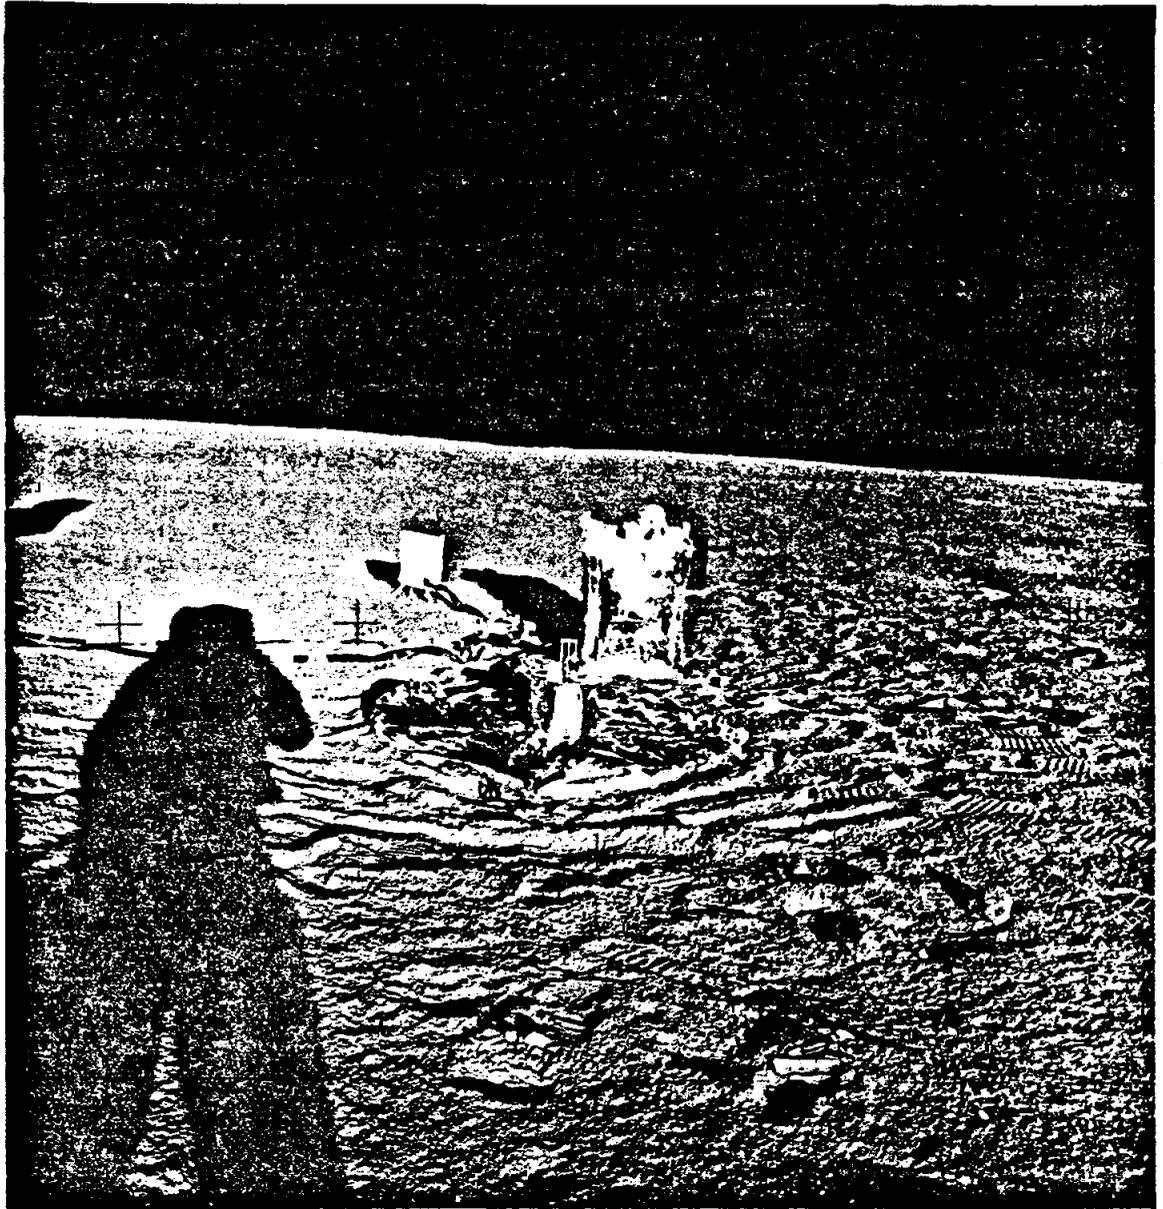
Figure 14-42. - Passive seismic experiment deployed.

The passive seismic experiment, shown in figure 3-5, has operated as planned with the exceptions noted. The sensor was installed at a location west-northwest from the lunar module (fig. 3-6) at a distance of 130 meters from the nearest footpad. The crew reported that tamping the surface material with their boots was not an effective means of preparing the surface for emplacement because the degree of compaction is small. Spreading the thermal shroud over the surface was difficult, because in the lunar gravity, the lightweight Mylar sheets of this shroud would not lie flat (see section 14.3.4).

The short-period vertical-component seismometer is operating at a reduced gain and fails to respond to calibration pulses. Detailed comparisons between signals observed on both the long- and short-period vertical-component seismometers has led to the initial conclusion that the inertial mass of the short-period seismometer is rubbing slightly on its frame. Nominal response is observed for signals large enough to produce inertial forces on the suspended mass which apparently exceed restraining frictional forces. The threshold ground-motion acceleration required to produce an observable signal cannot be determined accurately, but it is probably less than $8 \times 10^{-4} \text{ cm/sec}^2$, which corresponds to surface motions of 2 millimicrons at a frequency of 10 hertz. On December 2, 1969, a series of square-wave pulses were observed on the short-period vertical trace over a period of approximately 13 hours. The pulse amplitude was constant and was approximately equal to a shift in the third least-significant bit of a telemetry data word. These pulses are also observable on the records from the long-period seismometers, but with reduced amplitude. The problem is believed to be in either the analog-to-digital converter or the converter reference voltage.

The response of the long-period vertical seismometer to a calibration pulse was observed to be oscillatory soon after activation. In the presence of feedback, this effect can be produced if either the natural period of the seismometer is lengthened or the feedback filter corner period is shortened beyond design values. It is probable that the natural period of the seismometer was lengthened from 15 seconds to approximately 60 seconds as a result of vibration effects. Acceptable operation has

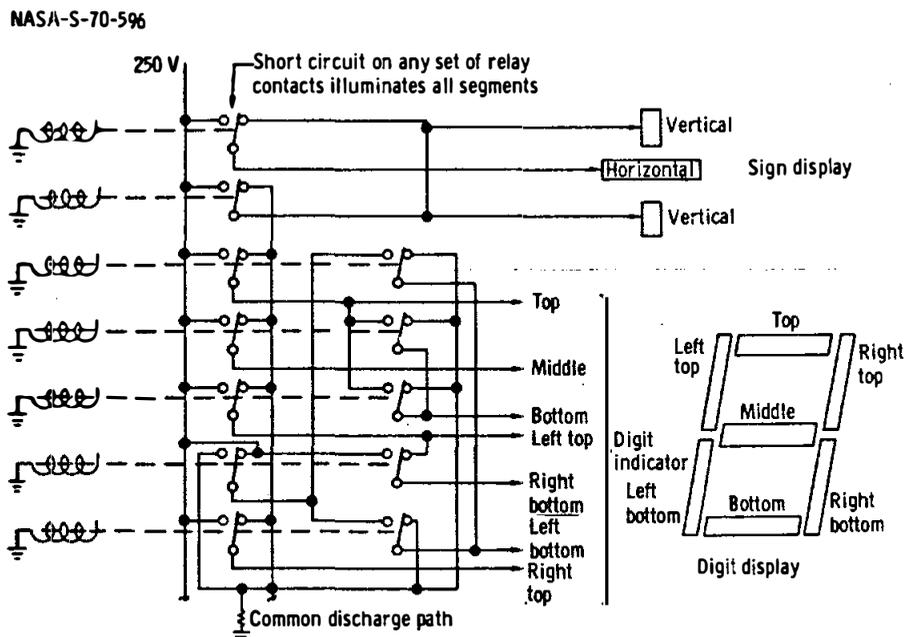
Figure 14-1.- Simplified schematic diagram of relay matrix.

The crew reported several intermittent, all-"8's" displays on the main display and keyboard assembly approximately 1-1/2 hours before launch, but no display malfunction occurred in flight. The display segments are illuminated by applying 250 V ac through the contacts of miniature relays, as shown in figure 14-1. When a segment is off, it is grounded through a resistor and the normally closed contacts of a relay to avoid residual illumination. The normally closed contacts of all relays are tied together; consequently, a short across the contacts of any one relay will apply the voltage to all segments of each display. The effect of the short in conjunction with the common discharge path is shown in figure 14-1 for a typical character and one sign. A short across the relay contacts will affect only the display function of the unit.

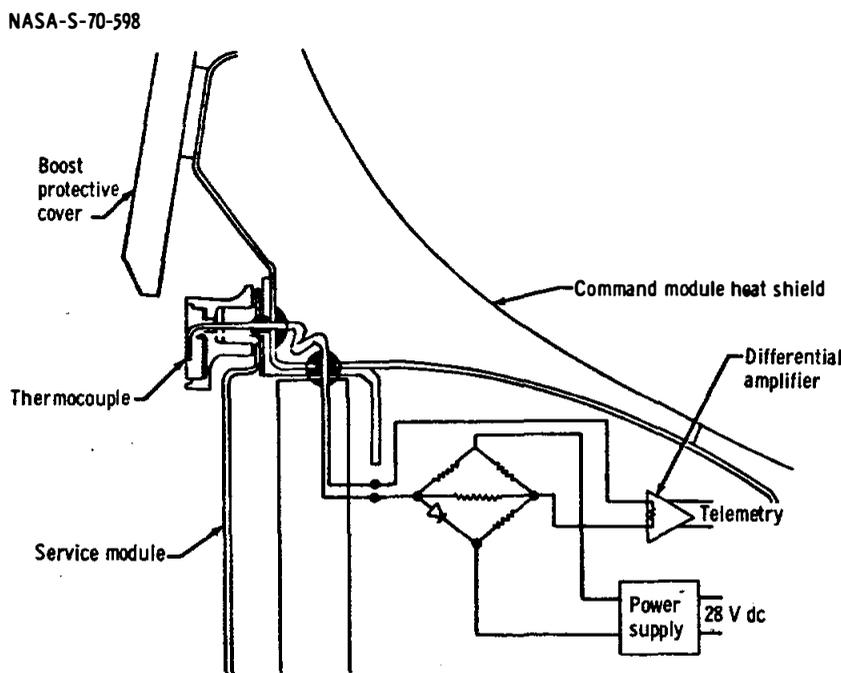
Figure 14-3. - Simplified schematic and location of a typical outer skin temperature sensor.

The service module outer surface temperature measurements use a chromel-constantan thermocouple and a reference junction. The reference junction is a bridge made up of three resistors and a temperature-sensitive diode (fig. 14-3). The resistors normally operate at about 0.020 ampere and will open in the region of 0.100 ampere. An open bridge resistor would drive the signal output off-scale high or low depending upon which resistor fails.

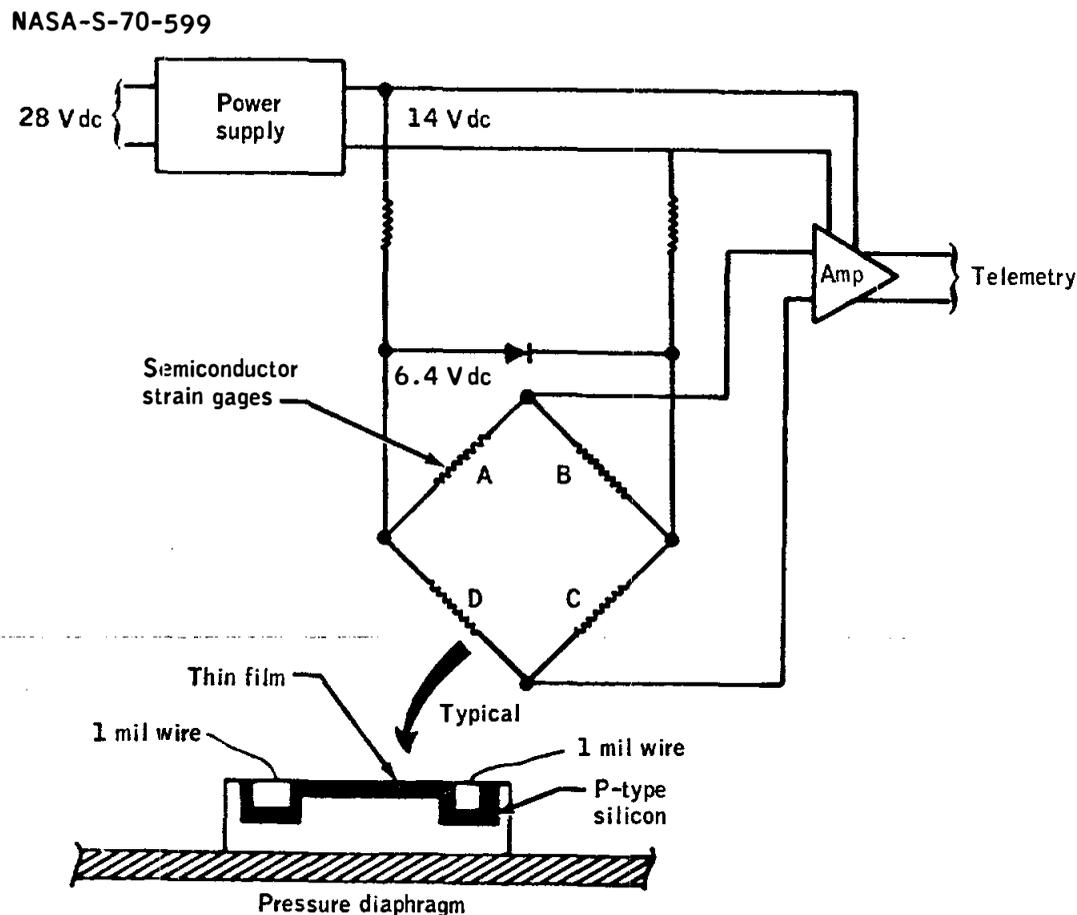
Figure 14-4.- Propellant quantity transducer schematic.

The reaction control propellant quantity measurements use semiconductor strain gages on a pressure-sensitive diaphragm (fig. 14-4). The semiconductors are a thin film type, and excessive current would probably damage their capability to operate as pressure-sensitive resistors. An alternate possibility is that the Zener diode, used to regulate the 14-volt supply to 6.4 volts, was burned out. Loss of this diode would explain the instrumentation symptom, which in all four cases was full-scale and unchanging.

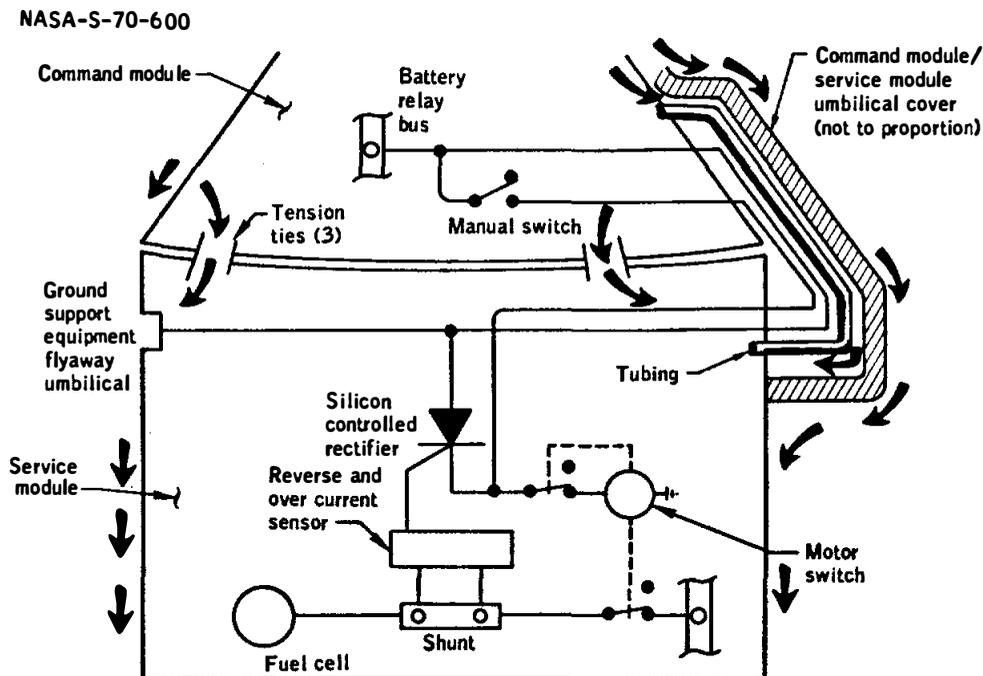
Figure 14-5.- Fuel cell disconnection circuitry.

The voltage transient that was induced on the battery relay bus by the static discharge exceeded the current rate-of-change characteristics of the silicon controlled rectifiers in the fuel cell overload sensors and disconnected the fuel cells from the bus (fig. 14-5). As a result, the main bus loads of 75 amperes were being supplied totally by entry batteries A and B, and the main bus voltages dropped momentarily to approximately 18 or 19 volts, but recovered to 23 or 24 volts within a few milliseconds. The low dc voltage on the main buses resulted in the illumination of undervoltage warning lights, a drop out of the signal conditioning equipment, and a lower voltage input to the inverters. The momentary low-voltage input to the inverters resulted in a low output voltage which tripped the ac undervoltage sensor causing the ac bus 1 fail light to illuminate. The transient that disconnected the fuel cells from the buses also caused the silicon controlled rectifier in the overload circuits to indicate an ac overload. At 2 minutes 22 seconds into the flight, the crew restored fuel cell power to the buses. All bus voltages remained normal throughout the remainder of the flight.

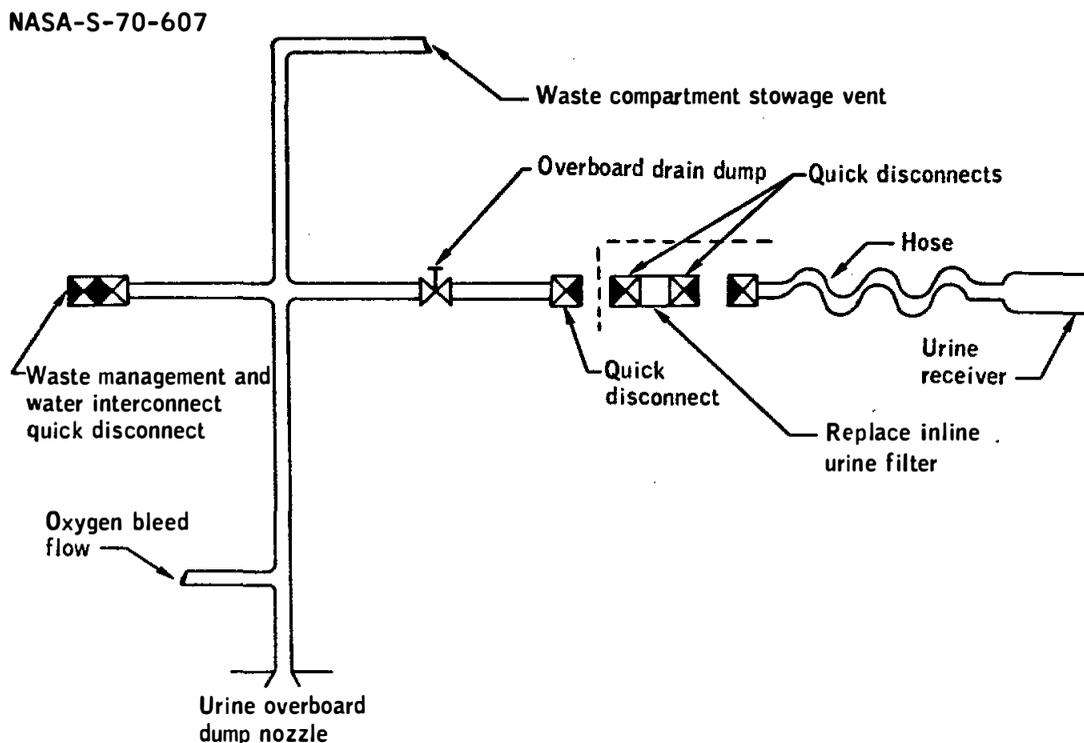
Figure 14-12.- Urine dump system flow schematic.

By about 215 hours, the crew reported that both urine filters had clogged and that the urine overboard dump system was being operated without a filter. The inline filter (fig. 14-12) clogged the day after the Commander and the Lunar Module Pilot returned to the command module from the lunar surface activity (day 7). The filter was then replaced by a spare unit which also clogged 2 days later. The urine dumping system operated satisfactorily without a filter for the remainder of the mission (approximately 30 hours).

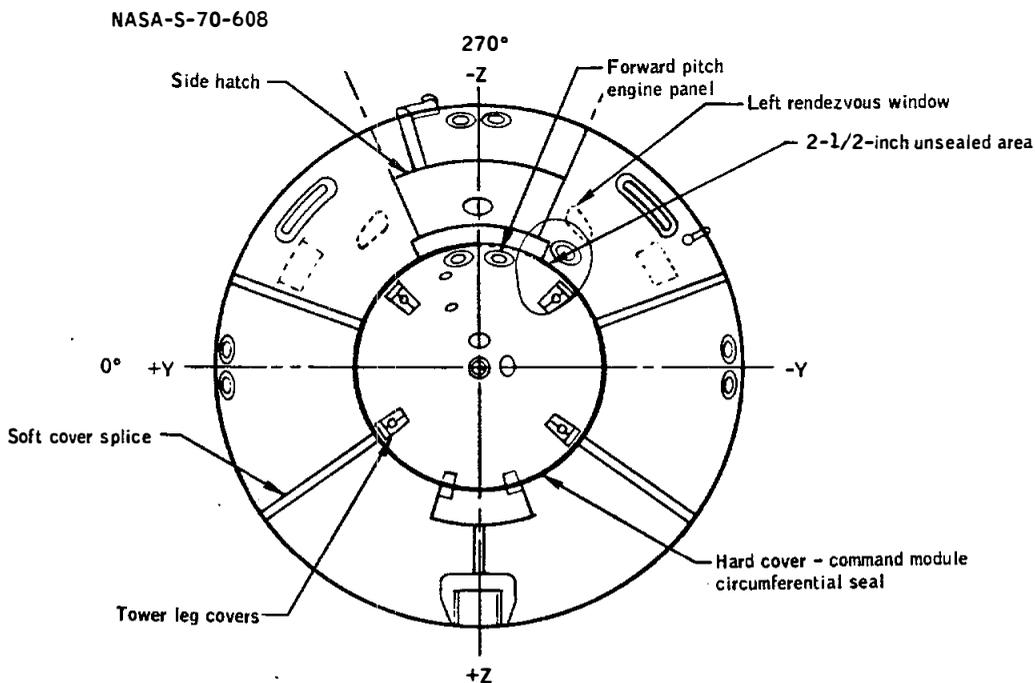
Figure 14-13.- Boost protective cover view looking aft.

The hatch, left-hand side, and both rendezvous windows of the command module had considerable amounts of contamination appearing as vertical streaks on the exterior surfaces. Before flight, gaps in the boost protective cover were noted in the hard-to-soft transition region over the left rendezvous window (fig. 14-13). A procedure requires that these gaps be sealed with a composition sealant on final installation of the boost protective cover; however, some gaps were not sealed. The crew reported that during the heavy rain just prior to launch they saw water on the exterior window surfaces and also observed water flowing over the windows at tower jettison. The water rivulets acted as collection sites for the exhaust residue during escape motor firing. After the water evaporated, the residue deposits remained on the surfaces of the windows.

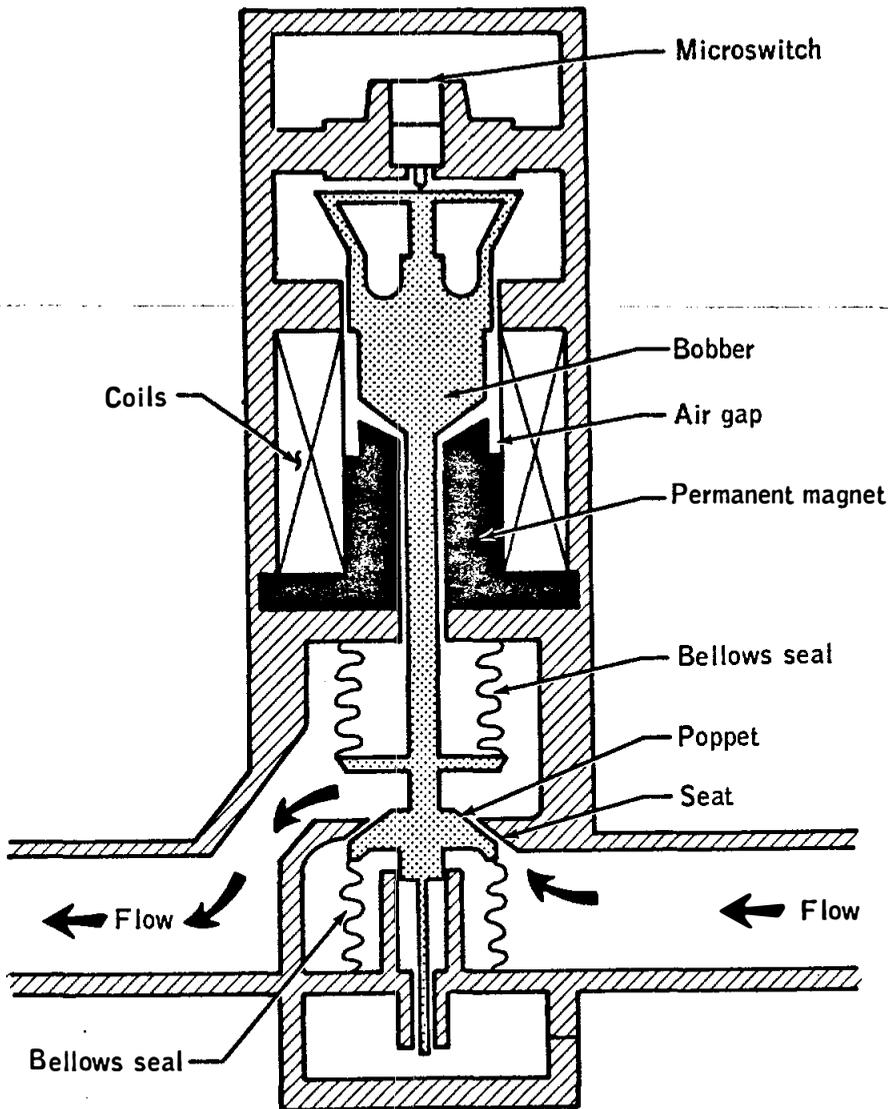
Figure 14-16.- Cross sectional view of reaction control system isolation valve.

When the oxidizer isolation valve was disassembled after flight, the inlet-side bellows had been deformed enough to prevent the valve from staying in the closed position. The bellows in the system 1 propellant

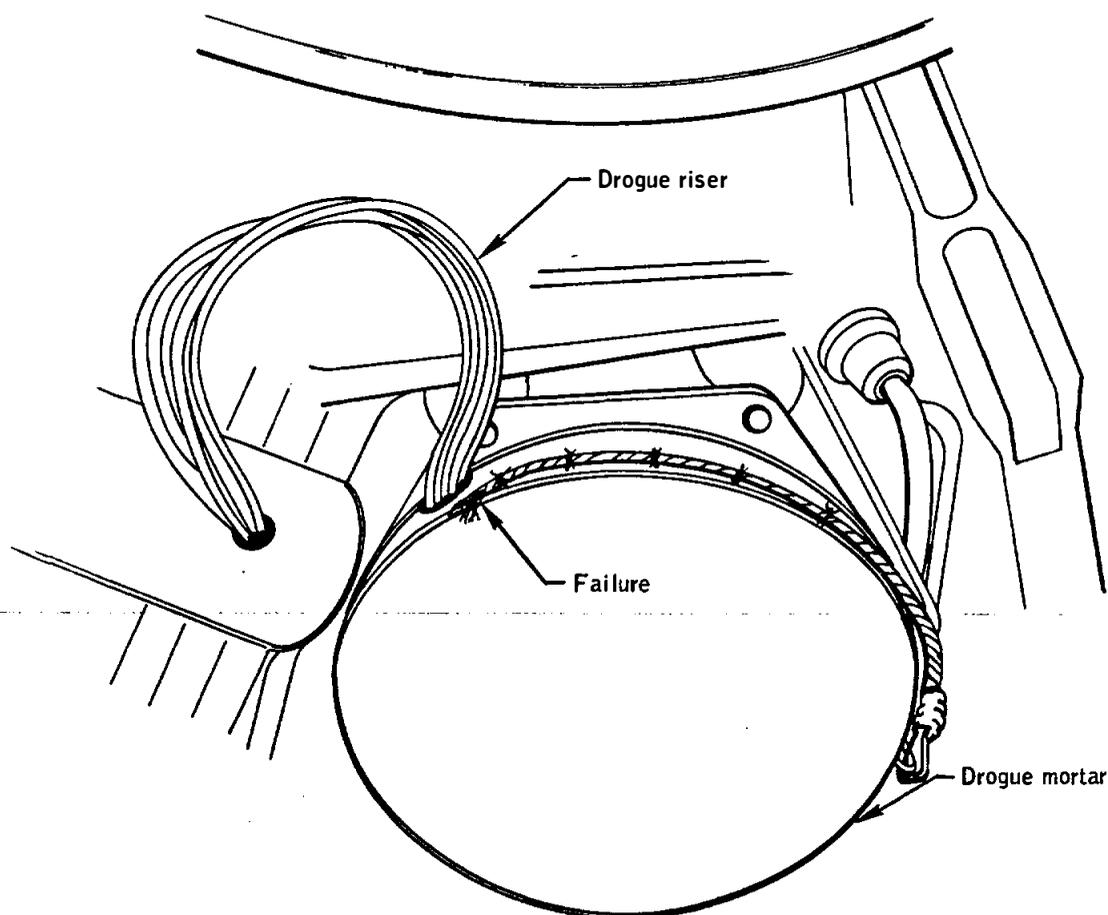
Figure 14-20.- Failed lanyard at right-hand drogue mortar.

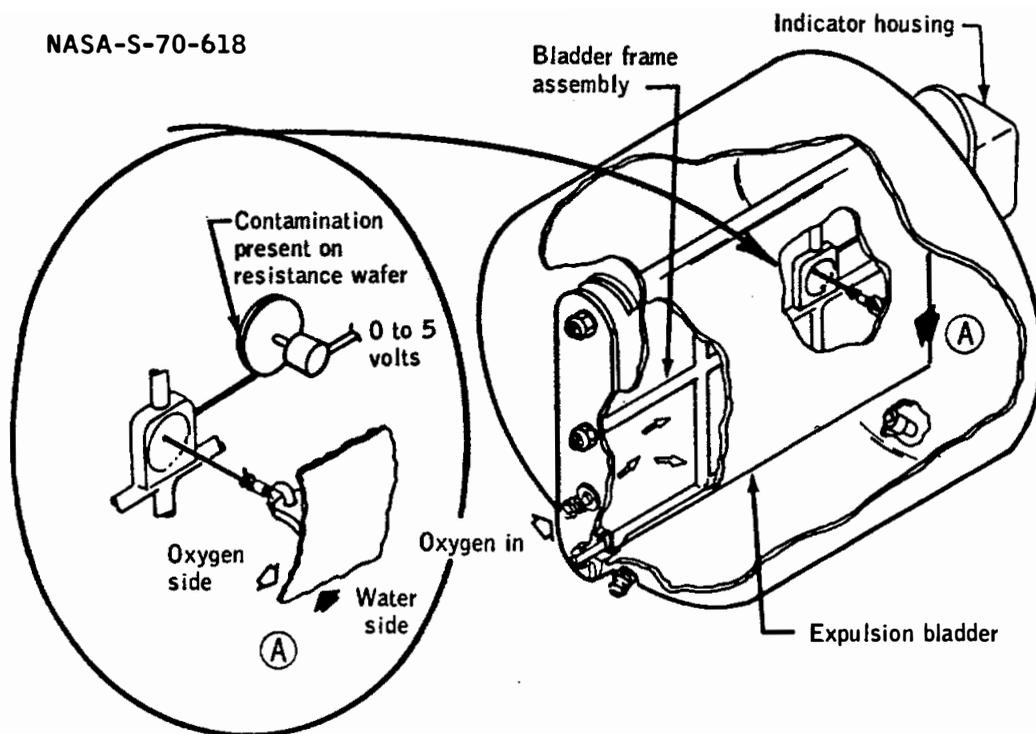
Tests of the potentiometer reproduced the output fluctuations for wiper positions equal to approximately zero quantity (zero volts) and full quantity (5 volts). The potentiometer was disassembled and appeared clean and free of contamination except for a slight stain on the end surfaces of the resistance wafer (fig. 14-24) corresponding to wiper positions for the 0 and 5 volts. The film was removed with a water-moistened swab, but the quantity of contaminate was too small to be identified.

Figure 14-23.- Area of failure in erratic potable water transducer.

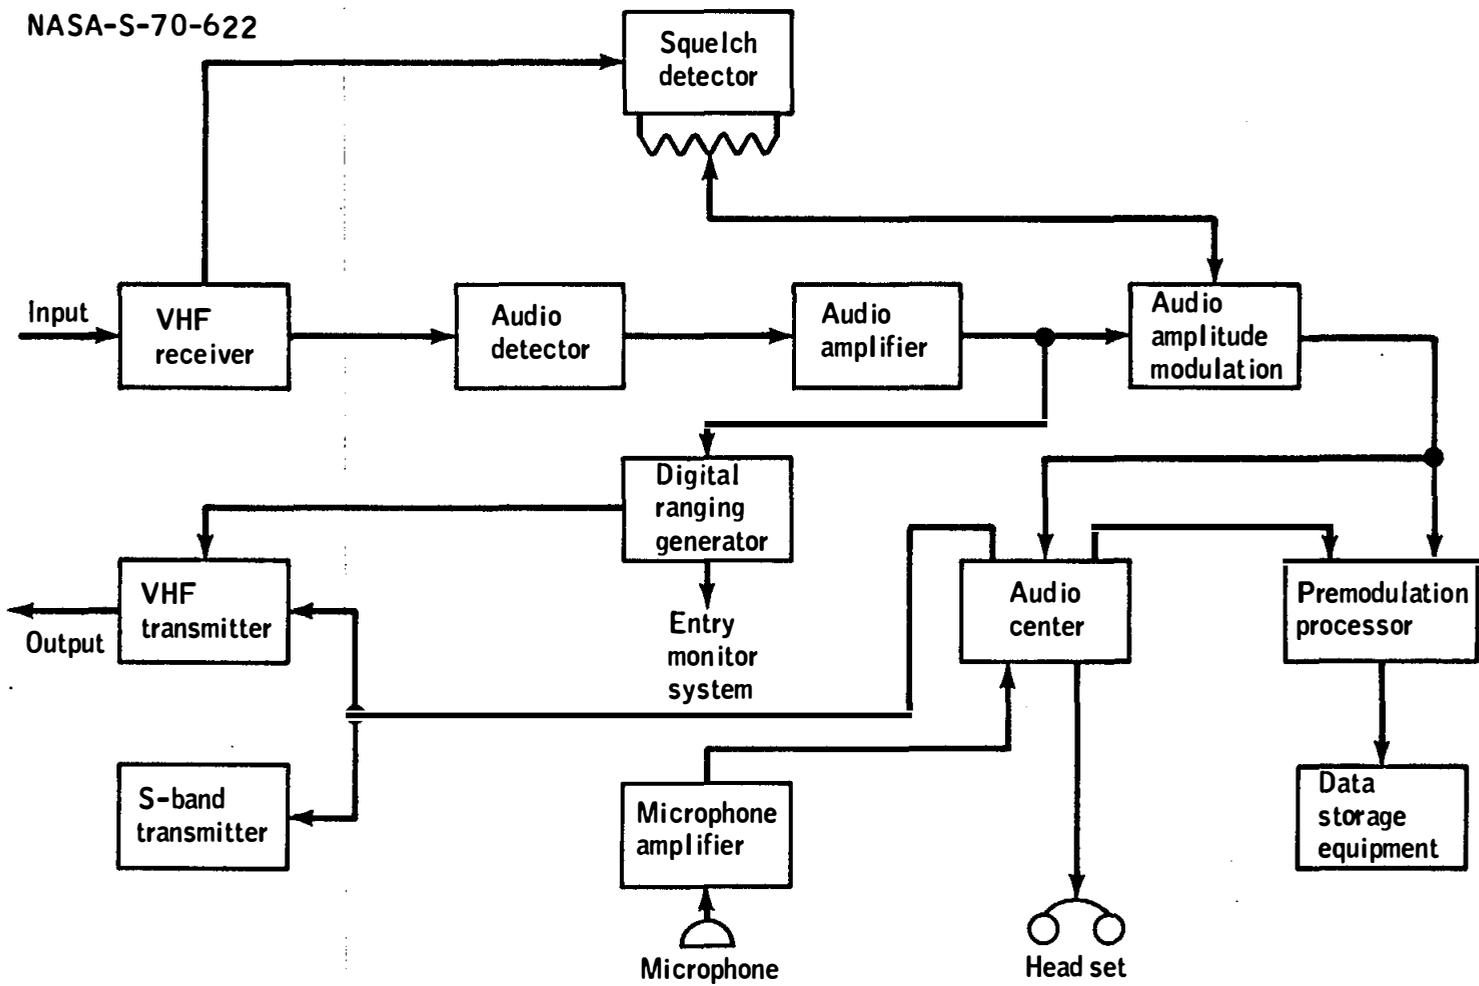
Figure 14-27.- Command module VHF communications configuration.

During the time period from 142:43:00 to approximately 142:53:00, the signal strength was strong enough to maintain the squelch circuit open, as verified by flight data. During the concentric sequence initiation maneuver, the squelch was noted as dropping in and out. According to predictions, the selection of either the left or the right command module antenna did not significantly affect voice communications. During this time, the received signal strength (fig. 14-28) was approximately minus 105 dBm while using the command module right antenna and lunar module forward antenna. This figure also shows the signal strength to be minus 102 dBm or less while using the command module left antenna and lunar module forward antenna according to the flight plan. From previous tests, the squelch thumbwheel, when set at approximately 6, requires from minus 100 to 105 dBm to unsquelch the audio signal.

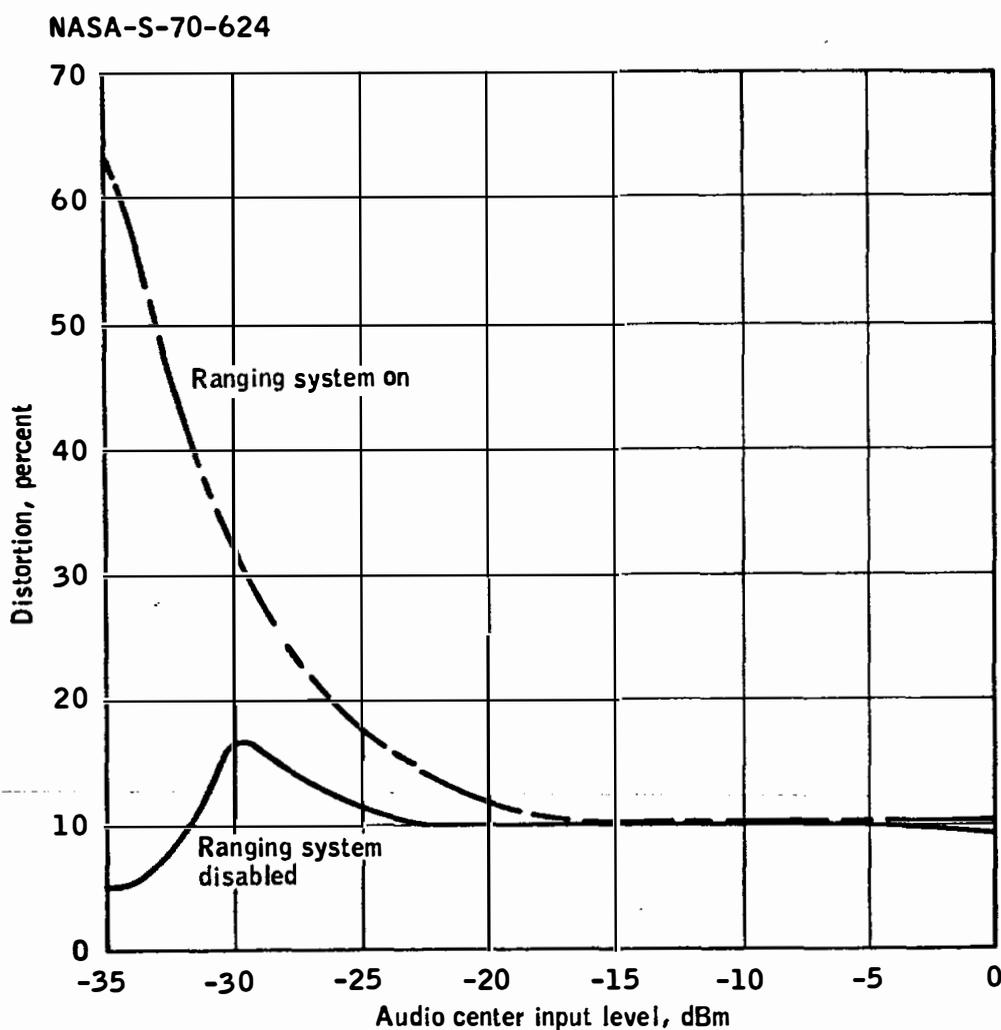
Figure 14-29.- Lunar module received VHF audio distortion.

reduced level can then cause a voice-operated dropout of the voice operated transmitter. Such dropout did not occur at this time, because the Command Module Pilot was using the push-to-talk mode. Figure 14-29 shows the percent distortion of the lunar module received signal versus the command module audio center input, both with and without ranging. The curve shows that, in the ranging mode as the input level to the audio center decreases, distortion of the received signal increases significantly. This distortion cannot be directly related to intelligibility, but it does indicate that system performance is degraded by the low input levels.

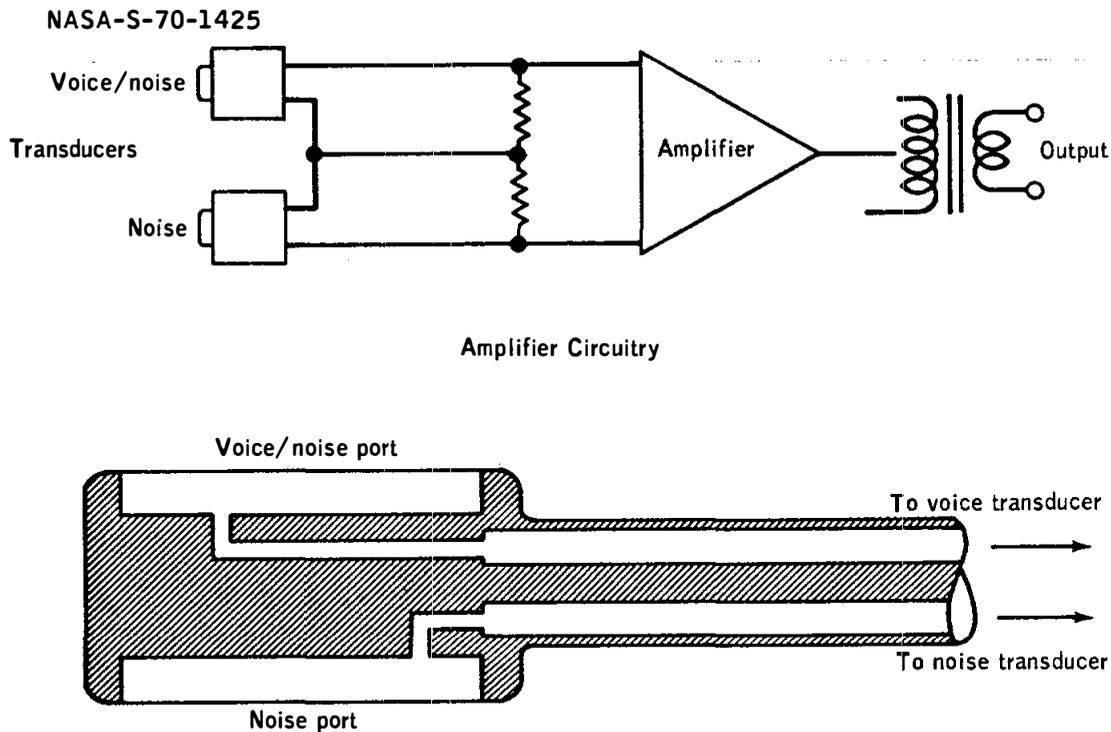
Figure 14-30.- Headset microphone voice/noise ports and amplifier circuitry.

The headset microphone was designed to provide noise cancelling through mechanical spacing of the voice-capture and noise-cancelling ports (fig. 14-30). The output of the microphone amplifier is the amplified difference between the voice and noise transducer outputs. Therefore, with improper microphone placement, voice transmissions also enter the noise port, partially cancel transmissions entering the voice port, and thereby reduce the overall voice output level.

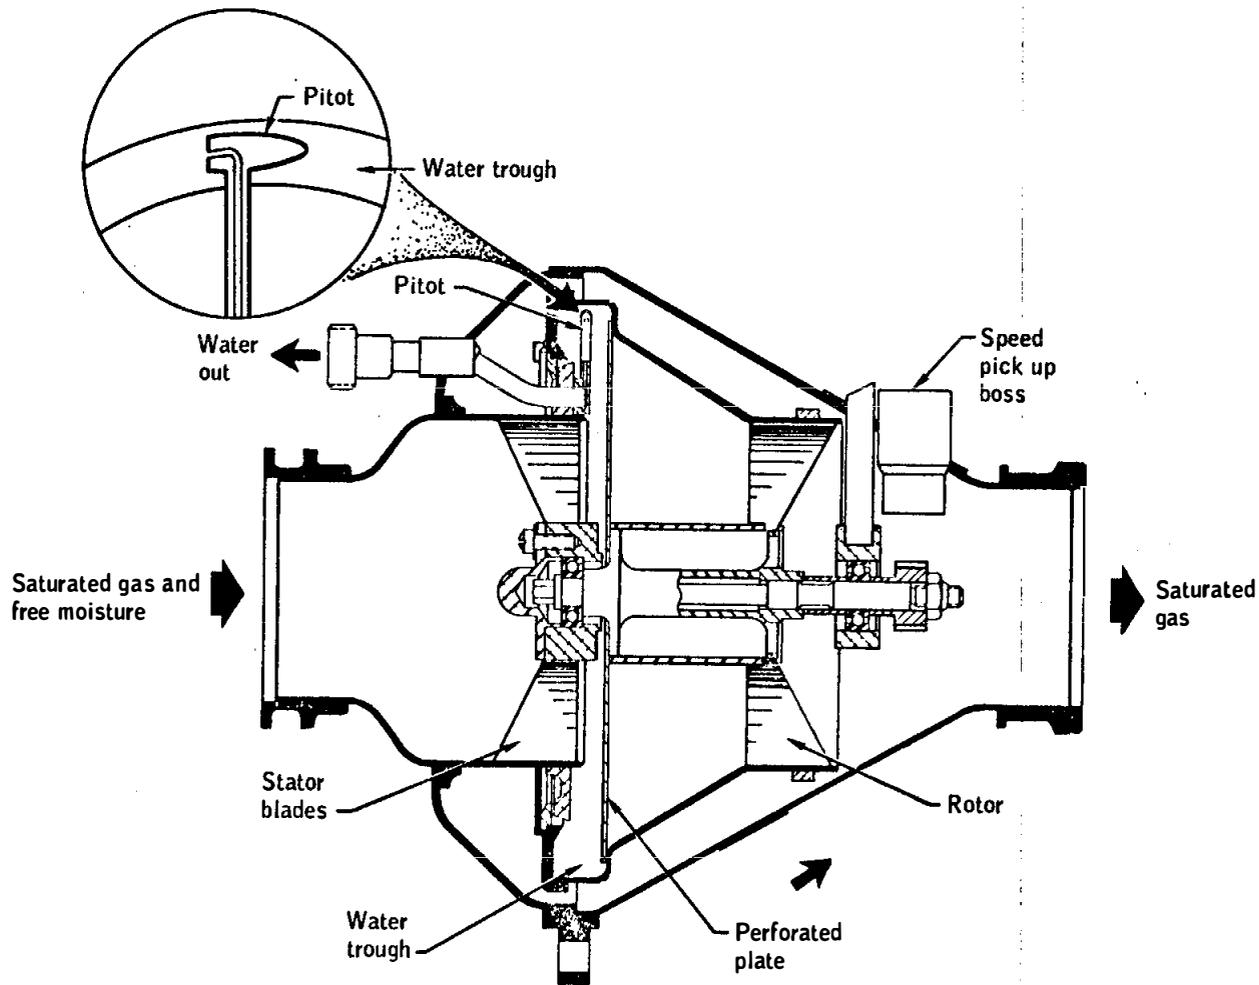
Figure 14-31.- Water separator and pitot configuration.

The water separator speed indication was above the upper limit (in excess of 3600 revolutions per minute) for about 50 percent of the mission. Since the water separator is a gas-driven centrifugal pump, this high speed indicates a higher than normal gas flow through the separator. Tests have shown that, at separator speeds in excess of 3700 revolutions per minute, water splashing occurs at the pitot tube (fig. 14-31) allowing water to bypass the separator.

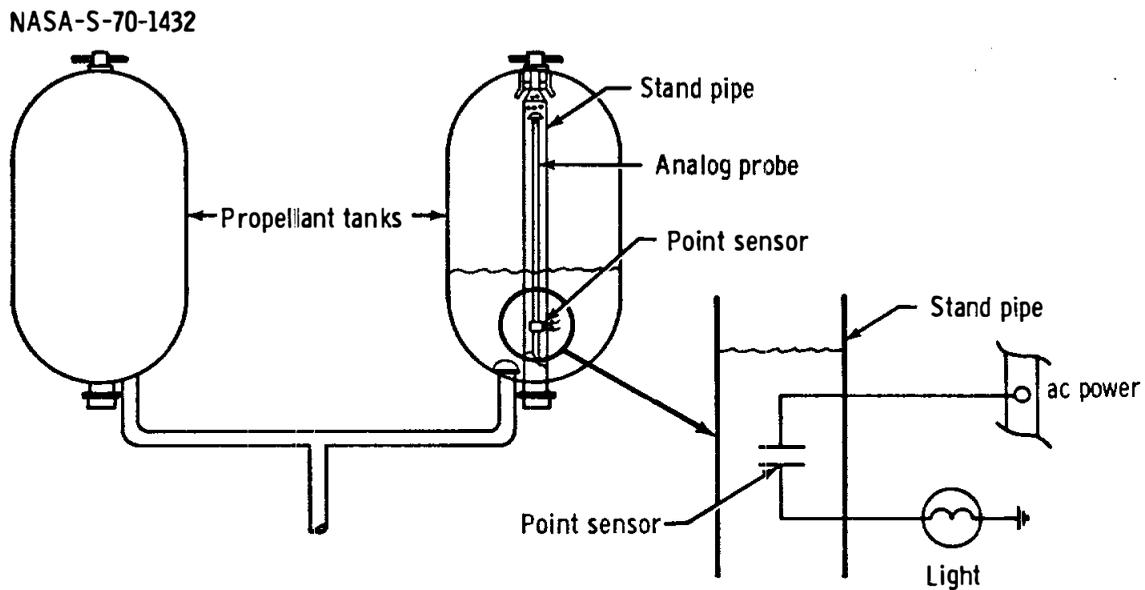
Figure 14-37. - Descent propellant tank low-level sensor schematic.

The low-level light for descent propulsion propellant quantities illuminated about 25 seconds early. The low-level light is activated and remains latched on when any one of the four low-level point sensors (one in each propellant tank) is uncovered (fig. 14-37).
