Reusable Solid Rocket Motor STS-114 Flight Readiness Review/CoFR

Motor Set RSRM-92

29-30 June 2005

092-FRRK

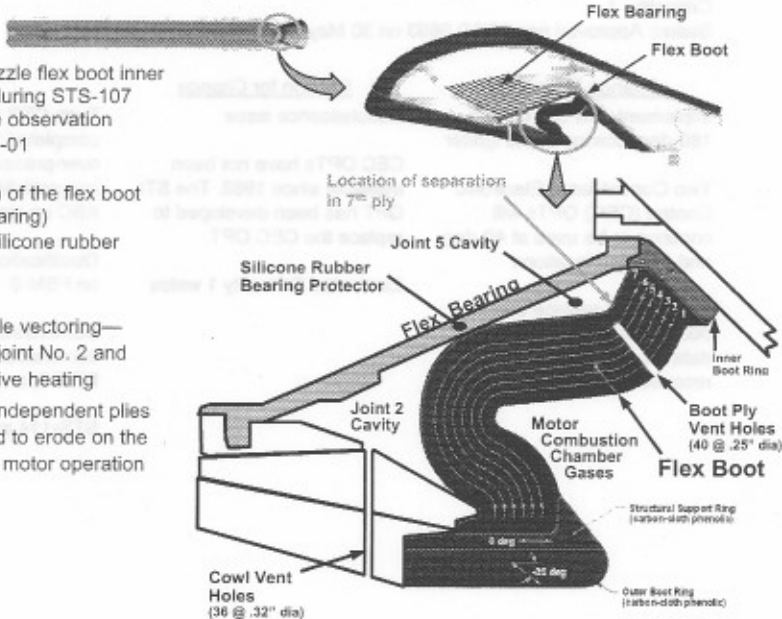
In-Flight Anomaly (IFA) STS-107-M-01 (RH Nozzle Flex Boot Separation)

- A 57-in. separation of the RH nozzle flex boot inner (seventh) rubber ply was noted during STS-107 postflight disassembly—first-time observation
 - Elevated to IFA STS-107-M-01 (20 Feb 2004 PRCB)
- Separation did not affect function of the flex boot (thermal protection of the flex bearing)
 - No heat affect to adjacent silicone rubber bearing protector

- Rubber boot "flexes" during nozzle vectoring—protects flex bearing and nozzle joint No. 2 and No. 5 from convective and radiative heating
- The boot is comprised of seven independent plies of rubber—the rubber is designed to erode on the combustion chamber side during motor operation

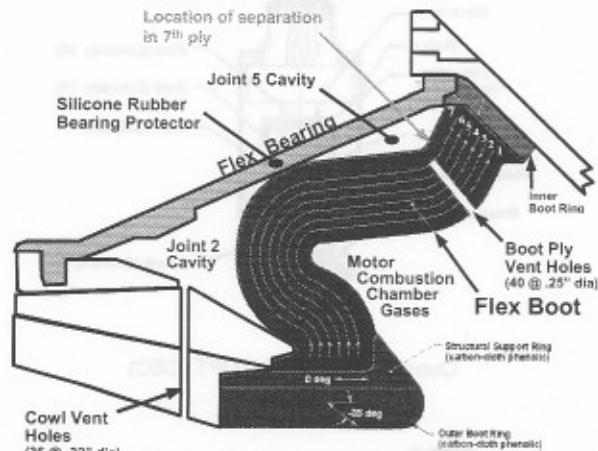
- Plies are vented via forty 0.25-in.-diameter holes to reduce stiffness of boot during motor operation
- Each ply is comprised of multiple 0.10-in. vulcanized layers

Ply 1	4 layers
Plies 2-6	3 layers in each
Ply 7	Varies from 3.5-5.5 layers

- Number of layers in seventh ply are varied to meet overall boot thickness requirements while precluding interference with the bearing protector and flex bearing (assembly fit-up)

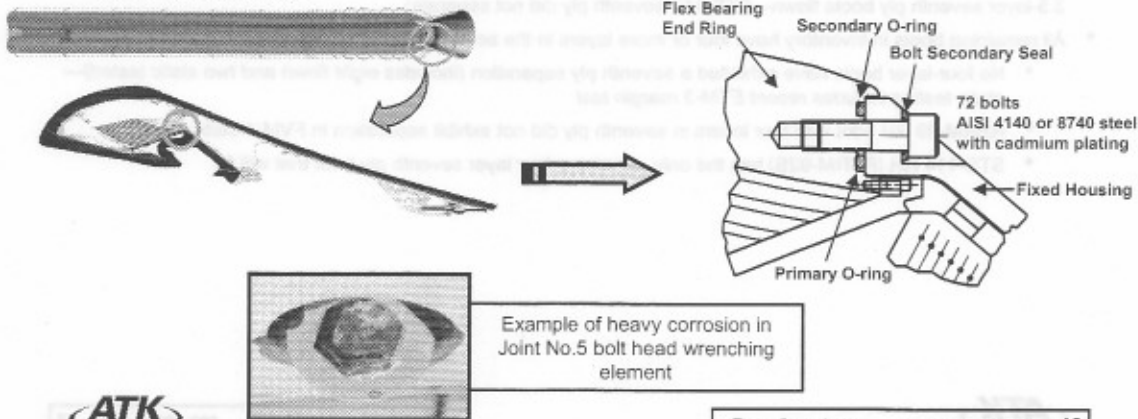
Nozzle Joint No. 5 Bolt Corrosion

- PRs AB-BI125-0002 [STS-114 (RSRM-92)] and SB-BI124-0020 [STS-121 (RSRM-90)] have been written against four RSRM nozzles for corrosion on the nozzle joint No. 5 bolts. Corrosion is in the head-wrenching element

- Corrosion of high-strength steel raises a concern for degradation of bolt capability due to net section loss and/or environmentally-assisted cracking (stress corrosion cracking or hydrogen embrittlement) and subsequent bolt failure

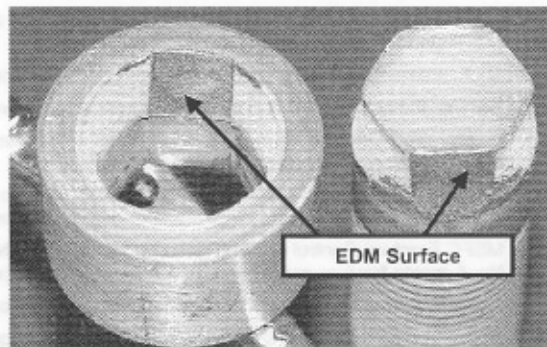
EDM Notched Bolt

- Residual capability test, simulating a crack completely through one of six bolt-wrenching element plains, showed bolt heads to be fault tolerant
 - Electron discharge machined (EDM) flaw at the bottom of the socket head to the head/shank radius—approximately 0.35 in. wide by 0.3 in. deep
 - Four bolts pulled to failure and all bolts broke in the head at loads greater than 70 kips—minimum specification limit is 63 kips, maximum preload is 54 kips

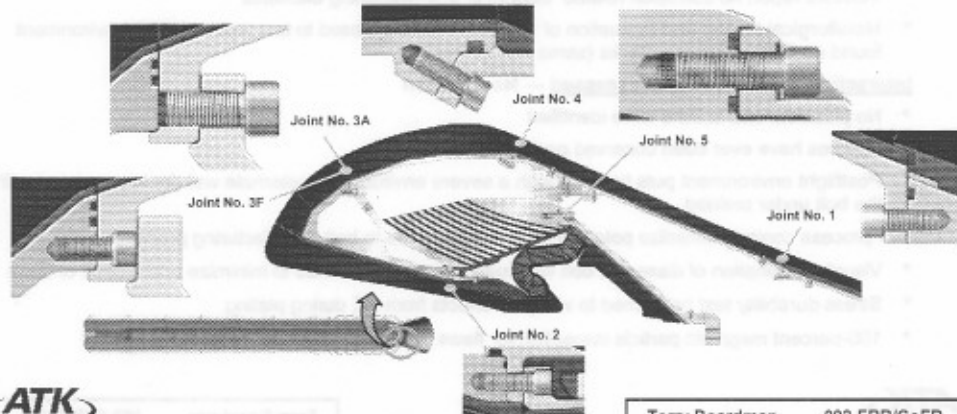
- All nozzle joints are fault tolerant with respect to bolt failure
 - Compressive operational loads are carried across nozzle joints
 - Joint No. 5 seal tracking ability assured with a pattern of three bolts out—one bolt in
- Joint No. 5 represents bounding case for nozzle joint Nos. 1, 3F, 3A, and 4 which use bolts of the same material
 - Joint No. 5 is the only opening joint
 - Only joint in which bolt stress increases during motor operation
 - Only joint with a secondary seal provided by packing-with-retainer
