APOLLO 16 MISSION  
ANOMALY REPORT NO. 10

REAR STEERING INOPERATIVE

PREPARED BY  
Mission Evaluation Team

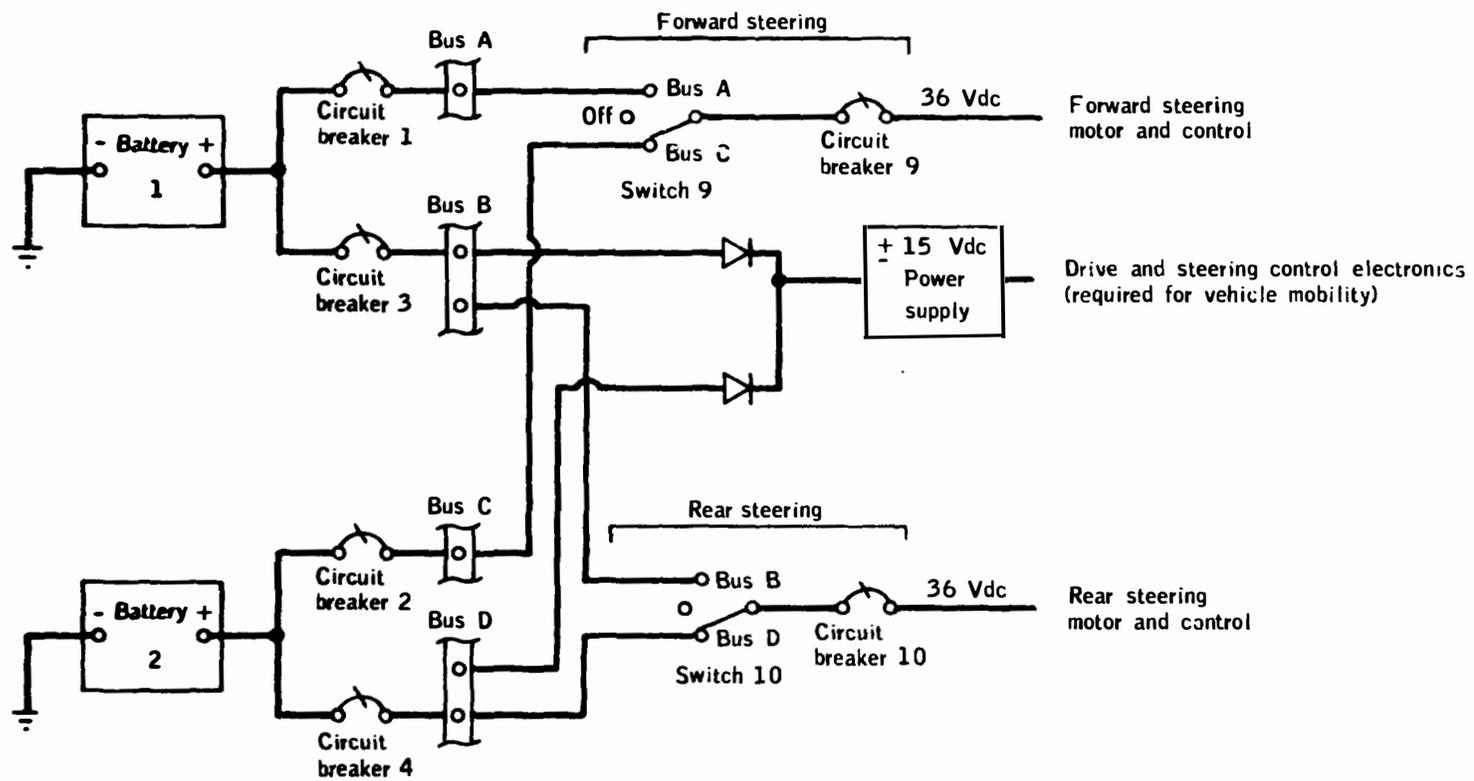
Figure 1.- Lunar roving vehicle steering power schematic.

Both the front and rear wheels of the lunar roving vehicle are steerable and are controlled by a hand controller. The driver can select front, rear, or both front and rear steering using switches located on the control and display panel. The rear steering system is powered when either circuit breaker 3 or 4 is closed, and circuit breaker 10 is closed with switch 10 positioned to the active bus (fig. 1).

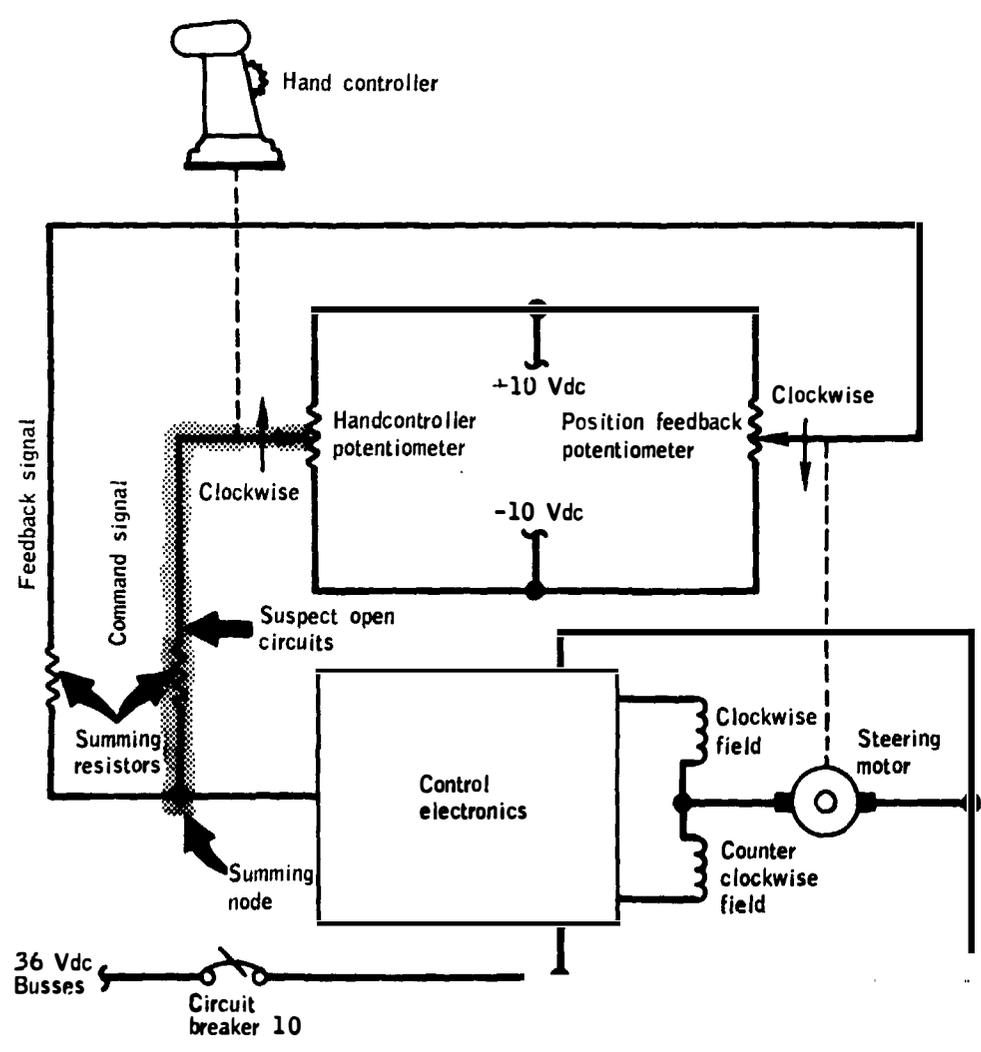
Figure 2. - Electrical steering system.

The only condition that will cause loss of steering and still keep the wheels centered during turns is an open circuit, either in the hand controller potentiometer or in the wiring between the potentiometer wiper and summing node (fig. 2).

The wiring, connectors, and summing resistor are all adequate. The only problem found was that the potentiometer wiper would open-circuit at temperatures below minus 58° C because the lubricant used in the potentiometer congealed. Thermal analysis, however, showed that neither lunar roving vehicle 1 or 2 reached temperatures below minus 5° C.

An open circuit must have occurred either in the hand controller potentiometer or between the potentiometer wiper and the summing node.

No corrective action was taken since the problem could not be further isolated and since the vehicle design and testing were considered adequate.
