14.4.8 Sample Collection Bag Fell Off the Portable Life Support System Tool Carrier

14.4.9 Lunar Surface Far Ultraviolet Camera Azimuth Adjustment Became More Difficult

14.4.10 Velcro Patch Came Off Both Padded Sample Bags

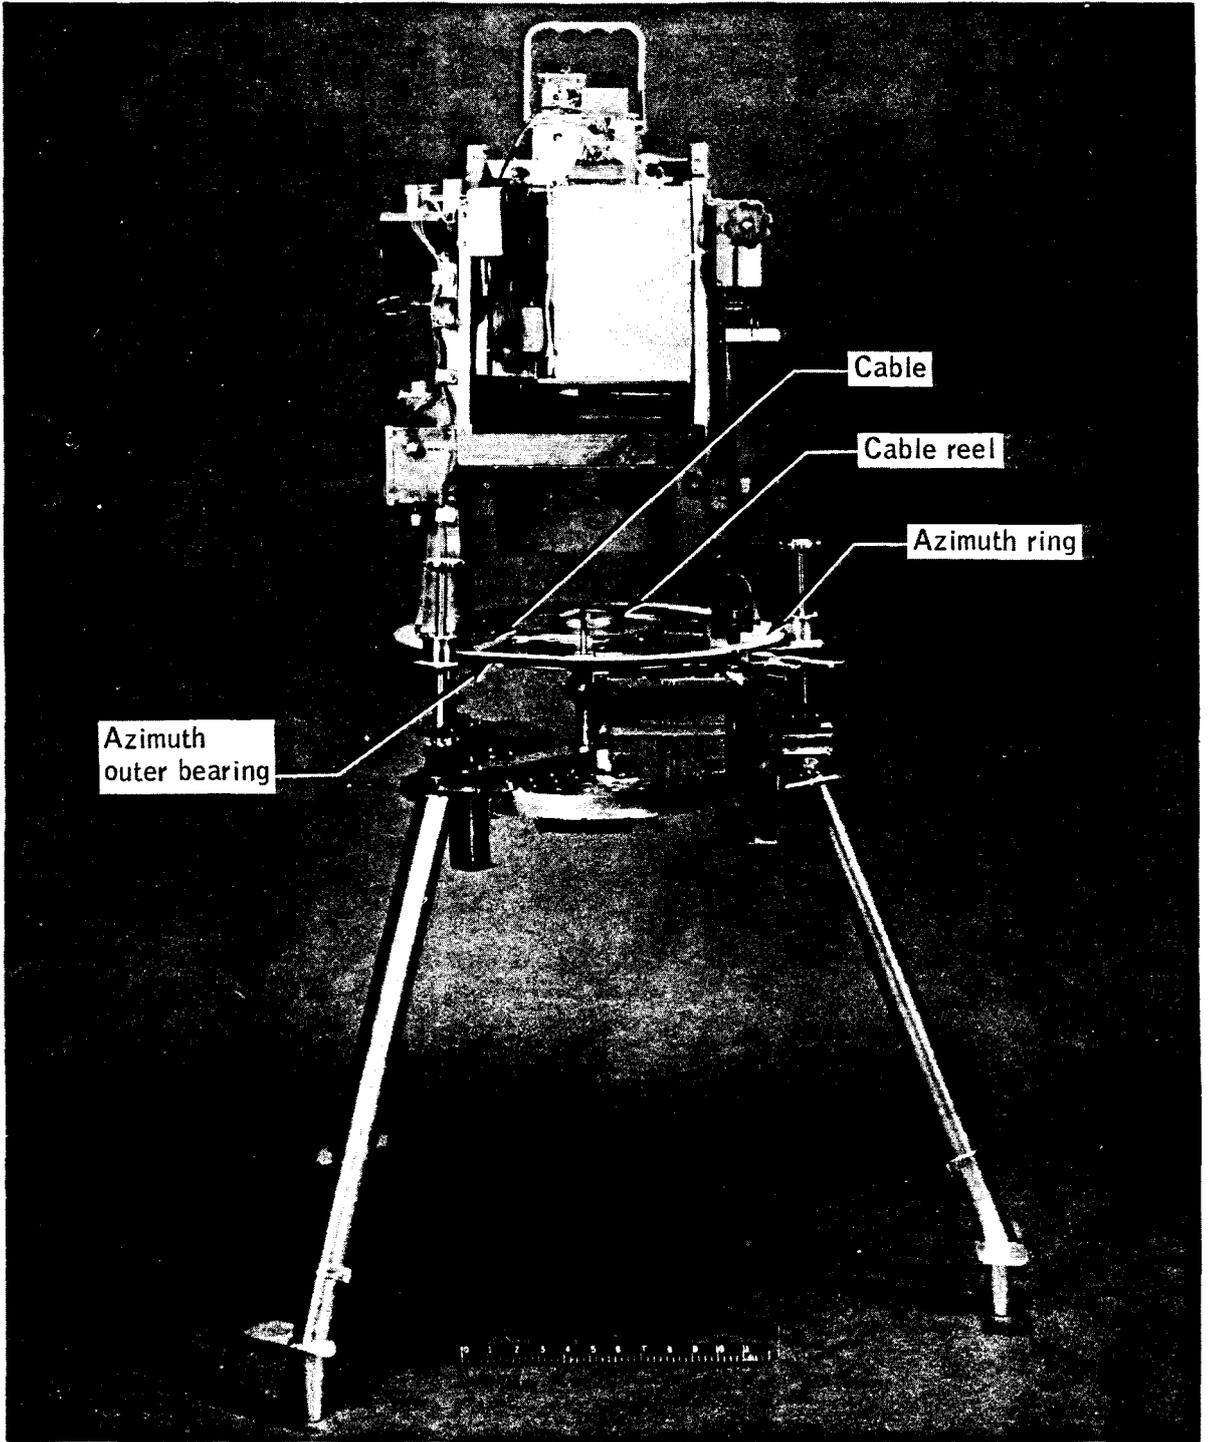
Figure 14-63.- Far ultraviolet camera.

Rotating the camera assembly for each azimuth setting was more difficult than expected, and became progressively difficult during the lunar stay.

To adjust the azimuth to the proper dial reading, the camera is rotated on a 12.5-inch diameter ball-bearing ring (fig. 14-63). The bearing is not sealed; however, the crew did not observe any lunar dust on the bearing.

The azimuth ring bearing was packed with a waxy, low-outgassing grease which stiffens appreciably at temperature below 50° F. This grease is normally used as a sealant rather than a lubricant. The camera was intentionally kept in the shade to protect the film from high temperatures. As a result, the grease stiffened. The manual azimuth adjustment operation was not included in cold chamber tests with other operations of the camera.

The difficulty was caused by the use of the wrong type of grease in the azimuth ring bearing.

The experiment is not scheduled for another flight, and no further action is required.

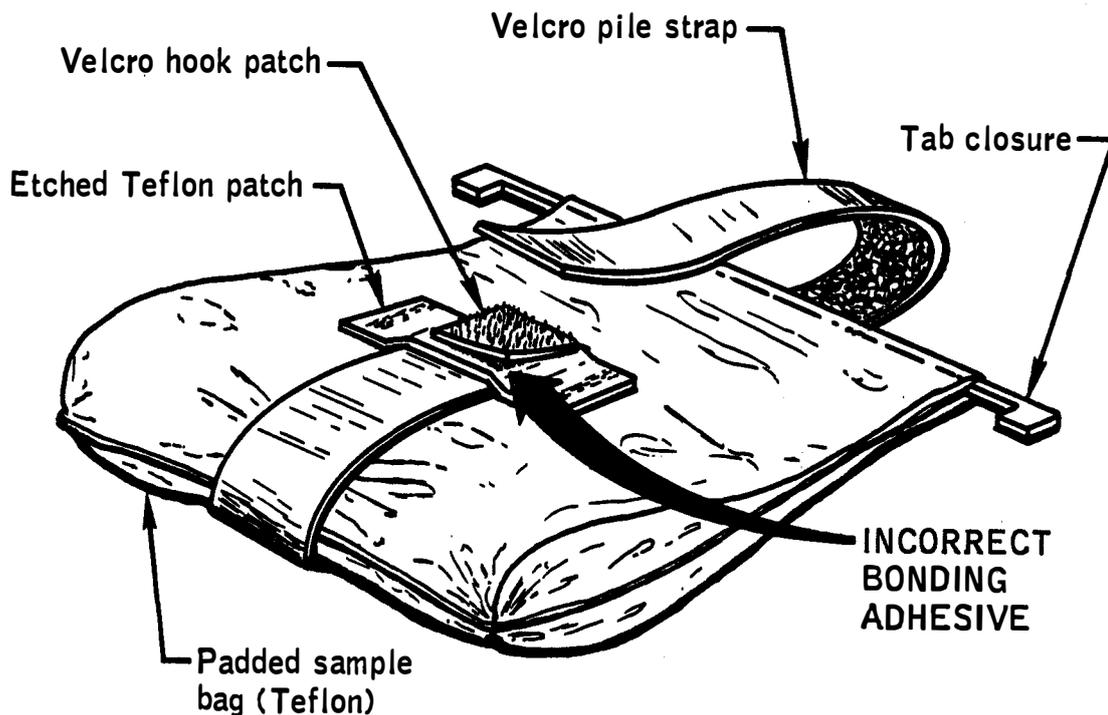
Figure 14-64.- Padded sample bag.

When the crew wrapped the Velcro strap around each of the padded sample bags to further secure them, the Velcro attachment patches came off the bags and the straps were ineffective.

A 20-inch-long wrap-around Velcro pile strap is provided to hold the bag closed in addition to the usual tab closure (fig. 14-64). One end of the strap is bonded with a fluorel adhesive to an etched Teflon patch which
