NASA TN D-6722

APOLLO EXPERIENCE REPORT -  
LUNAR MODULE DISPLAY AND  
CONTROL SUBSYSTEM

*by Andrew J. Farkas*  
*Manned Spacecraft Center*  
*Houston, Texas 77058*

NATIONAL AERONAUTICS AND SPACE ADMINISTRATION • WASHINGTON, D. C. • MARCH 1972

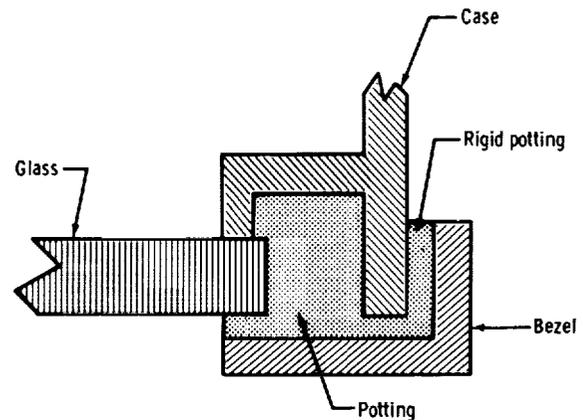
Figure 4. - Meter case seal.

4. Sealing cases — The most significant problem during early testing of meters was in sealing the front glass within the case. Failures occurred during thermal vacuum testing. Specifically, breaks occurred in the bond between the glass and the case. During the thermal vacuum test, stresses developed which pulled the bond apart. Changing the potting to a stronger, more rigid material improved the bond, but caused the glass to crack. In analyzing the problem (fig. 4), the determination was made that a material had to be selected that had the proper shear strength, yet was flexible. The potting material between the meter case seal, the glass, and the case was changed to a flexible polyurethane, and the glass was made smaller to allow more potting. This change reduced the stress at the bond line so that seal breaking was prevented and the bond was flexible enough at a low temperature to prevent the glass from breaking.

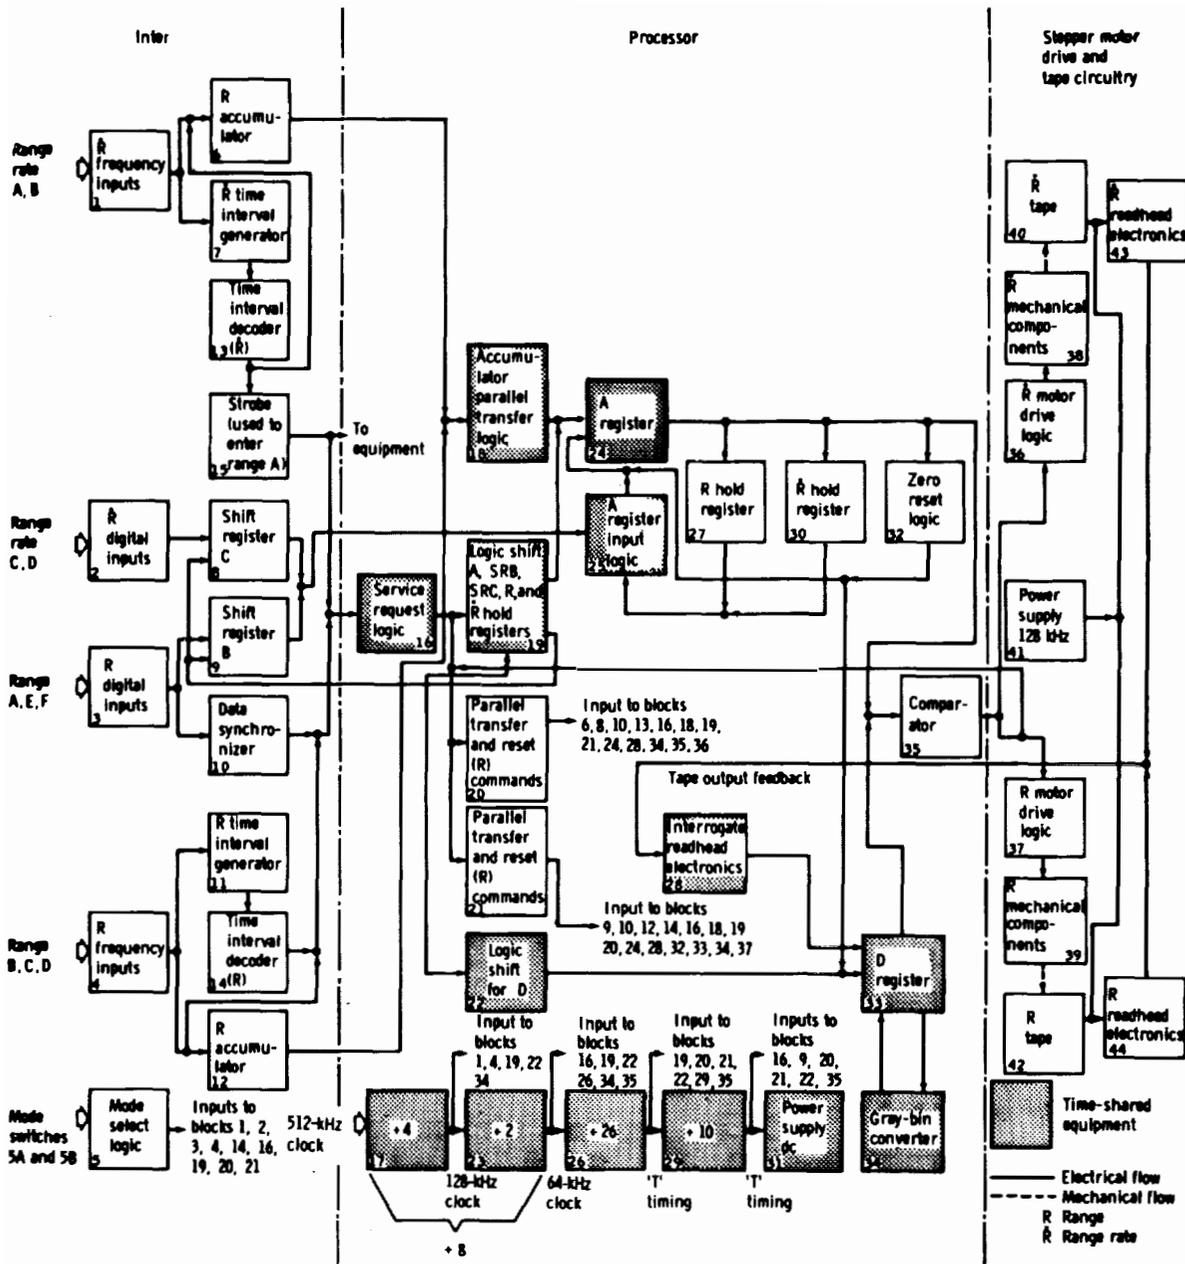
Figure 5. - Simplified signal flow diagram, lunar module range/range-rate indicator.

The high-reliability indicator has been the source of many problems throughout the program. The most significant problem occurred on the Apollo 9 mission (LM-3) just before launch. Test personnel observed erratic range tape operation while conducting various tests. The tape dropped below zero off-scale, oscillated below zero, or moved slightly below zero and then continued normal operation. Extensive testing on the vehicle could not duplicate the failure. A decision was made to replace the indicator and return the malfunctioning equipment to the manufacturer for failure analysis. Extensive testing by the manufacturer, including vibration and thermal environment, reproduced the failure; however, failure occurrence was random. Analysis finally identified two causes for the problems:

1. Oscillation below zero was caused by the serial number on the tape. This failure occurred only if the tape went below zero, not a normal condition.

2. A dual inverter gate micrologic circuit was found to have a poor weld on the common emitter connection. Visual inspection showed the lead surface to be mottled. This failure caused incorrect information to be shifted into the comparator, and this shift resulted in the tape slewing below zero.

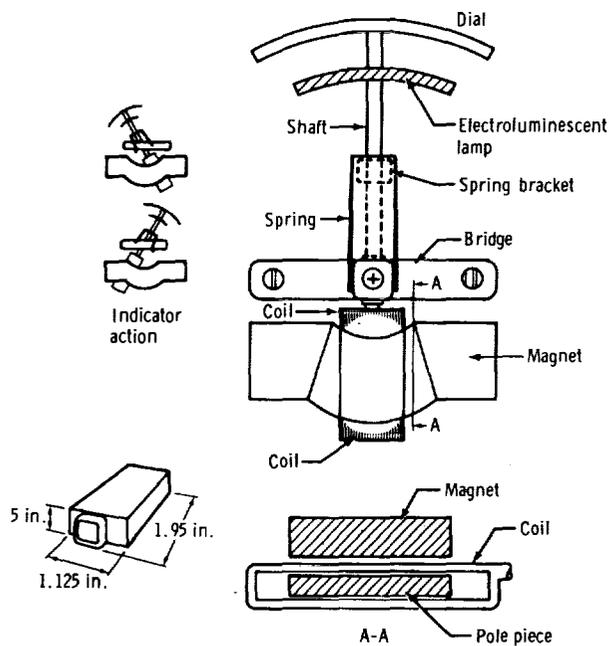
Figure 8. - Flag indicator.

The flag program, from initial development to present usage, has had many problems. The most annoying problem has been flag hangup, or hesitation. Although many corrective actions have been taken, this problem has never been solved. An analysis of acceptance and qualification failures identified the following failure modes.

1. Bearing bridge resonance — The bearing bridge resonated under random vibration, causing the flag to hang up. Design changes were made to the bridge to increase the resonant frequency above the critical level.
2. Coil clearance — The clearance between the coil and the pole piece or magnet (or both) was not sufficient; under random vibration, the coil would bind. Corrective action included increasing clearance and more accurate part alinement.
3. Spring system — Many flag hangups were caused by improperly formed springs. Procedures were implemented for proper spring formation and for spring tension measurement.

A review of these problems and earlier flag problems indicates that the best corrective action would be flag redesign. Redesign would provide enough dial restoring torque to overcome any slight increase in friction or sticking. Steps were taken to improve the yield without redesign. A quality control audit was conducted to eliminate contamination; acceptance thermal cycling was added; manufacturing procedures were refined; and additional screening was added to acceptance testing. These actions, while reducing the number of field failures, have not eliminated them. Field failures that do occur are not hard hangups. The flags recover after a few seconds or require tapping to cause transfer. Because of low mission criticality of the flags, this solution to the problem was considered acceptable. Failures of this type (hesitation) have occurred on almost every flight of the LM.

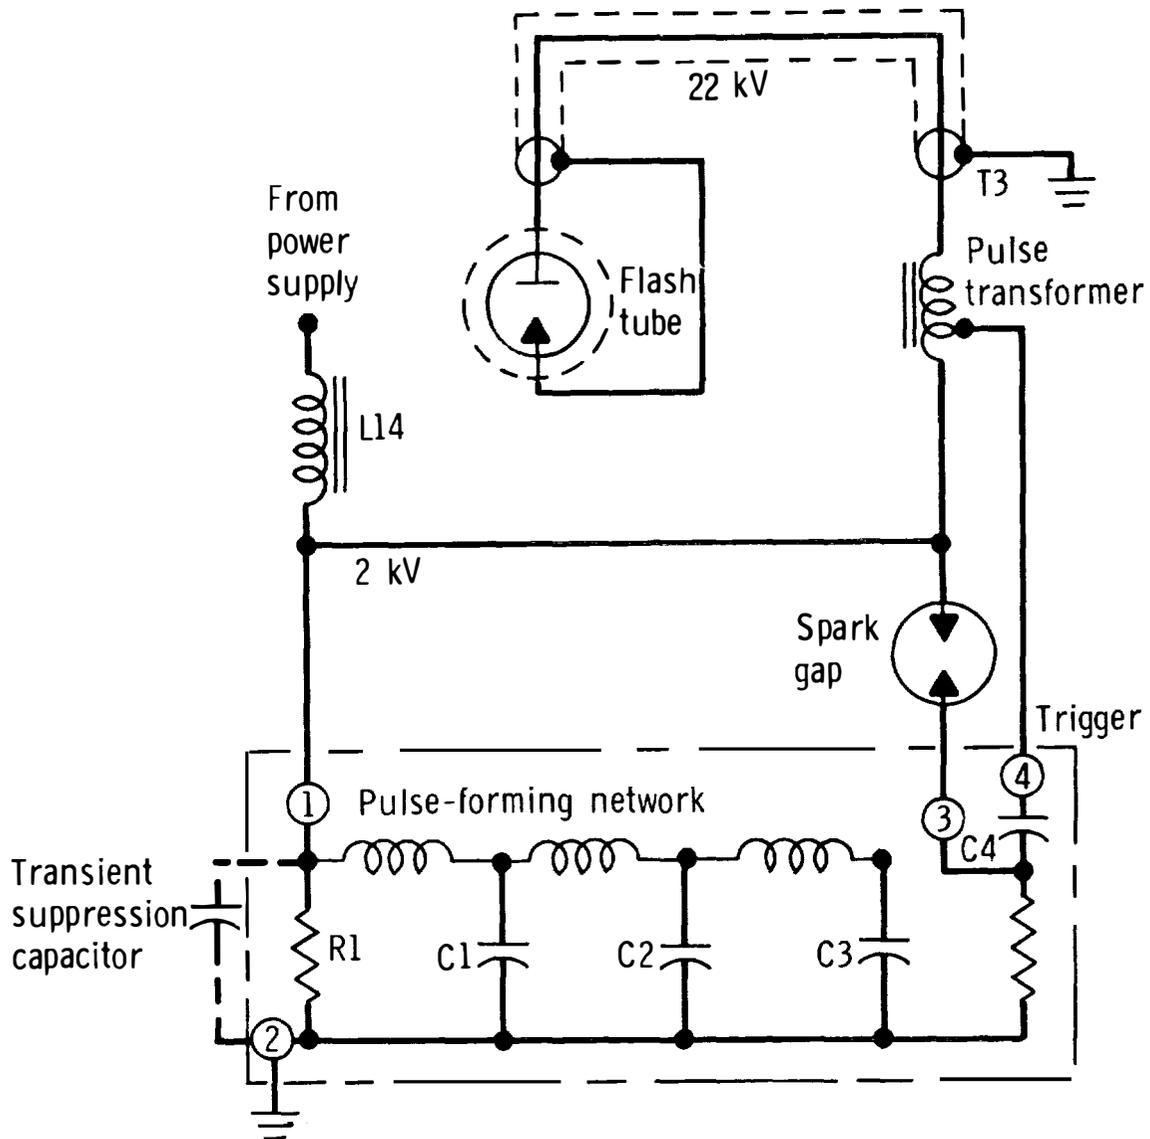
Figure 12. - Pulse-forming network, trigger, and lamp circuits.

Tracking light history has been marked by numerous failures that have occurred in testing, acceptance and qualification, and flight during the Apollo 9 and 12 missions. As a result of design problems, the contract with the original light manufacturer was terminated before any manned Apollo missions were flown, and a new manufacturer was obtained. The new manufacturer, along with the prime LM contractor, was responsible for design and fabrication of the light used during all LM flights. Failures

that occurred were attributed to high-voltage section problems. These failures, and the corrective action listed as follows were encountered after the Apollo 9 failure.

1. Pulse-forming-network failure — Because of qualification failures, design changes were implemented on the PFN. Analysis indicated that the most probable cause of failure was a low-pressure void within the PFN, and this void allowed voltage breakdown. To ensure that a void could not occur and to correct other design problems, the following changes were implemented:
