NASA TN D-6845

**APOLLO EXPERIENCE REPORT -
LUNAR MODULE INSTRUMENTATION SUBSYSTEM**

by David E. O'Brien III and Jared R. Woodfill IV

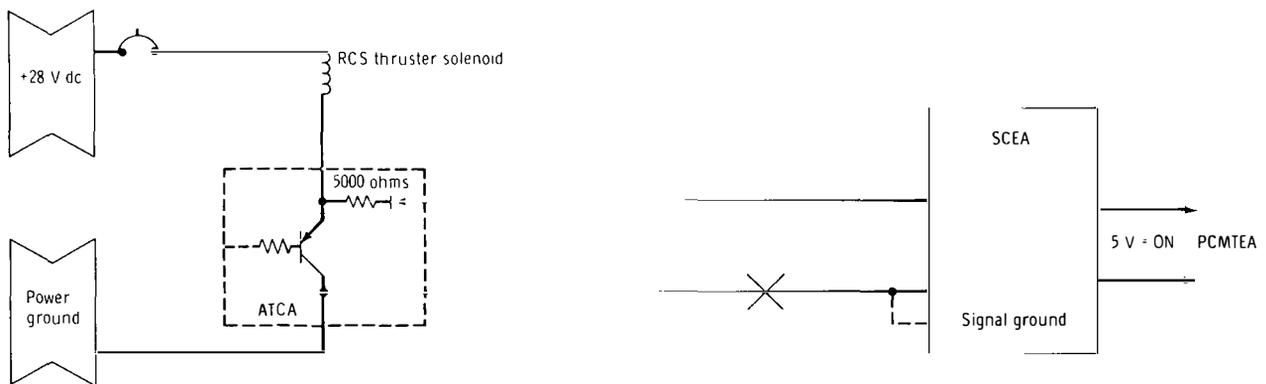
Figure 13. - Discrete buffer, showing the lead to power ground rerouted to signal ground.

Some difficulties arose during the vehicle/instrumentation-subsystem integration. One of the most difficult problems involved the discrete buffer that monitors the reaction control subsystem (RCS) thruster commands in the attitude and translation control assembly (ATCA) (fig. 13). The discrete buffer is designed to monitor either mechanical or solid-state switch closures. The buffer gives a 5-volt ON signal when the resistance across mechanical contacts drops below 120 000 ohms or when the voltage across a solid-state switch drops below 4 volts with a corresponding drop in resistance. The firing command is given in the ATCA by grounding the low side of a solenoid through a transistor switch. The inputs of the discrete buffers are connected across the transistor so that, when the system is activated, the buffer input senses 28 volts until a firing command is given; then, voltage drops to zero and the buffers produce a 5-volt ON output signal. The problem arose when the solenoid circuit breaker was open and no voltage was present across the transistor and buffer inputs. The high emitter-to-collector resistance normally prevents the buffer from giving the ON signal. However, during these periods of no voltage on the transistor, the buffer would occasionally output the 5-volt ON signal. This problem was attributed to noise on the power ground to which one side of the buffer was connected. This connection was moved to signal ground, and the other input remained on the high side (emitter) of the transistor.

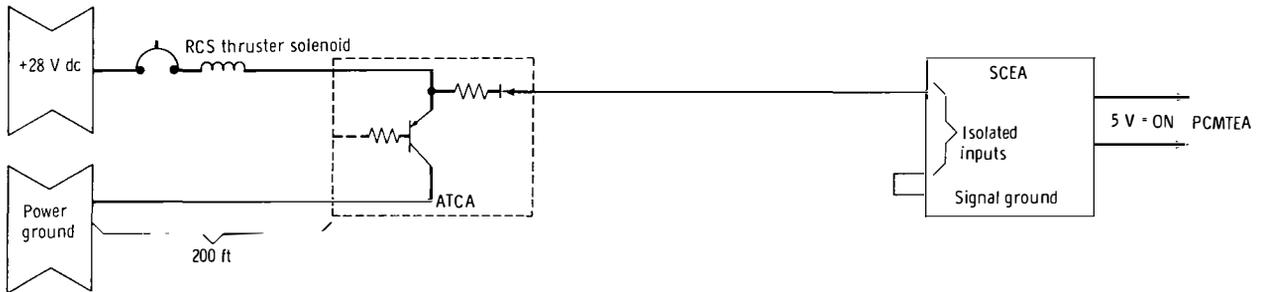
Figure 14. - Discrete buffer, showing how the 200-foot ground lead produced a +6-V dc potential between SCEA and signal ground.

After this change, RCS tests were performed at the White Sands Test Facility (WSTF), and a new problem appeared in the form of short-firing indications. The buffer would give the ON command and then go OFF after a few seconds while the ATCA was still firing the thrusters. The cause of this problem was traced to the setup at the WSTF. The ATCA and the SCEA were located in the blockhouse, and command wires were routed to the pad where the thruster and the electrical power were located. Therefore, the ground wire leading from the collector of the transistors was approximately 200 feet in length (fig. 14). When the firing command was given, the voltage at the transistor dropped to zero, but rose to 6 volts as the current through the solenoid increased. This 6-volt rise was caused by the IR (current \times resistance) drop across the 200-foot ground lead. If the buffer had been connected in the original configuration, with its low side on the collector instead of on signal ground, this short-firing indication would not have occurred. Only a small (0.5 volt) drop across the transistor rather than the 6-volt drop between the transistor and the battery ground would have reached the buffer. No modification was made to the WSTF test setup after the problem had been identified.

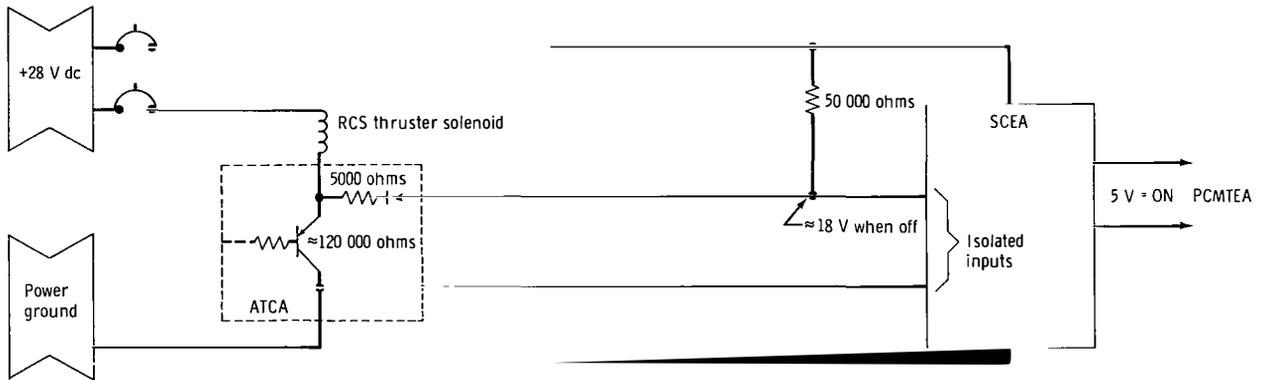
Figure 15. - Discrete buffer, showing how a 50 000-ohm resistor between SCEA power and ATCA transistor produced approximately 18 V dc when transistor was off.

Meanwhile, the first problem (spurious jet firing) still was occurring occasionally. Further investigation revealed that some of the ATCA transistors had a low emitter-to-collector resistance of approximately 120 000 to 130 000 ohms. This low resistance, with noise on the power ground, was sufficient to trigger the buffer into the ON state sporadically. With the new information, the low side of the buffer input was returned to the collector side of the transistor, and a 50 000-ohm resistor was placed between the SCEA circuit breaker and the emitter side of the ATCA transistor (fig. 15). This resistor formed a voltage divider whenever the SCEA was energized and maintained approximately 18 volts across the buffer input until the transistor switched on and the voltage dropped to approximately 0.5 volt. The current through the resistor and transistor was negligible with the transistor on or off. This arrangement proved to be a satisfactory fix for the interface incompatibility.

The first problem occurred again when the open-contact resistance of a relay decreased with usage until it reached the 120 000-ohm level and triggered the buffer on. This condition was eliminated in a similar manner.

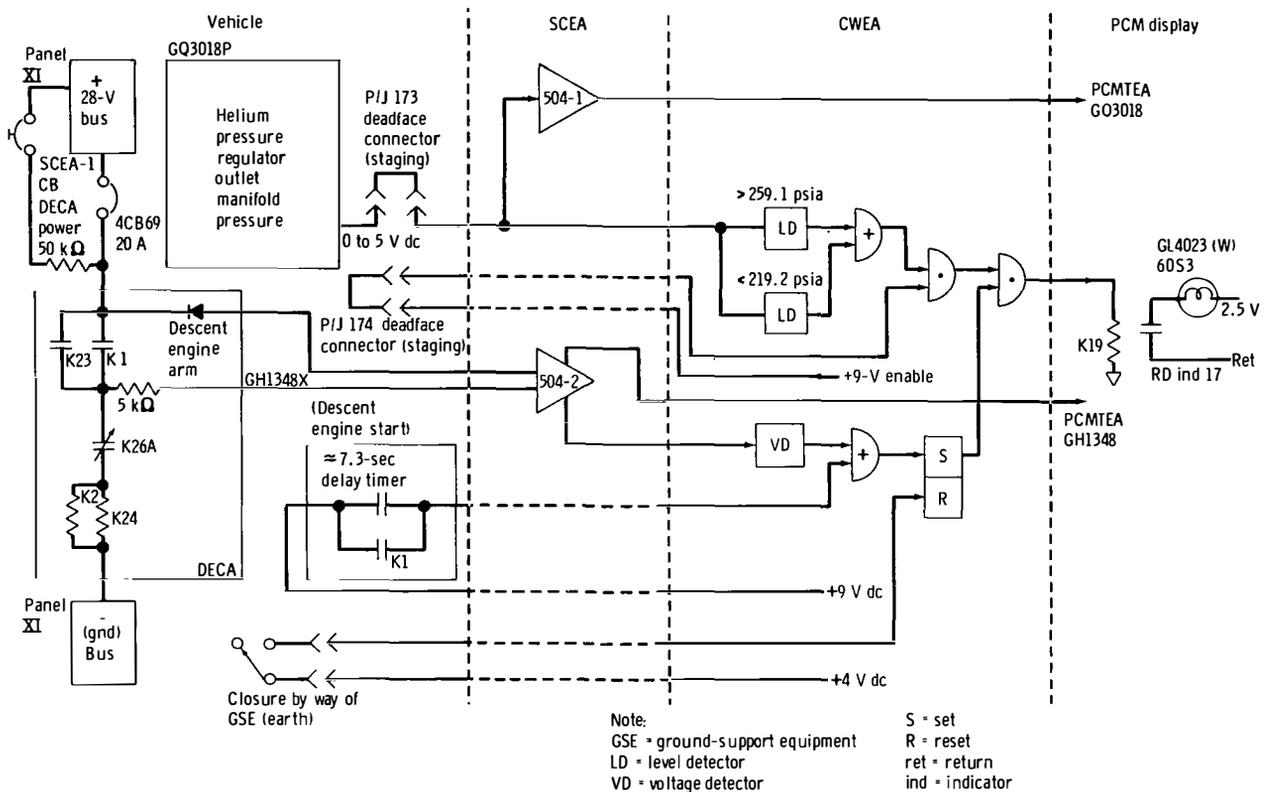
Figure 19. - Helium pressure regulator manifold failure-detection circuit.

Venting of descent helium will cause a descent helium regulator warning indication and a master alarm.

Discussion. - The fuel vent (GQ3500X) and the oxidizer vent (GQ4000X) are used to vent the descent helium shortly after lunar landing. The helium regulator outlet pressure (GQ3018P) will fall below the CWEA trip level of 219.2 psia and activate warning light GL4023 (fig. 19) and the master alarm.

Corrective action. - The master alarm should be reset. The warning light will be extinguished automatically at staging. However, it can be extinguished before staging by cycling the CWEA circuit breaker following removal of descent engine arm.

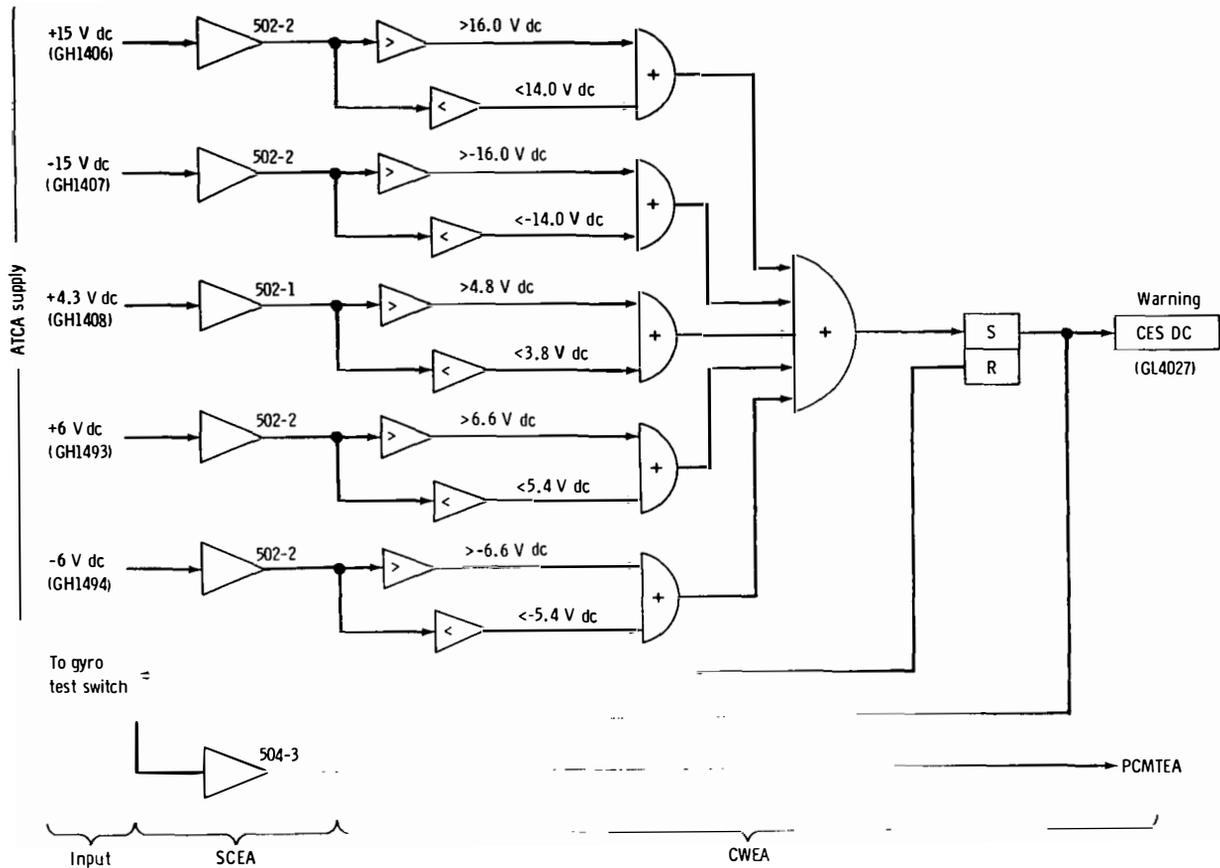
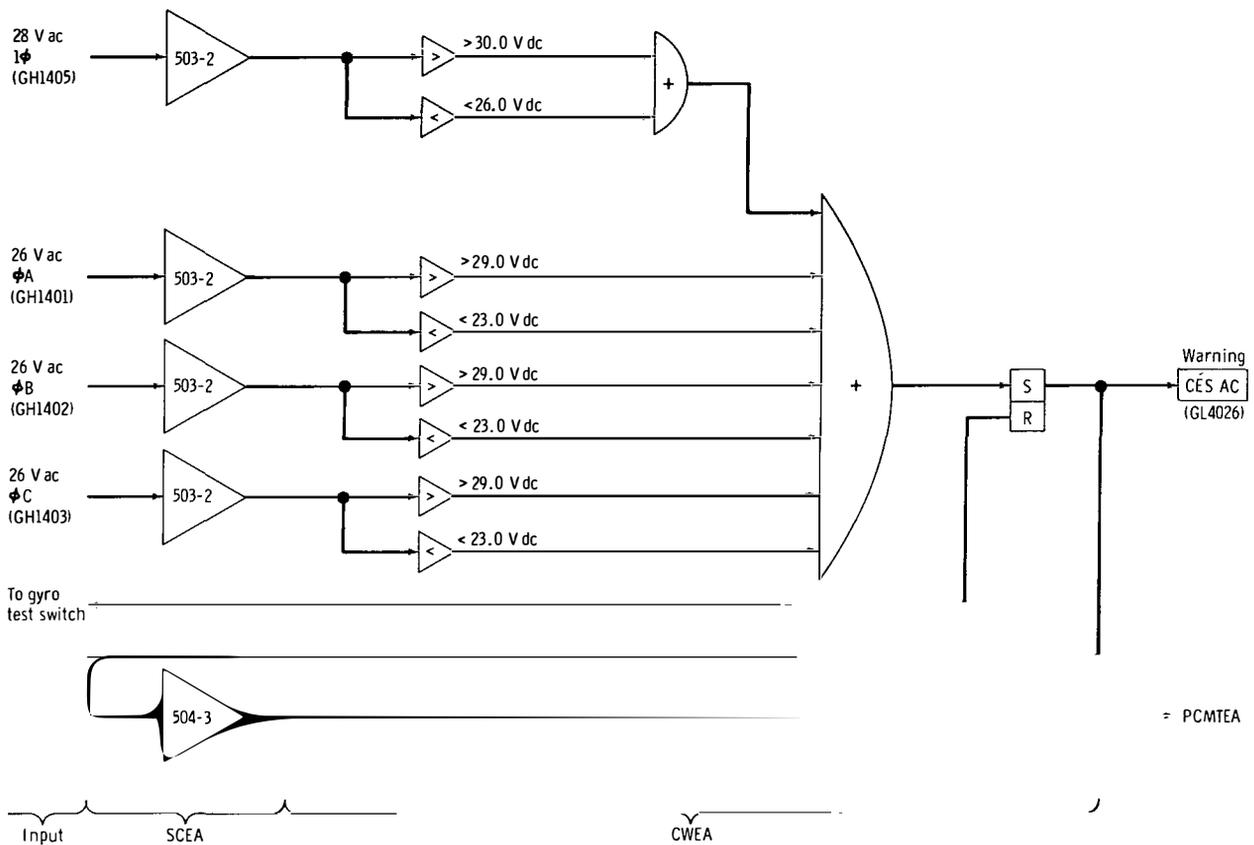
Each control electronics section (CES) power-supply output is monitored by an individual level detector in the CWEA (figs. 20 and 21). Each level detector is designed to produce a logic zero at its output if the power supply being monitored is delivering a voltage within predetermined levels. If the power supply exceeds these levels (either above or below), a logic one is produced at the output of the level detector. The outputs of each group (ac or dc) of level detectors are OR-gated and fed to their respective flip-flops. When all power supplies are in limits, a logic zero from the output of each level detector is applied to the flip-flop. The flip-flop is in the reset state with a logic zero at its output. If any power supply goes out of limits, a logic one is transferred to the input of the flip-flop. This transition from a logic zero to a logic one at the input to the flip-flop is required to set the flip-flop, activate the master alarm, and illuminate the annunciator light.

During LM missions, the CWEA is turned on prior to activation of the CES power supplies. As a result, the level detectors in the CWEA sense zero voltages at their respective inputs and produce logic ones at their outputs. The flip-flop is set, the annunciator lights are turned on, and the master alarm is activated. The annunciator lights can be extinguished by resetting the flip-flop by means of the rate gyro assembly gyro test switch. This action, however, does not remove the logic one at the input to the flip-flop.

1. All power supplies operate normally and are in limits. In this case, the logic one at the input to the flip-flop is removed, and the failure-detection circuits are able to recognize a subsequent power-supply failure.
2. One or more of the power supplies fails to come within limits. In this case, the logic one remains at the input to the flip-flop, and the failure-detection circuits are unable to detect the failure.

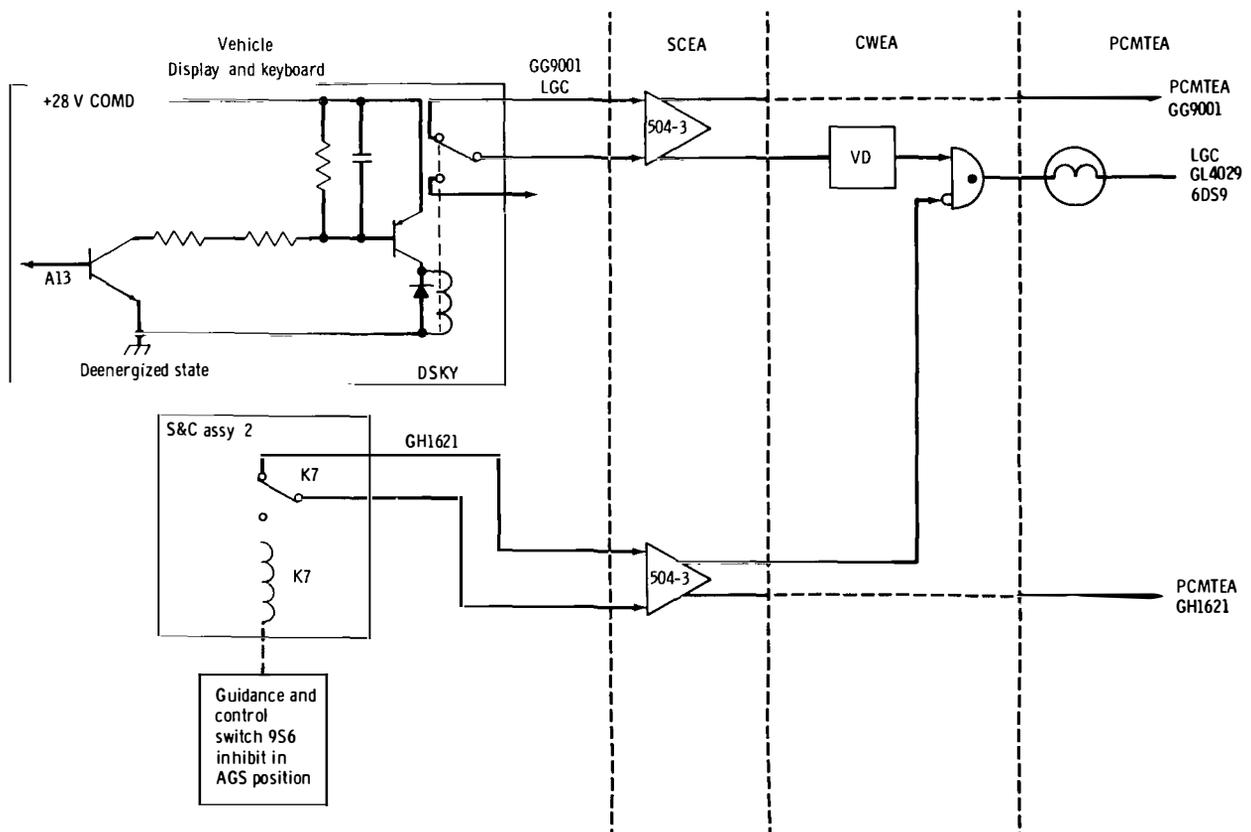
Figure 23. - Lunar module guidance computer failure-detection circuit.

A false master alarm may be generated with activation of the LM guidance computer (LGC)/display and keyboard (DSKY) circuit breaker subsequent to turn-on of the CWEA circuit breaker (fig. 23).

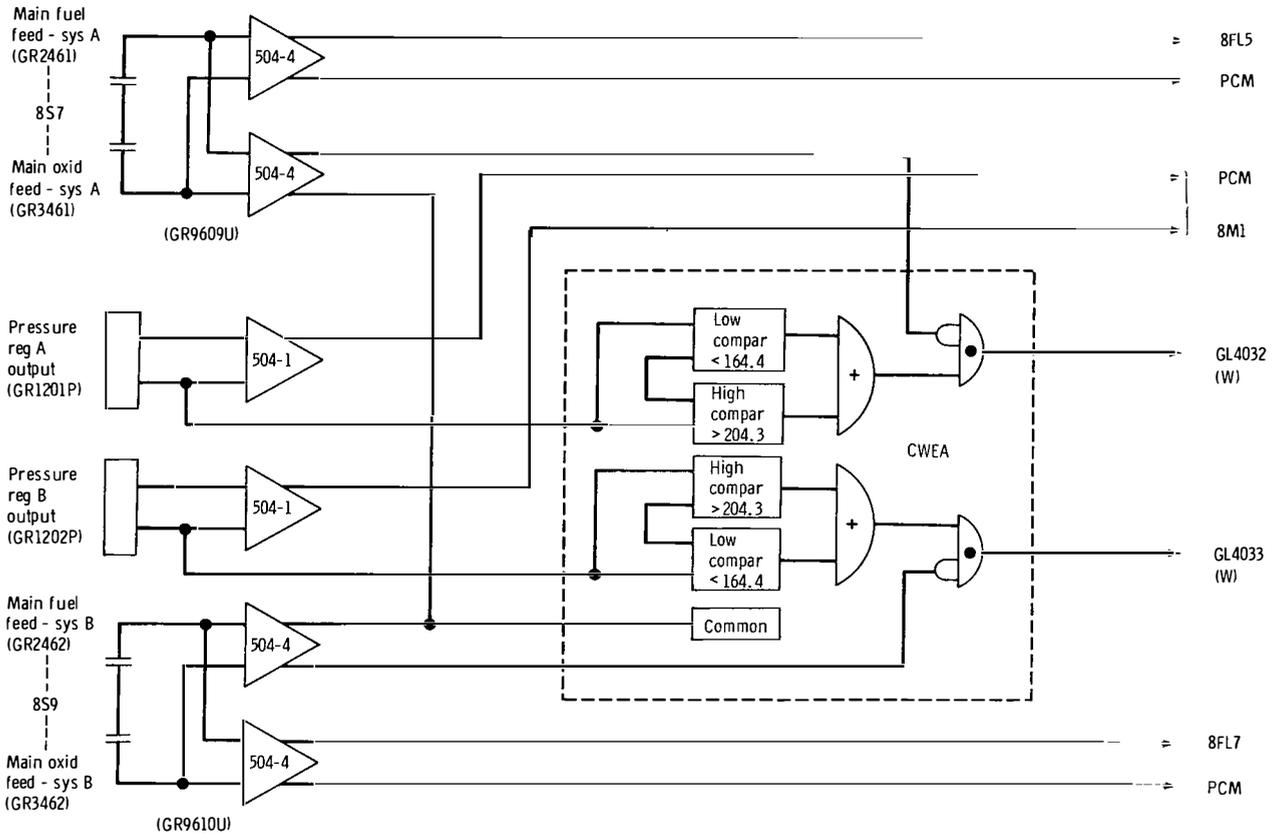
Figure 25. - Reaction control subsystem helium pressure regulator failure-detection circuit.

The RCS helium regulator warning lights come on prior to pressurization (fig. 25).

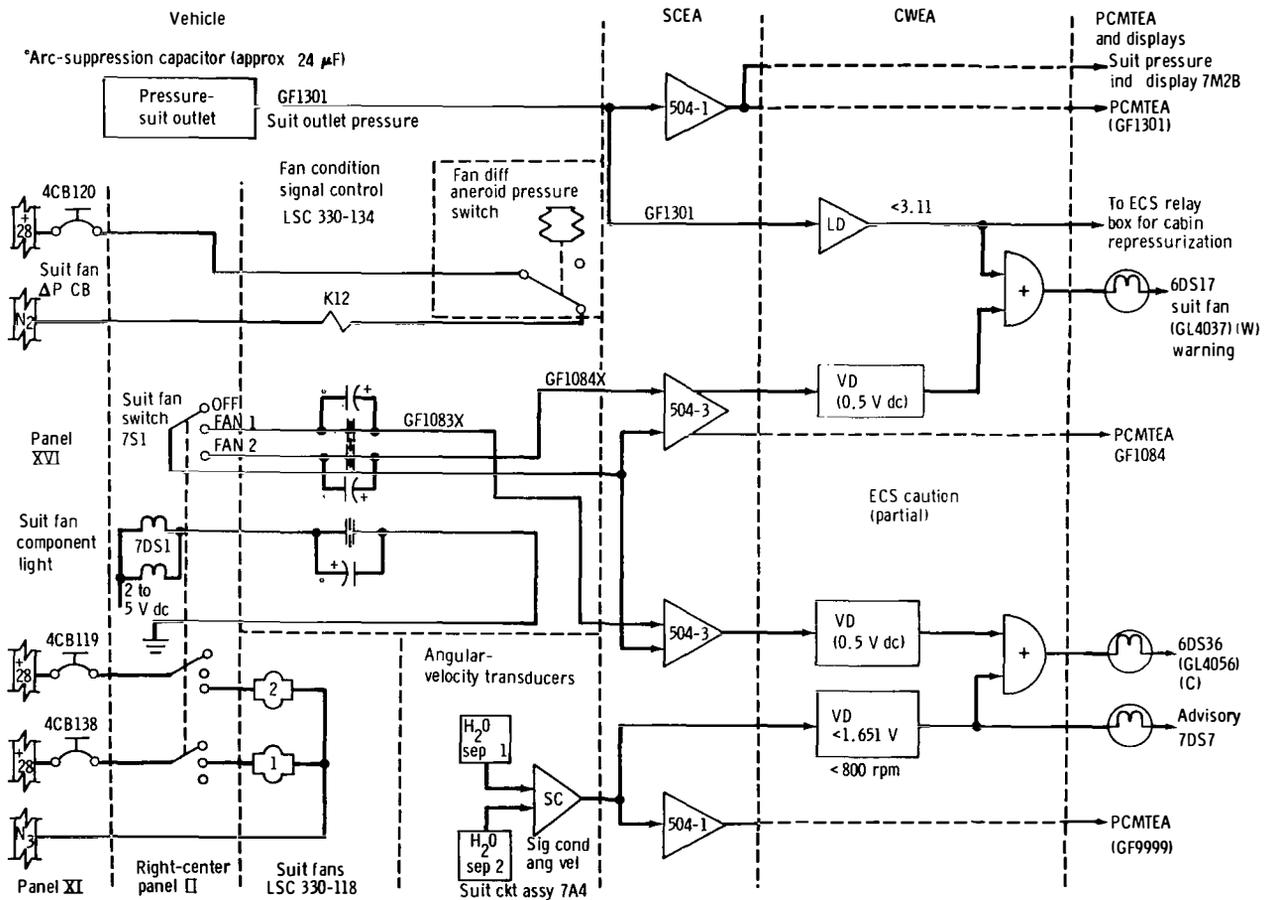
Figure 26. - Environmental control subsystem suit outlet pressure failure-detection circuit.

Switching from suit fan 1 to suit fan 2 (under a condition of low differential pressure with fan condition signal-control relay K12 energized) may cause two successive suit/fan warnings (fig. 26).

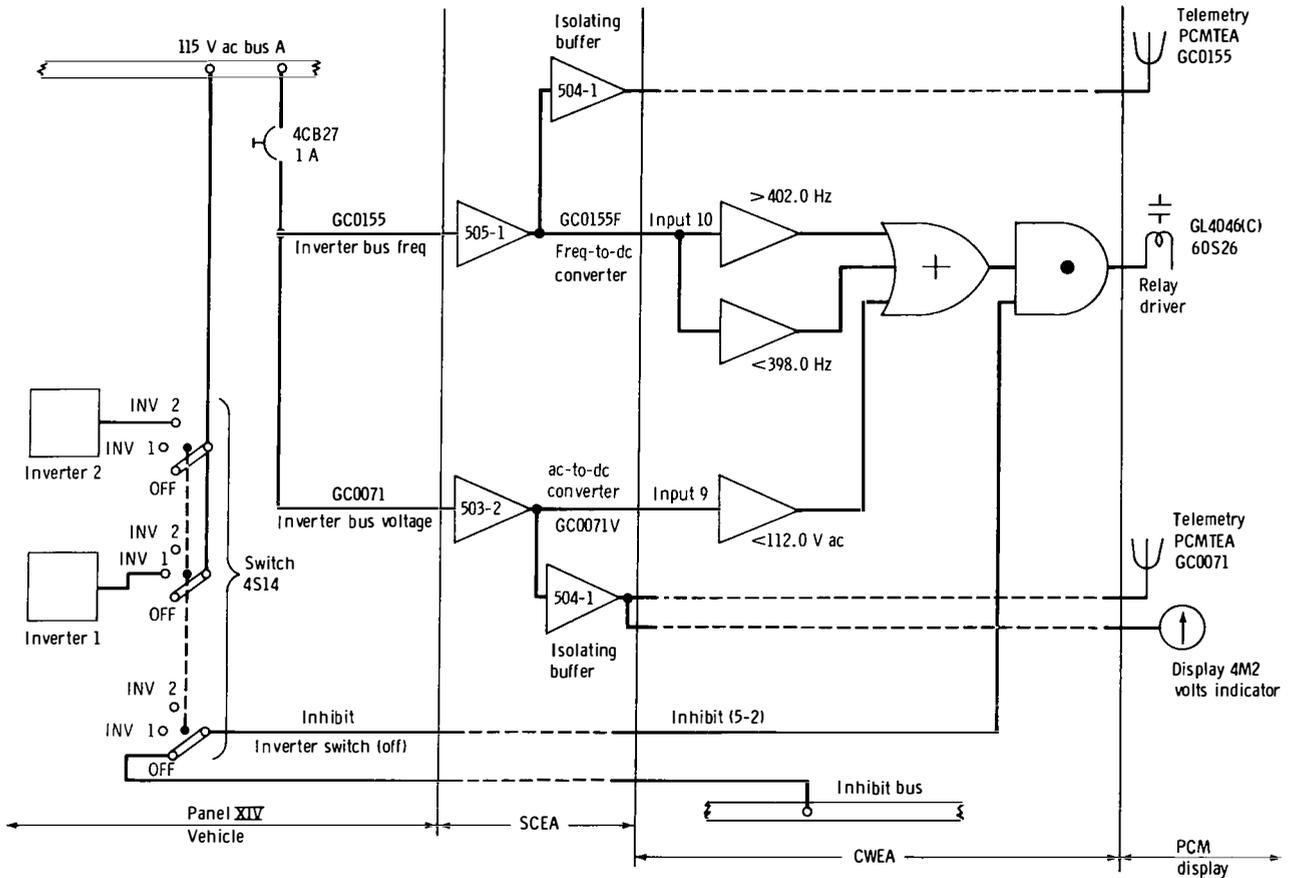
Figure 27. - Electrical power subsystem inverter voltage and frequency failure-detection circuit.

An inverter caution occurs when selecting either inverter from the off position (fig. 27).

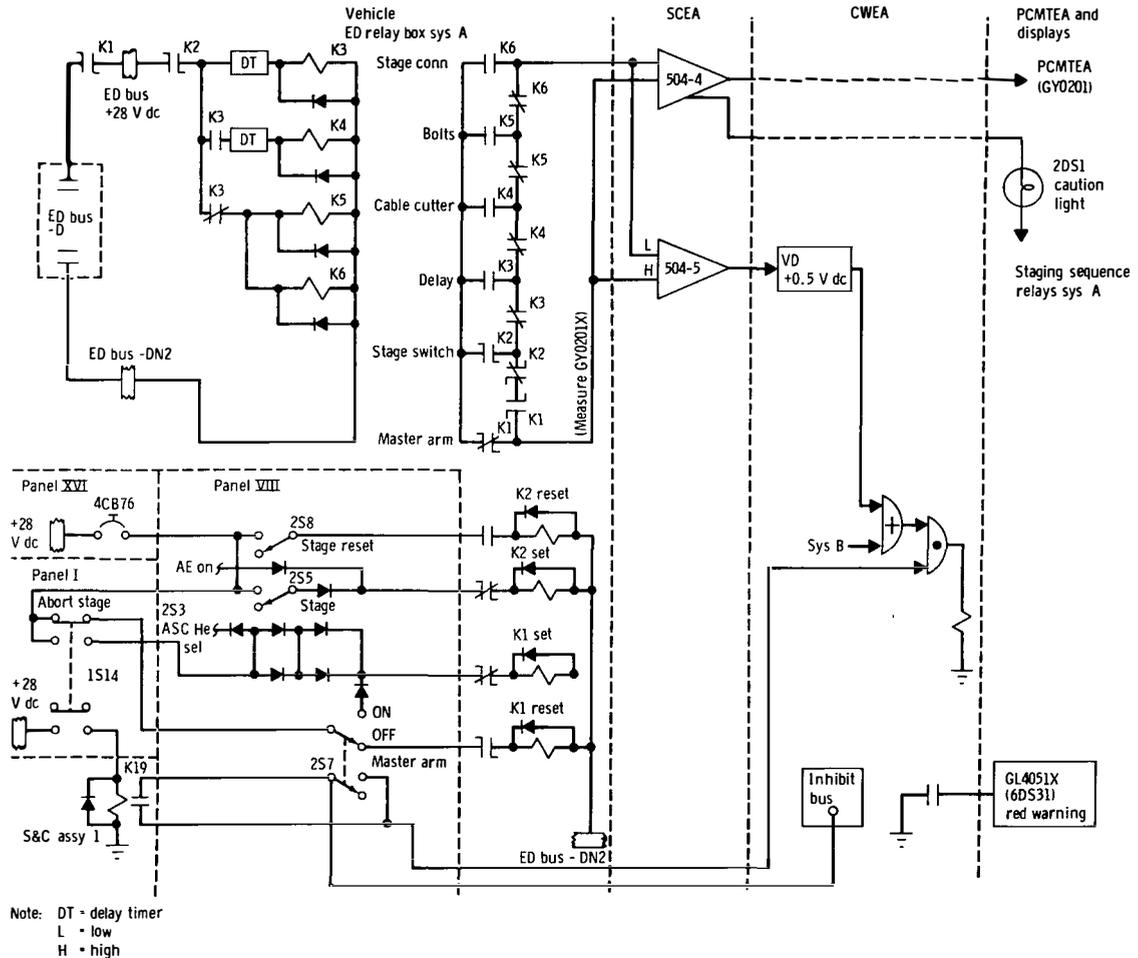
Figure 30. - Explosive devices subsystem stage sequence failure-detection circuit.

An explosive devices (ED) malfunction alarm occurs when the abort stage switch is reset after staging.

Discussion. - When the abort stage switch (fig. 30) is depressed, ED relay K1 is set and the ED bus is armed. This action completes the contact closure path in the relay "daisy chain" (relays K1 to K6) and provides an input to the CWEA. The master alarm does not operate, however, because S&C relay K19 also is energized by the abort stage switch and inhibits the CWEA. A third set of contacts on the abort stage switch signals the CES to issue a stage command. This stage command from the CES sets relay K2, which initiates staging by sequentially energizing relays K3 to K6.

Resetting the abort stage switch after staging removes the inhibit voltage from the CWEA by deenergizing relay K19. Relay K1 is reset, removing the +28 volts from the ED bus and deenergizing relays K3 to K6. Relay K2 has no automatic-reset capability and, therefore, completes the closed-contact path to the SCEA input, activating the master alarm.

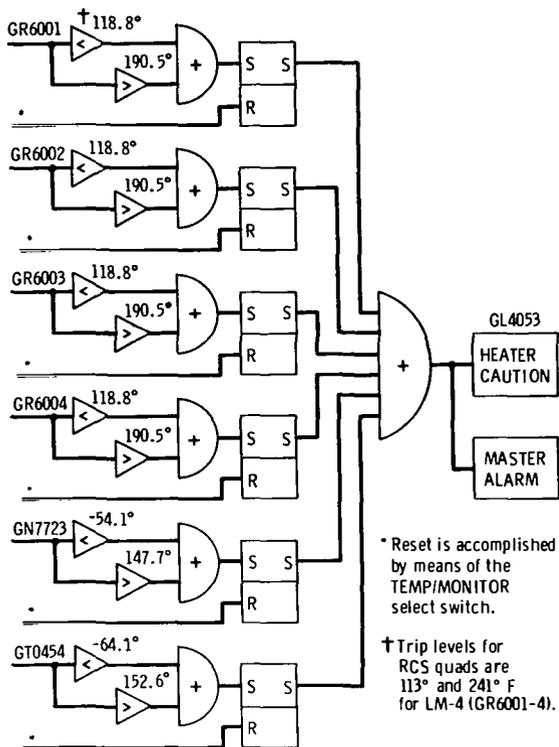
Figure 31. - Heater caution circuit.

Characteristic 1 is caused by the lack of a staging enable to the CWEA logic (fig. 31). When vehicle staging is performed, the wiring to the LR temperature sensor is severed by the cable cutter. This operation places an open circuit at the input to the SCEA, which is analogous to an out-of-temperature condition at the high end; and the CWEA initiates a master alarm.

Corrective action for LM-3 and LM-4. - To preclude the issuance of a master alarm during staging, the LR temperature interface was removed between the SCEA and the CWEA. This modification will cause a master alarm when the CWEA circuit breaker is closed; however, because a master alarm is assured when the CWEA is activated during the mission as a result of the incapability of the RCS quad heaters to establish an in-limits condition before activation, the master alarm is of no significance. The LR heater caution can be reset by rotating the temperature monitor switch to the LR antenna position. After resetting, the circuit is disabled for the remainder of the mission, unless the CWEA is turned off and then back on. This cycling of the CWEA circuit breaker would require resetting the LR heater caution.

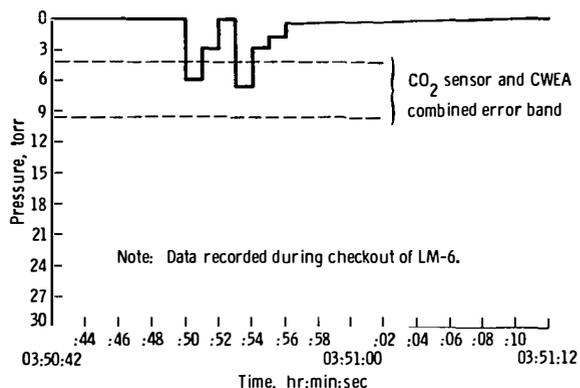
Figure 32. - Typical plot of carbon dioxide pressure variation during ground checkout.

A master alarm may occur during vehicle ground checkout when the carbon dioxide (CO₂) sensor circuit breaker is closed (fig. 32). This possibility results from a transient voltage produced by the CO₂ sensor when power is applied. The magnitude of this transient voltage varies with CO₂ sensors and may not be sufficient to trip the ECS caution light and produce a master alarm. A master alarm resulting from this characteristic has been experienced only during checkout of one vehicle (LM-4).

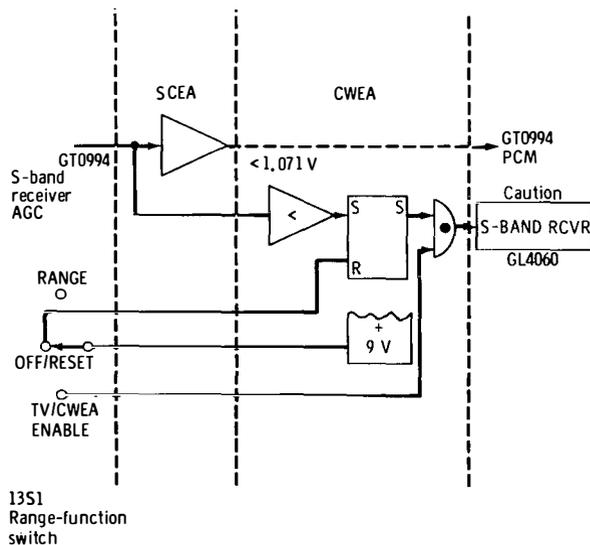
Figure 33. - S-band receiver AGC failure-detection circuit.

At the completion of the S-band ranging function, the S-band range-function switch (13S1) is placed in the off/reset position (fig. 33). This action will reset the S-band caution circuit. However, any subsequent decrease of the S-band automatic gain control (AGC) voltage (as a result of signal fading) below the CWEA reference level, while the switch remains in the off/reset position, will register a failure in the CWEA memory. Subsequent enabling of the S-band caution indicator would cause a master alarm.

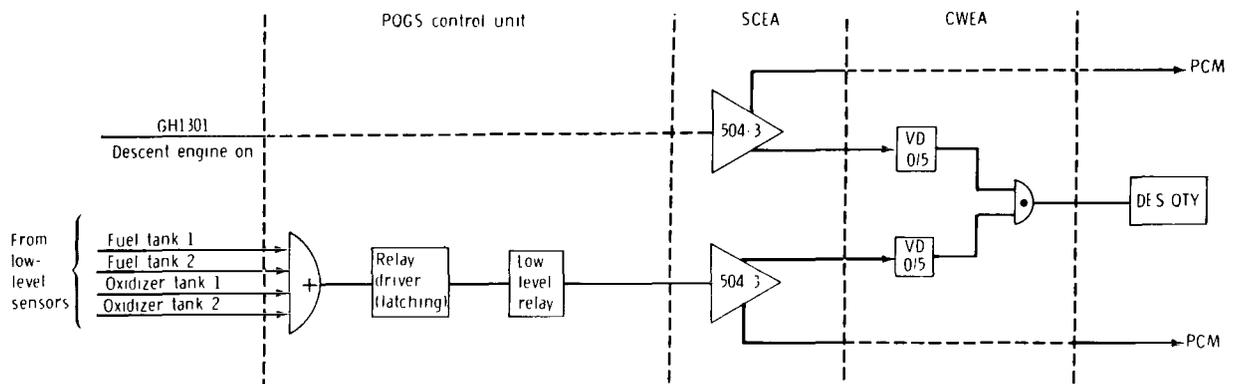
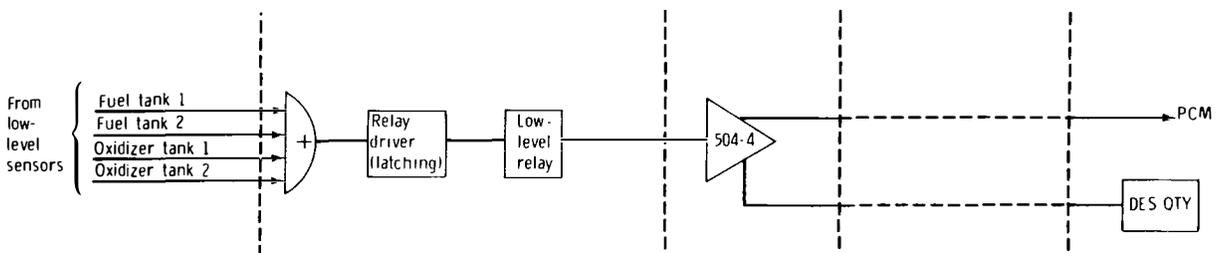
Figure 34. - Descent propellant low-level quantity circuit.

A high probability exists for the occurrence of a master alarm during a normal lunar landing.

Discussion. - The GL4024 warning indication (fig. 34) was designed to alert the crew to a propellant quantity remaining equal to 2 minutes at 25 percent thrust. There is a high probability that the propellant level will reach this point prior to touchdown on a normal lunar landing.
