Fiscal Year 2003 NASA-Wide Facilities Condition
Assessment and Deferred Maintenance Estimate

Lessons Learned Report

NASW - 02010 Task Order 05

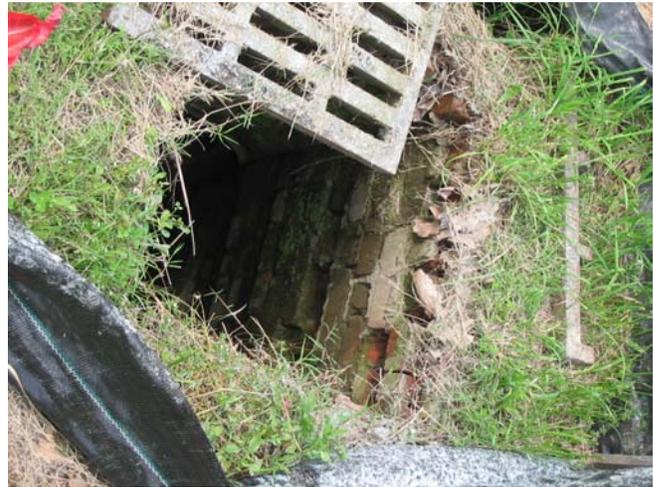
Figure 10. Storm drainage system, Facility # S-0009, is aged and in significant need of repair.

At the end of the assessment, it was discovered that the WFF storm drainage system is aged and in need of significant repairs. After reviewing the four applicable RPI records, it was also determined that the CRV for the WFF storm drainage system was too low; it is believed that the total CRV should be about \$25M. This was not noticed last year and the system ratings last year were a “3” compared to this year which are rated at a “2.” NASA WFF personnel are working to address this problem. The four facility items with questionable CRVs are:

It was found that the combined CRV for the storm drainage system throughout the Center is too low. Further investigation of the storm drainage system revealed that the system is in need of significant repair. The assessed system ratings for these facilities are a 2.

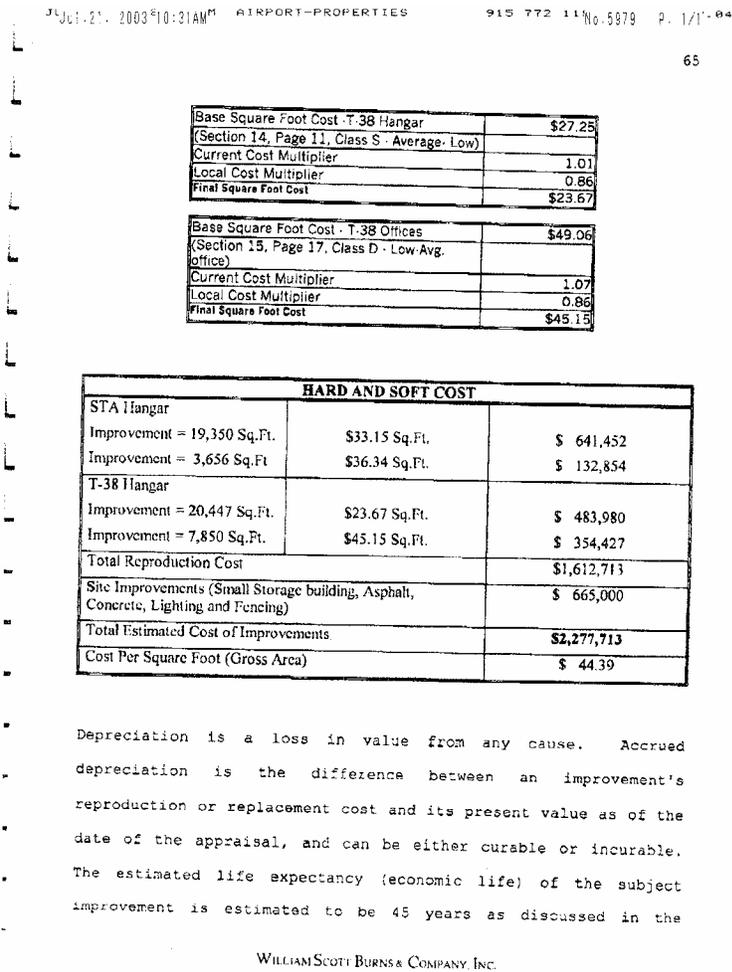
Real Property Records JSC WSTF Hanger1 and Hanger 2 at El Paso Airport:
 Two aircraft hangers with office space that are not owned by NASA, but leased from the City of El Paso have a recorded CRV of \$0. Is CRV the estimated value to purchase a similar facility or the value of the new lease for similar facilities? In a conversation with program manager, Larry Larosse, the ability to lease/purchase other space was all but non-existent at the time. The attached document is a scanned copy of a professional estimate that Mr. Larosse provided for review in looking at the potential CRV for this facility.

Figure 19. Lease for airport hangers

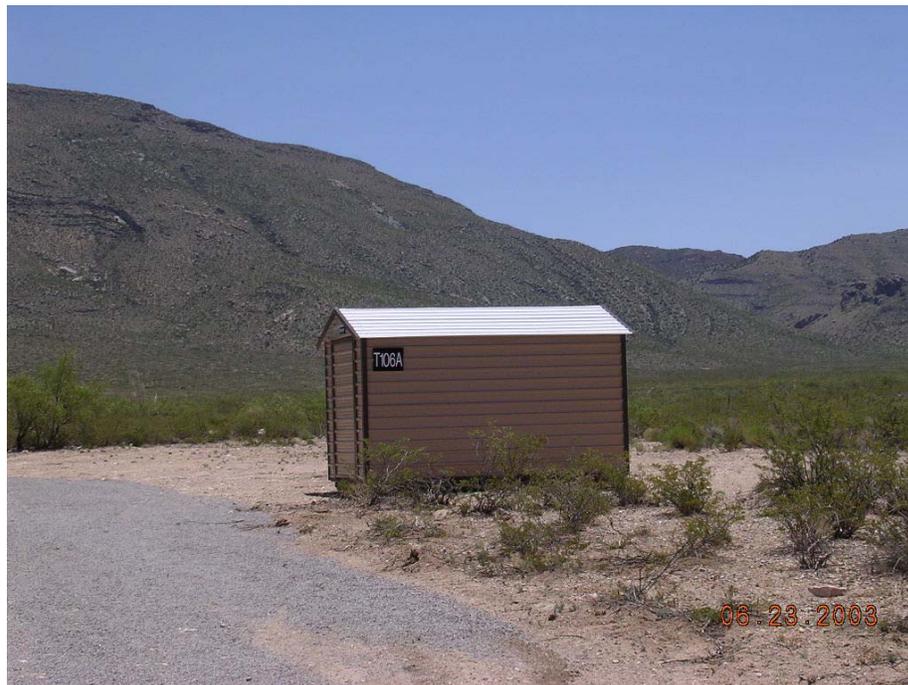
Portable buildings (such as the one shown in the photo below) at WSTF are not considered as real property if the original purchase/installation cost is below \$5,000. RPI procedures and cost of purchase of these items shown to us during

the visit verify this point. Portable buildings, such as this, do not show up on the RPI list managed by WSTF personnel. The WSTF fire and rescue services have taken it upon themselves to assign building numbers and put these numbers on the buildings. Because of this visible number the buildings were picked up in the last DM visit and added to the Plexus report. These buildings and their repairs are covered at WSTF under their NASA Equipment Management System (NEMS) Personnel Property account at this time. A decision will have to be made as to which account these units are to be managed under. These are not much different from portable metal conex trailers. They have no electrical, plumbing, HVAC, etc. They are used only for storage of site materials and are moved on occasion from location to location if needed. If listed on RPI and on NEMS the financial issue is one of double dipping.

Figure 20. Portable building T106A
