Managing Space Shuttle Program Risk for Return to Flight: Why does risk management fail?

N. Wayne Hale
Manager, Space Shuttle Program

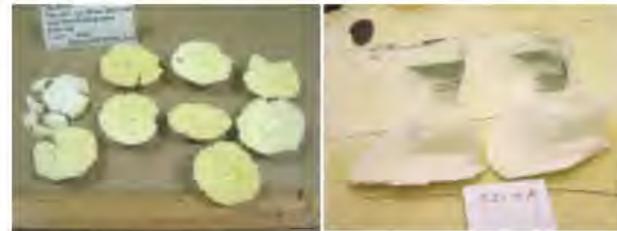
Test Verified Assumptions
(ie pop-off velocity, shape
and impact sensitivity)

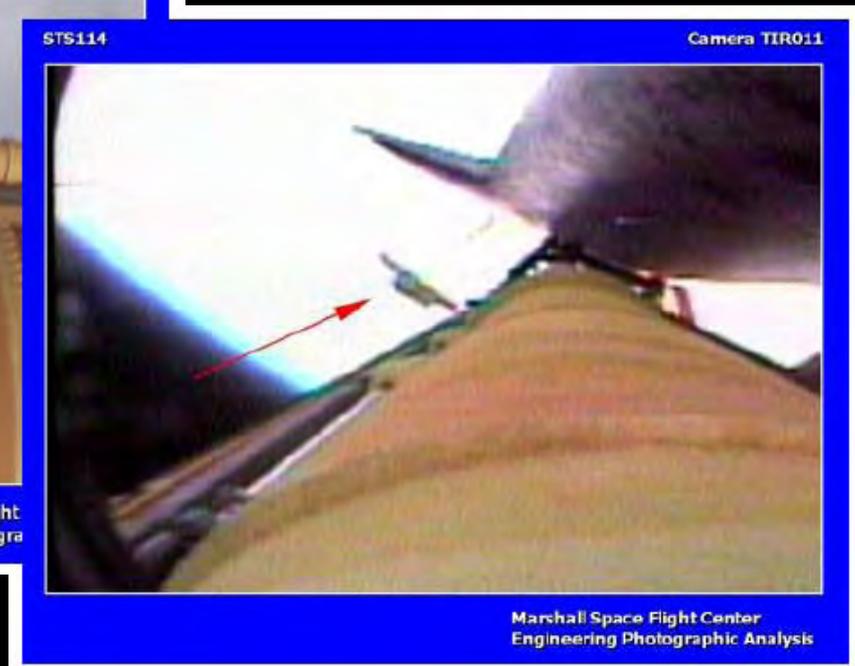
- We saw some unexpected foam losses on STS-114, including a significant loss from the LH2

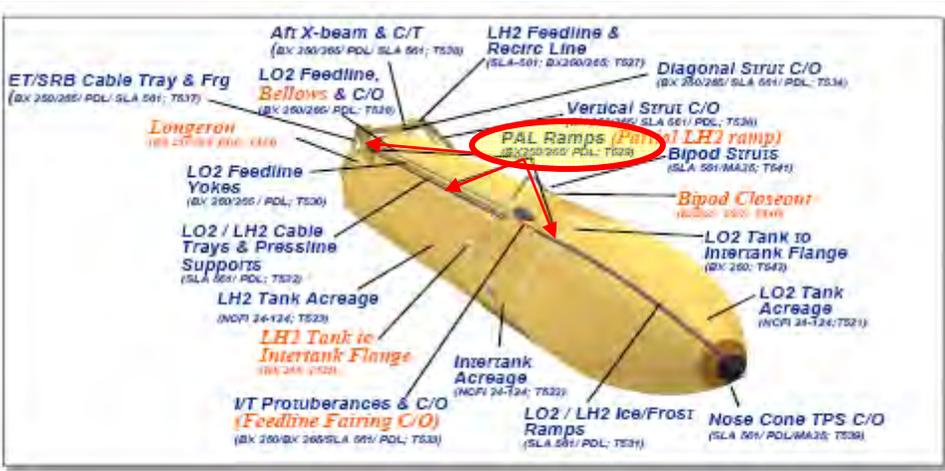
Assessing the Risk of ET TPS Failure

- Each TPS component is assessed for each TPS failure mode

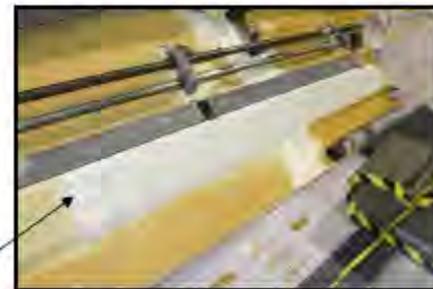
ET-120 LH2 PAL Ramp
Fwd 10 ft. Re-spray

- **Details of Change**
 - Replaced PAL ramp section using process recommendations and enhancements identified by the TPS Working Group and the Manual Spray Enhancement Team (MSET)
 - Removed and replaced GO2 and GH2 pressline sections and top half of forward LH2 ice/frost ramp
 - PAL ramp bondline relocated
 - Outer mold line unchanged
 - Closed out plug pulls with verified and validated repair method

New Bondline (located outside the critical bending region)

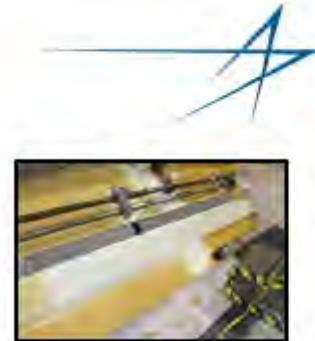
• Certification Summary

- Manual spray process verified / validated on full-scale article
 - Pre-control used to establish process performance requirements
 - As-sprayed acceptance testing used to verify critical performance requirements
 - Tensile strength, dissections, and density tests performed and inspected on HFPTA and/or witness panels

- Test-based verification demonstrates $FS > 1.25$ for critical failure modes
 - Outer Fiber Cracking / Bondline Delamination
 - Cryogenic / Flexure testing demonstrates 125% design limit structural flexure induced loading
 - Cohesive Strength
 - Min. MS = 0.25 (SF req'd = 1.25) using maximum observed defect size x 1.40
 - Critical max. observed defect size is 0.40 in. slot width

- Non-destructive inspection (using development techniques) of existing and replace PAL ramps showed no defects in excess of criteria dimension acceptance criteria

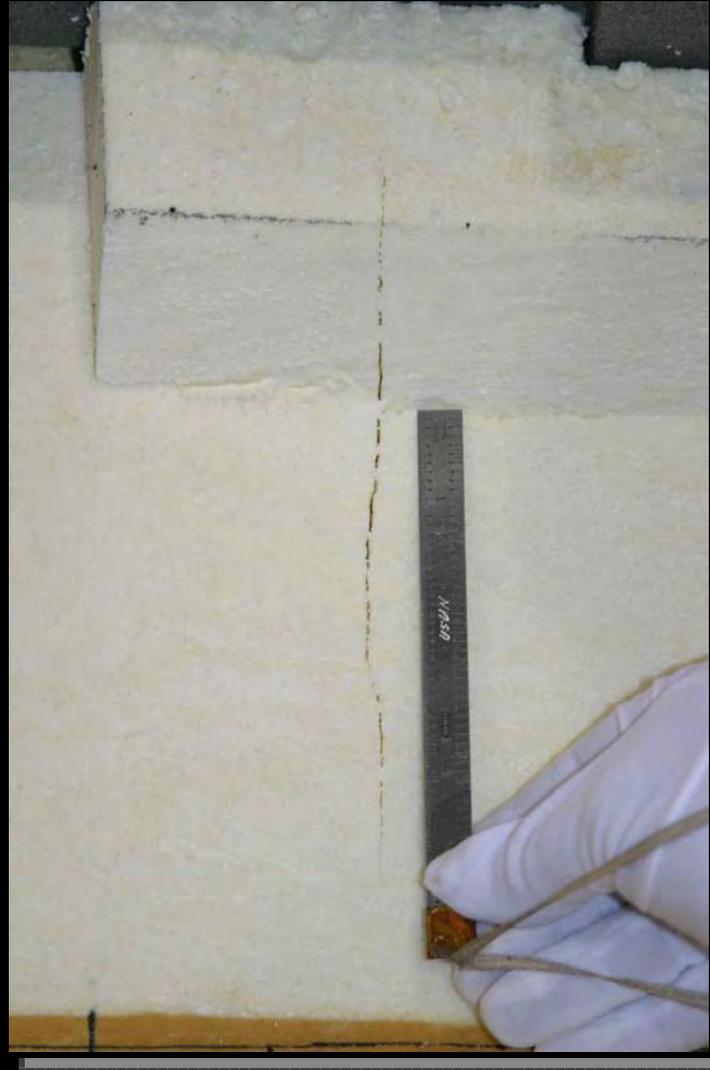
ET-120 PAL
Ramp Foam
dissection
showed
significant cracks

- Following STS-114, the Program shipped two tanks back to the factory for destructive and non-destructive inspection.
- Both had been modified in similar ways.
- One tank had not been through tanking and thermal cycles; it showed no cracks.
- The other tank had been through two tanking cycles....
