NASA Engineering and Safety Center

STS-114 Flight Readiness Review 29 June, 2005

STS-114 Return to Flight Constraints – Open Work

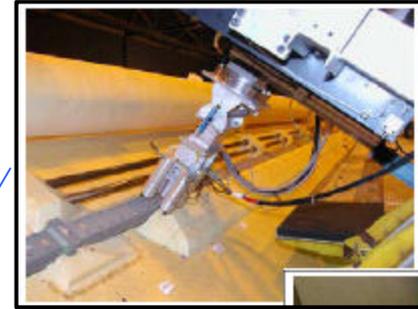
NDE of PAL Ramps

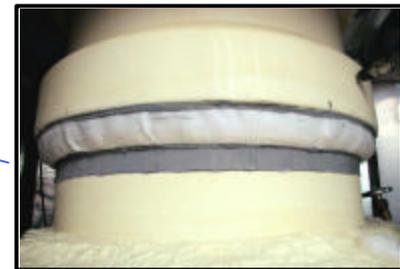
LO2 Feedline Bellows

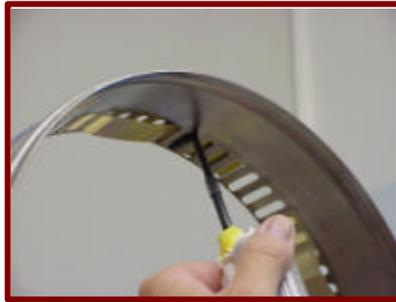
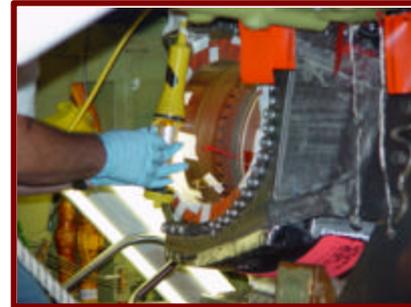
High-Fidelity Edge Replication Inspection Method

42 Cracks found
in OV-103

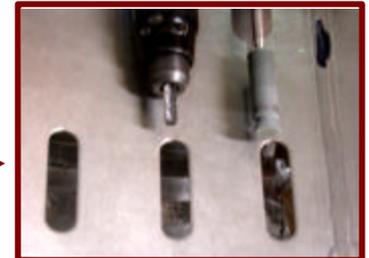
Integrated Dynamics and Fracture Analysis Method

Cracks removed
by polishing

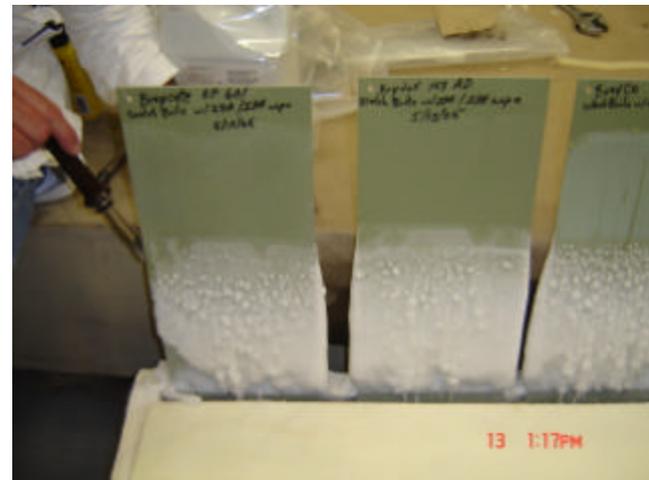
Panel Testing at MSFC

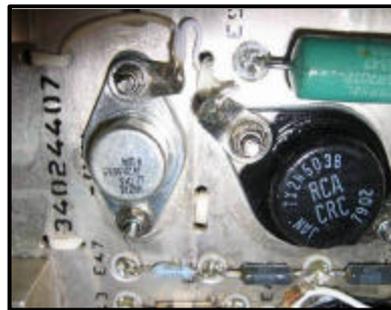
Darlington Pair Transistors
