Mishap at an Explosives R&D Laboratory

Leadership ViTS Meeting
October 2, 2006

Mishap with an Energetic Material at an R&D Laboratory

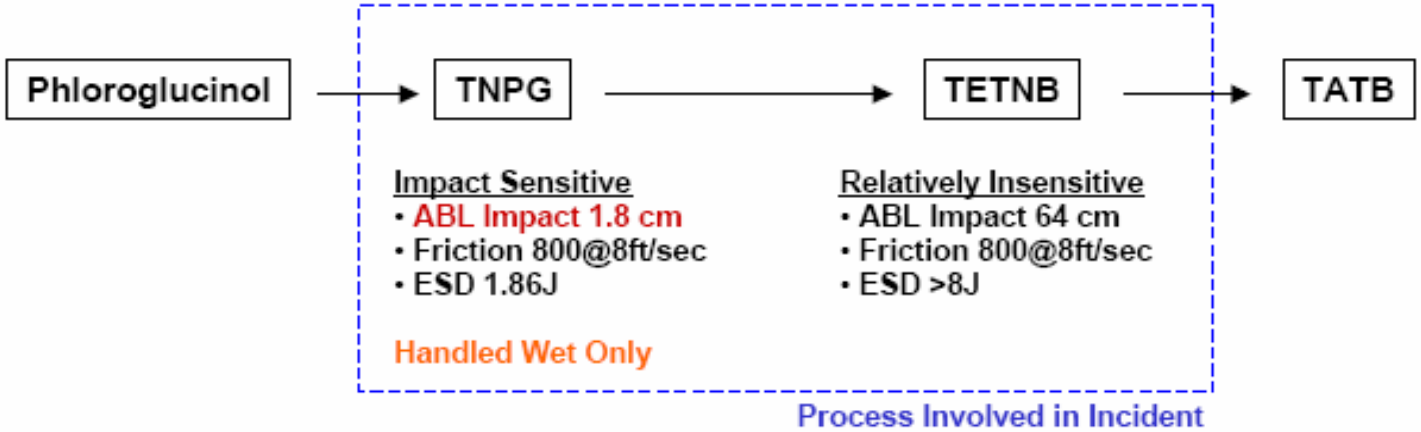
- ATK developing a three-step process for manufacture of TATB
  1. Nitration of phloroglucinol to make **TNPG**
  2. Alkylation of TNPG to make **TETNB**
  3. Ammonolysis of TETNB to make **TATB**.

Incident occurred as TETNB was being removed from a filter receiver and being placed in 5-gallon buckets for transfer and storage

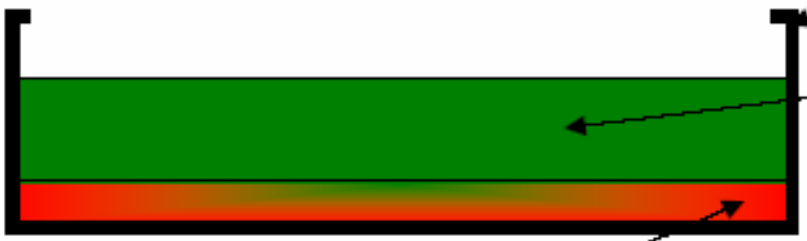
1. TETNB material in filter receiver was under-reacted and under-washed.
   - 11% DETNP (partially reacted TNPG), 4% TNPG (impact sensitive)
   - Second batch in 500 Gallon Reactor; First attempt at 65% Loading

2. Being more water soluble, DETNP and TNPG were concentrated in the bottom of the receiver forming an unusual hard, dry cake
   - Localized concentrations of up to 24% TNPG

3. Lab technicians improvised on their own, and used unauthorized tools (metal scoop, plastic shovel) to remove caked material.

4. Impact, most likely from an unauthorized tool, caused local ignition of TNPG and mass ignition of the DETNP
