APOLLO 15 MISSION REPORT

MSC-05161

Mission Evaluation Team

NATIONAL AERONAUTICS AND SPACE ADMINISTRATION
MANNED SPACECRAFT CENTER
HOUSTON, TEXAS
December 1971

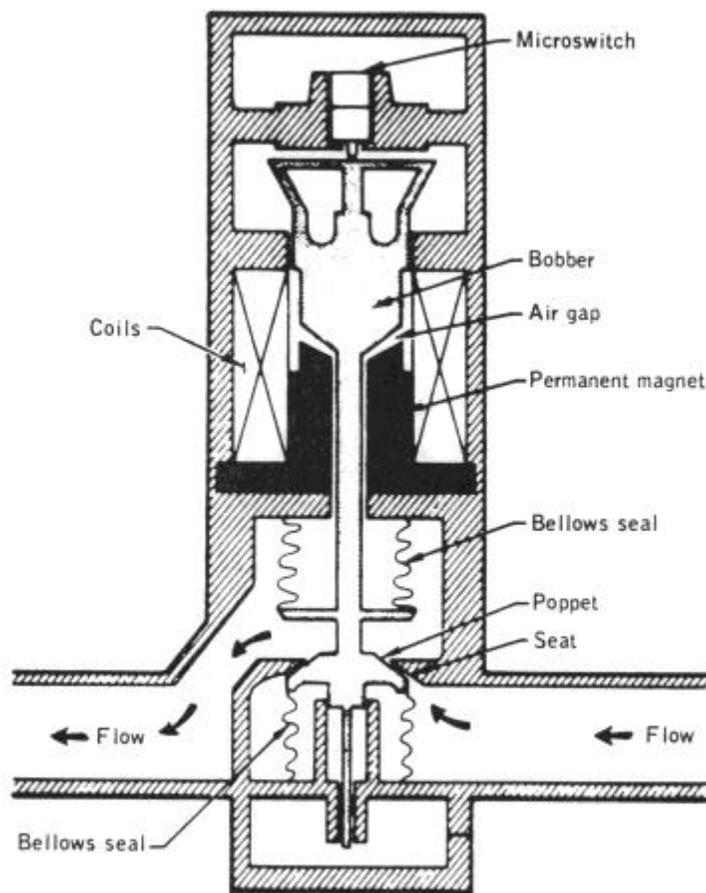
Figure 14-1.- Cross section of reaction control system isolation valve.

During postinsertion checks, the quad B secondary isolation valve talkback indicated that the valve was closed, and the switch was cycled to open it. Subsequently, talkbacks indicated that both the primary and secondary valves for quad D were also closed, and these valves were reopened. At S-IVB separation (approximately 3 hours 22 minutes), all the aforementioned valves closed and were reopened. Upon jettisoning of the scientific instrument module door, the quad B secondary valve closed and was reopened.

This type of valve (a magnetic latching valve, shown in **Fig. 14-1**) has, in previous missions, closed as a result of pyrotechnic shocks. Ground tests have shown that the valve will close at a shock level of approximately 80g sustained for 8 to 10 milliseconds. There were no indications of shock levels of the magnitude required to close the valve during launch.

Testing has shown that if a reversed voltage of 28 volts is applied to the valve, the latching voltage will drop to a point where the valve will no longer remain latched (magnet completely degaussed). In addition, at lower voltages with reversed polarity, the magnet would become partially degaussed.

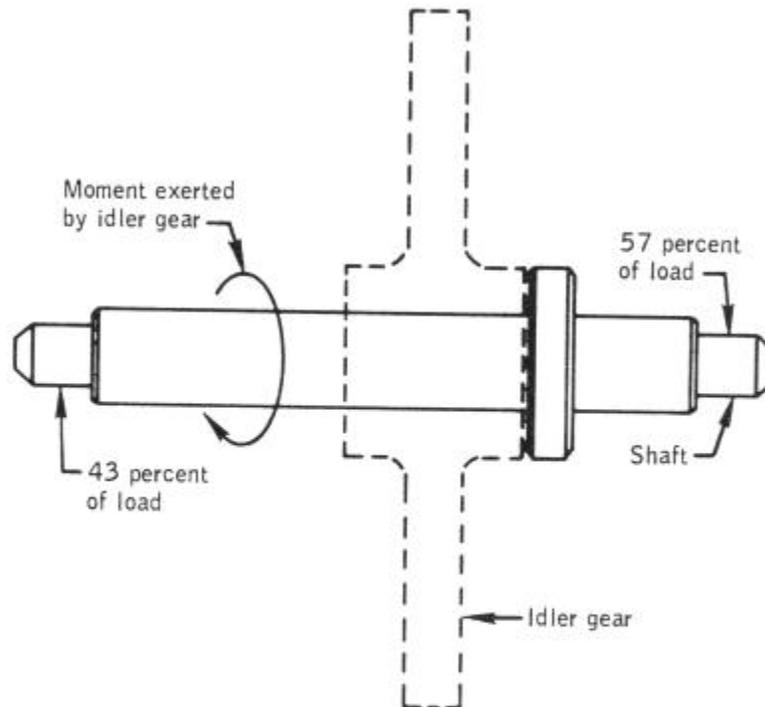
Figure 14-16.- Forces on idler gear shaft in countdown mode.

The seconds digit of the digital event timer, located on panel 1, became obscured by a powder-like substance that formed on the inside of the glass. Postflight analysis of the unit disclosed that the substance on the window was paint which had been scraped from the number wheel by the idler gear. The idler gear is free to rotate on the shaft (**Fig. 14-16**); however, the design allows the stainless-steel shaft to also rotate. The stainless steel shaft bearing points are in the magnesium motor plate and the shaft rotation wears away the softer magnesium material.

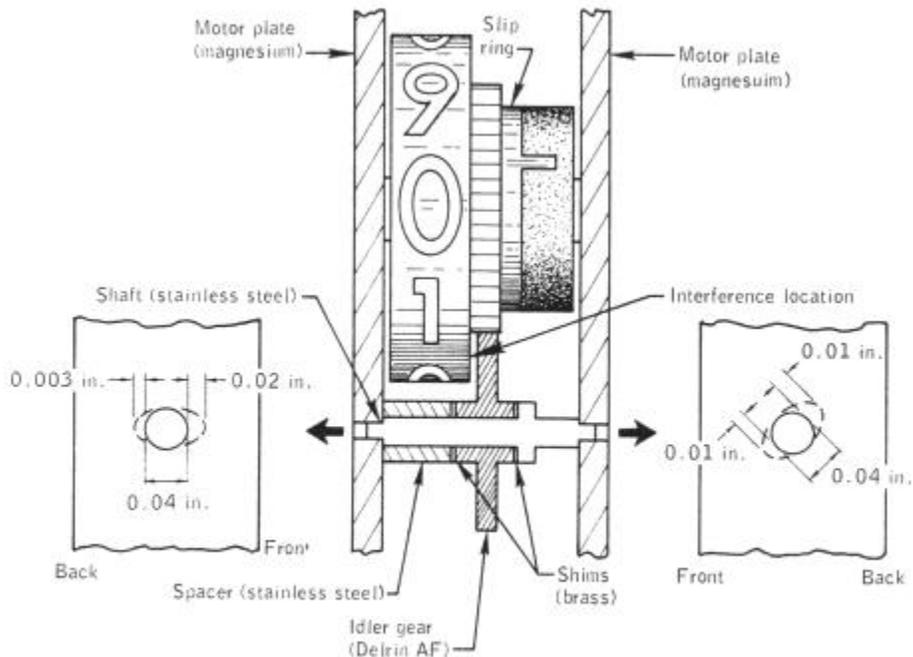
Figure 14-17.- Digital event timer mechanism.

Inspection of the unit showed that the magnesium bearing points had been elongated as shown in **Fig. 14-17**. Torque from the stepping motor applied to the idler gear not only resulted in rotation of the shaft but also caused the shaft to tilt (**Fig. 14-17**). The wearing eventually allowed the shaft to tilt sufficiently to cause the gear to rub against the number wheel. When the timer counted down, the motor torque threw the gear teeth into the front edge of the counter wheel. Testing indicates that this bearing hole elongation occurs after approximately 500 hours running time (specification life is 1400 hours).

A review of the history of the unit shows that it was built in 1966. Prior to installation in Apollo 15, the unit was modified because of failures on other timers. Brass shims (fig. 14-17) were installed to prevent the idler gear from rubbing on the number wheel.

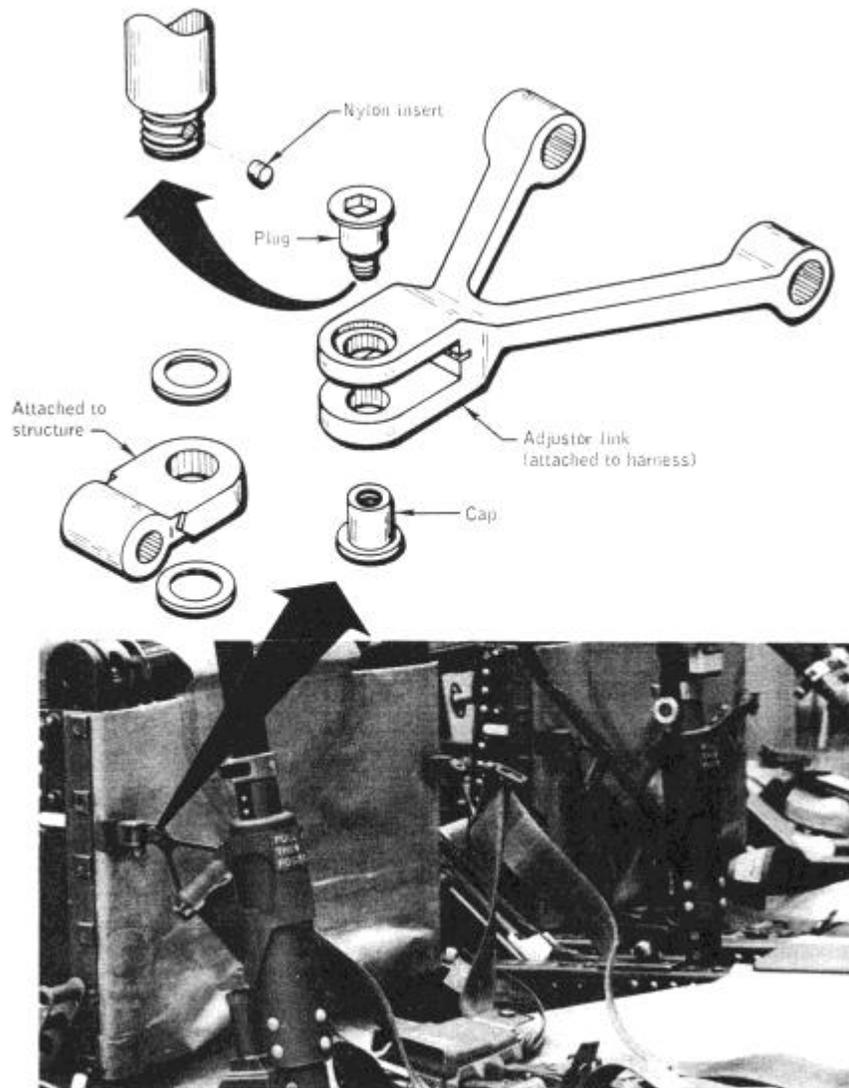
Figure 14-18.- Crew restraint harness connector.

The restraint harness on the right side of both the center and right crew couches came apart during lunar orbit. The assemblies had become unscrewed, but the crew was able to retrieve all the parts except one cap and reassemble the harnesses satisfactorily for landing. The mating plug for the missing cap was held in place with tape.

The plug-and-cap assembly (**Fig. 14-18**), which is part of the universal assembly that attaches the restraint harness to the couch seatpan, separated. (There are a total of six plug-and-cap assemblies on the crew couch, two per man.) The plug component (bolt) has a nylon insert in the threaded portion that acts as a locking device. Back-and-forth rotation of the adjuster link can cause the plug-and-cap assembly to unscrew from each other. Checks on the four other Apollo 15 assemblies showed zero torque on two of the units and minimum specification value (2.0 in-lb) on the others. The loss of torque is apparently due to cold flow of the plastic self-locking pellet, causing a loss of friction against the mating threads.

A thread locking sealant will be used to prevent the problem on future missions.

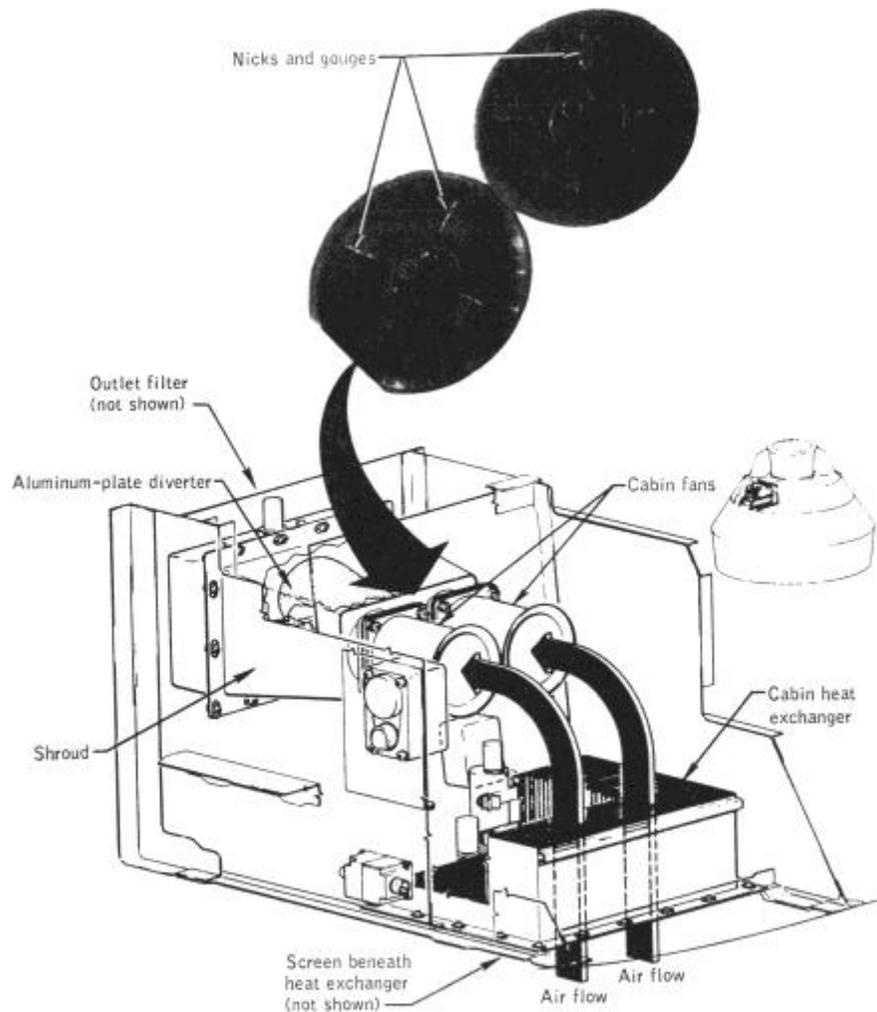
Figure 14-19.- Cabin fan installation.

During portions of the flight when the cabin fans (**Fig. 14-19**) were activated, the crew heard sounds like an object striking the blades. Cycling the fans several times allowed the object to be retained in a position that precluded it from interfering with fan operation.

Inspection of the fans revealed considerable gouging on the leading edges of the blades of both fans (**Fig. 14-19**). No marks were found on the outlet de-swirl vanes of either fan. After extensive examination, including the lunar dust filter, a 1/4-inch washer was found in the ducting.

Although the fan inlet is protected by screens in addition to the heat exchanger core, the outlet is relatively open and the washer could have drifted in and out when the fans were not operating. The outlet was protected only during the limited time when the lunar dust filter was installed. The washer could also have been left in the duct during assembly.

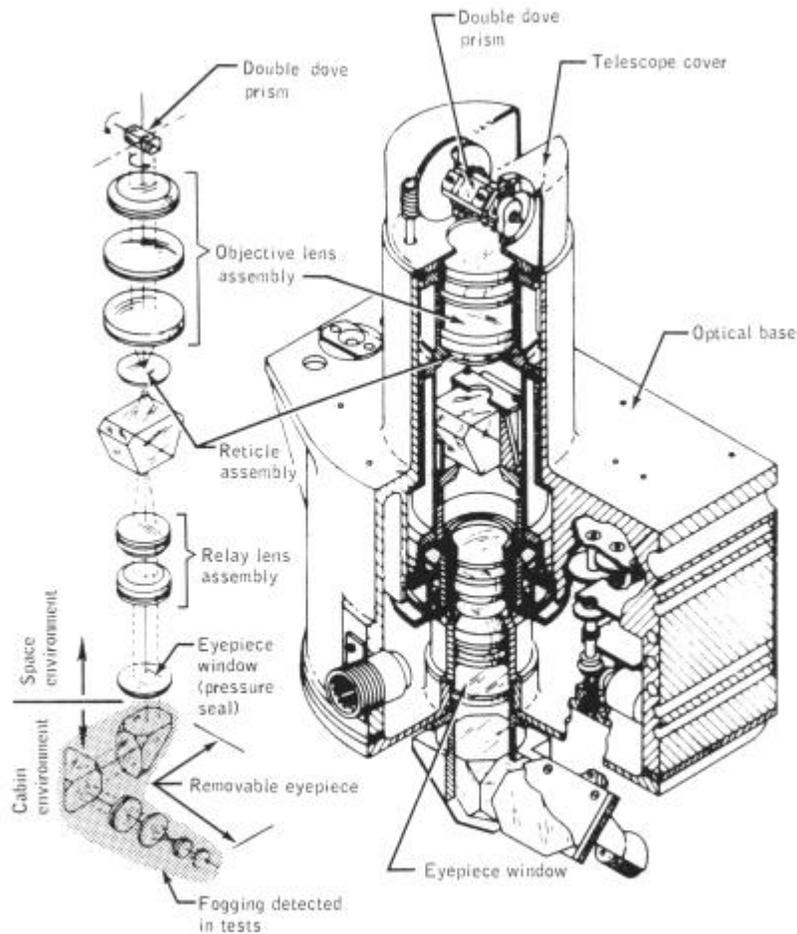
Figure 14-20.- Scanning telescope assembly.

The crew reported that excessive attenuation of light through the scanning telescope existed throughout the flight. The telescope was adequate to perform landmark tracking while in lunar orbit, but the crew was unable to identify constellations, even though large numbers of stars could be seen by looking out the spacecraft window.

Visual observations through the telescope (**Fig. 14-20**) were made at the spacecraft manufacturer's facility, and no degradation could be observed. A luminescent transmittance test was performed on the telescope before removal from the spacecraft and transmittance was calculated to be 25 percent. This compares with an acceptance test value of 55 percent. The decrease is due to the entry environment and sea water contamination. The 30-percent decrease agrees well with the expected results and is not significant as far as being able to see and recognize constellations is concerned. For comparison, the earth's atmosphere normally causes a 50 percent loss in star intensity; therefore, observing stars from earth with a telescope with a 50-percent transmittance would be equivalent to observing stars from a spacecraft in flight using a telescope with a 25- percent transmittance.

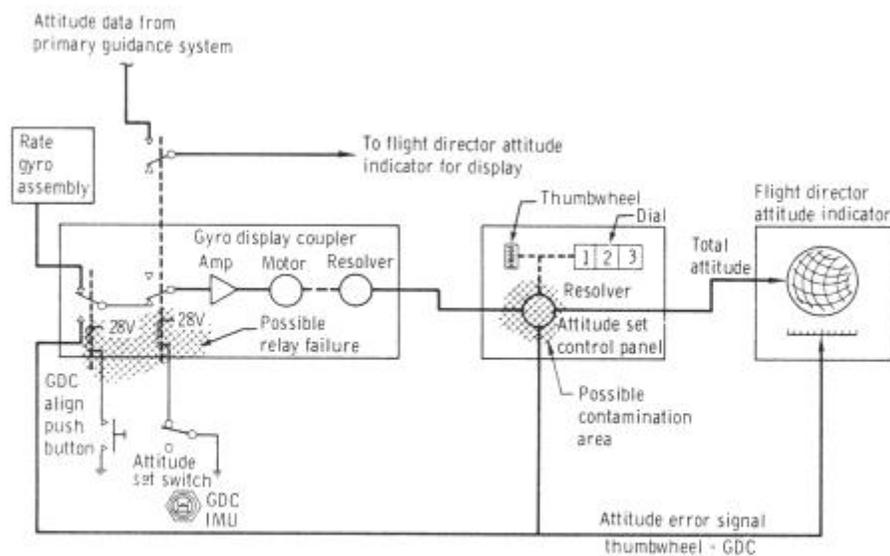
Figure 14-21.- Simplified align loop.

alignment pushbutton was pressed. The roll axis error was not nulled, whereas, the pitch and yaw axes were. Only by depressing the align pushbutton for progressively longer periods, and eventually, by moving the roll-axis thumbwheel, could the roll error be nulled.

For normal operation during alignment, resolvers in the gyro display coupler electronics are compared to resolvers, one for each axis, on the thumbwheels used to set desired attitude. The difference is an error signal. The error is displayed on the attitude error needles, and the signal is used to drive the resolvers to match the attitude set on the thumbwheels. The anomaly could have been caused by either of two failure modes. An intermittent open in the roll axis align loop or a low gain problem in the electronics (**Fig. 14-21**).

The gyro display coupler and attitude set control panel were put into the hardware evaluator simulator and functionally tested at the systems level in the actual spacecraft configuration in an attempt to repeat the flight problem. During this testing, an out-of-tolerance condition was observed on the attitude set control panel. This condition could have caused a gain type problem and been the cause of the flight anomaly. The measured resistance of the thumb wheel resolvers increased from the nominal in all three axes by as much as 1000 ohms. Normally, this value does not vary by more than 1 ohm. In order for this condition to have been the cause of the anomaly, a resistance change in the roll axis would have had to be an order of magnitude larger than that measured postflight. The resistance change is caused by contamination between the slip rings and the thumbwheel resolvers. As a result of the flight anomaly, several resolvers were examined and contamination was detected. The corrective action is to wipe the resolvers clean by rotating them several hundred revolutions. The attitude set

The flight condition could also have been caused by either of two golden-g" relays failing to close. Two failure modes have been determined. One failure mode is "normally open-failure to close", and other, "normally closed - failure to open", both caused by contamination. "Golden-g" relays were the subject of an extensive review in 1966 and 1967. Relays were classified as (1) critical, (2) of major importance, (3) of minor importance, and (4) having no effect. It was decided at that time to (1) make critical relays redundant, (2) improve screening tests, and (3) take no corrective action for non-critical relays. Both of the suspect relays are of major importance in that either one would cause loss of the normal alignment capability of the backup attitude reference system. The attitude reference system could be aligned, but extensive work-around procedures would have to be used.

Tests performed on the roll axis align enabling relay revealed contamination which could have caused the flight anomaly. The rationale developed during the "golden-g" relay review is applicable at this time.

control panels in Apollo 16 and 17 will be checked and the resolvers will be wiped clean, or will be replaced if necessary.

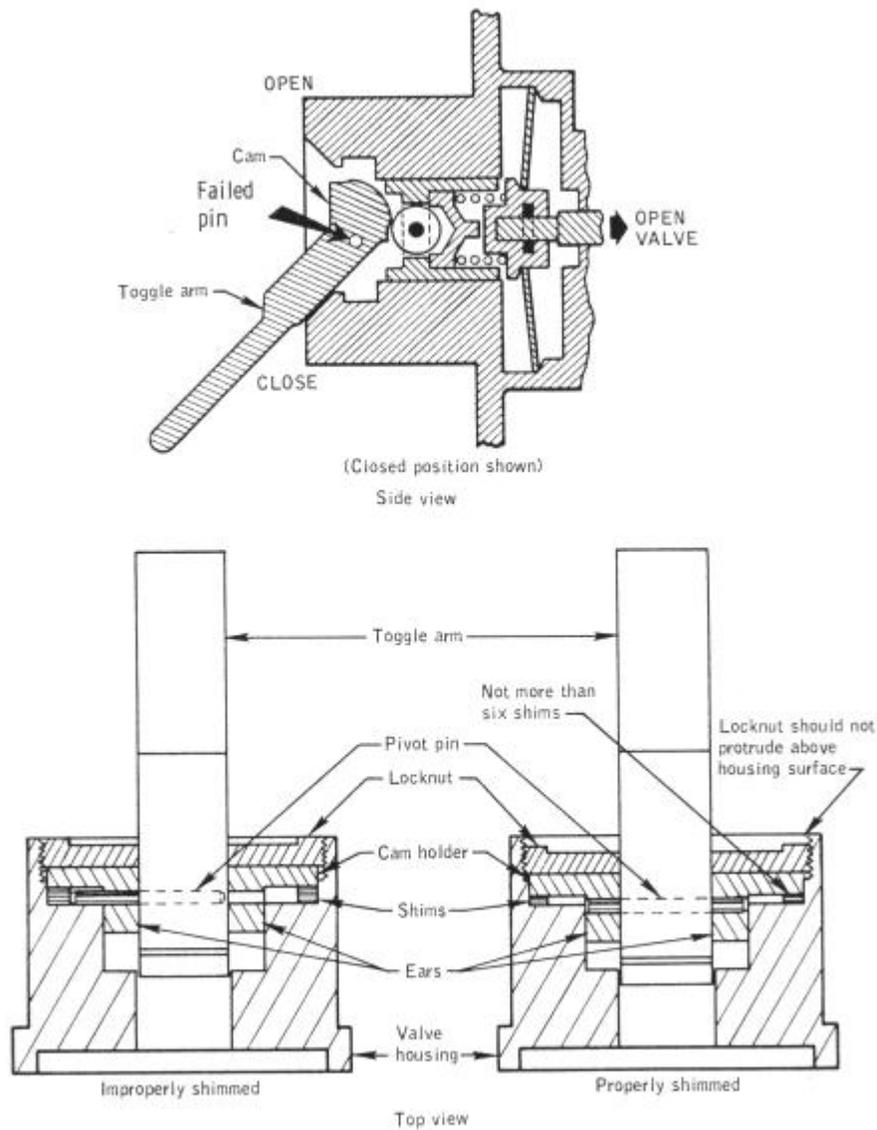
Figure 14-22.- Oxygen regulator shutoff valve.

The toggle-arm pivot pin for the side-A shutoff valve of the main oxygen regulator was found sheared during postflight testing. With the pin failed, the shutoff valve is inoperative in the closed position, thus preventing oxygen flow to the regulator.

The pivot pin attaches the toggle arm to the cam holder and is retained in place by the valve housing when properly assembled (**Fig. 14-22**).

Failure analysis showed that the pivot pin failed in single shear and bending. This failure resulted from improper shimming which allowed the pivot pin to come out of one side of the cam holder as shown in **Fig. 14-22**. Analysis and testing has shown that the pin strength is adequate in double shear, but will fail in single shear and bending with a force of about 70 pounds applied at the tip of the toggle arm when it is in the closed position. No marks were found on the toggle arm to indicate that it had been struck by some object.

with the valve components. These criteria are that the lock nut does not protrude and the number of shims does not exceed six (fig. 14-22).

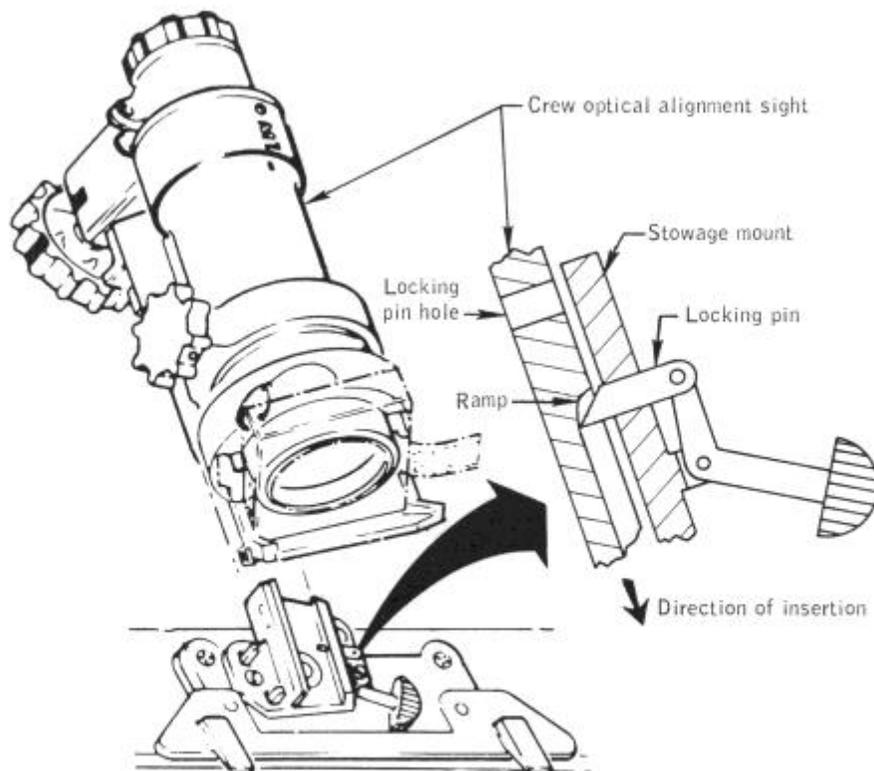
Figure 14-23.- Crew optical alignment sight stowage.

The crew optical alignment sight fell from its stowage mount during landing because the locking pin which secures it was not engaged. Normally, when the sight is placed into the mount, the locking pin is raised automatically by a ramp and the pin is moved into the locking pin hole by spring action (**Fig. 14-23**). Postflight examination showed that the ramp had been gouged preventing raising of the pin by the ramp. The cause of the gouge is not known.

The crew optical alignment sights for Apollo 16 and future spacecraft will be fit-checked to insure proper operation of the latching mechanism. Also, the Apollo Operations Handbook and crew checklist are being revised to include verification of the latching pin engagement prior to entry.

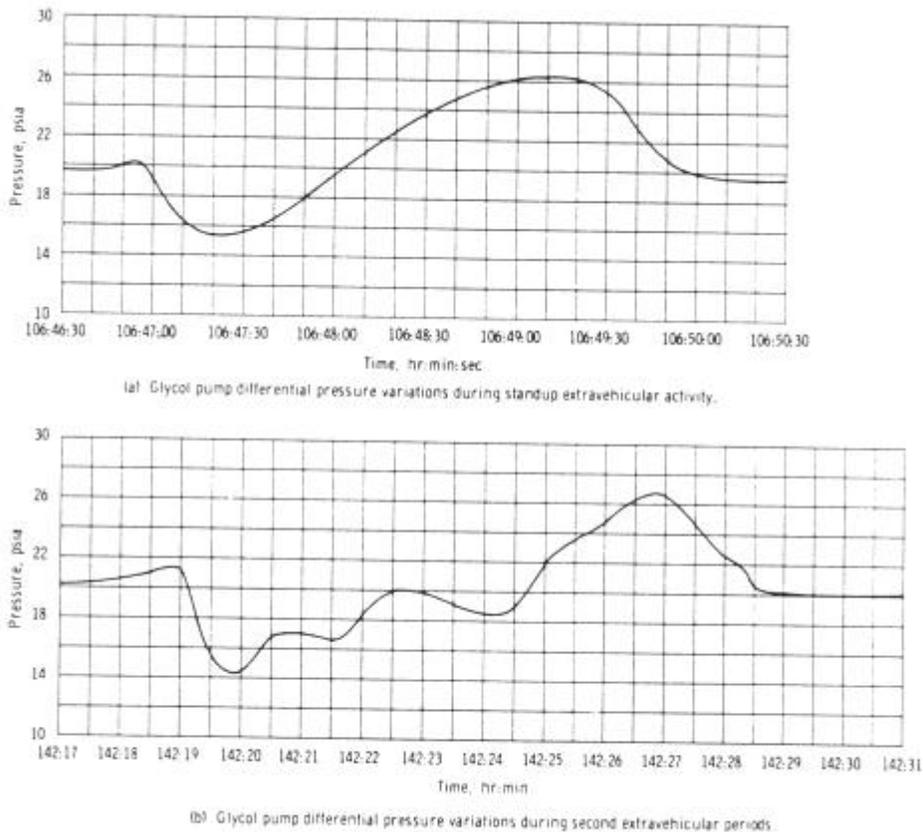
Figure 14-24.- Glycol pump differential pressure variations during extravehicular periods.

Variations were noted in the water/glycol pump differential pressure shortly after the cabin depressurizations for the standup extravehicular activity and the second extravehicular activity. The variations were similar on both occasions. The pressure differential decreased from about 20 psid (normal) to about 15 psid, then increased to about 27 psid and returned to normal (**Fig. 14-24**).

The total times for the cycles were 3 minutes during the standup extravehicular activity and 10 minutes during the second extravehicular activity. The pump discharge pressure remained relatively stable throughout both periods. If pressure fluctuations had taken place in the heat transport system, both the pump discharge pressure and differential pressure should have varied together.

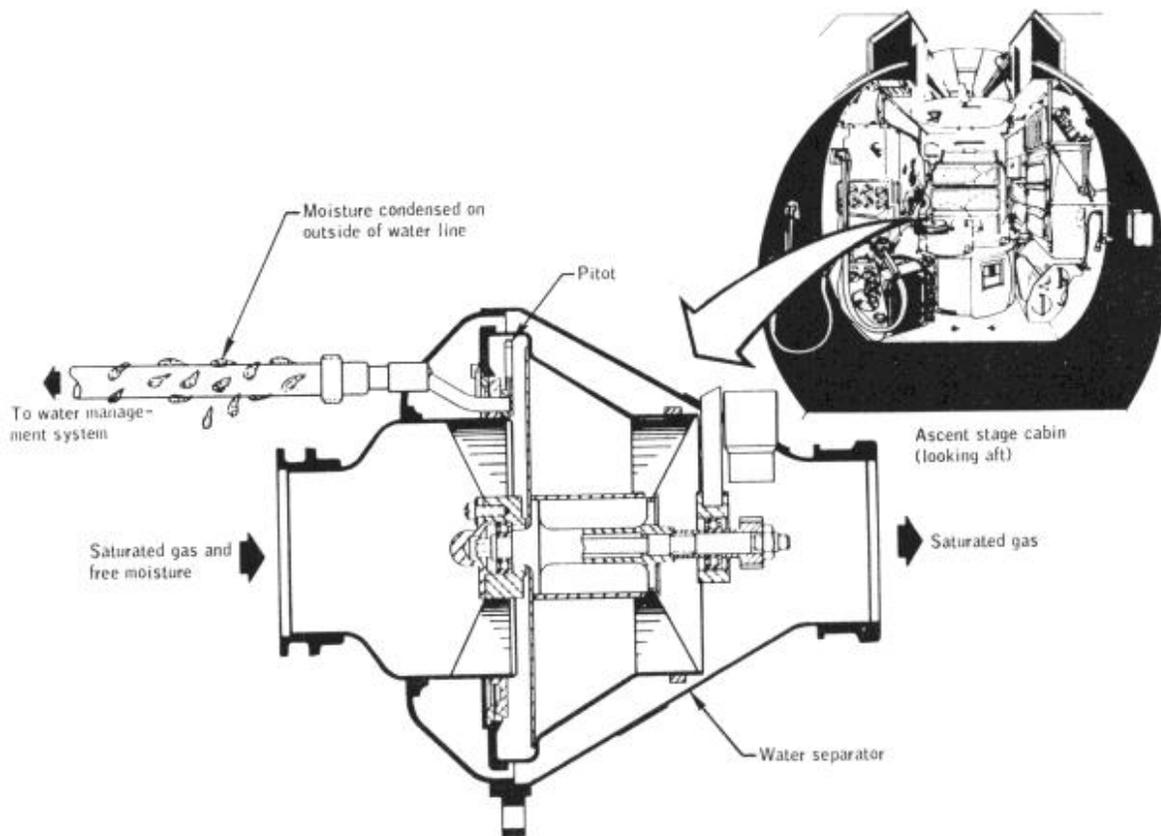
Figure 14-27.- Cross section of water separator.

Cabin atmosphere is cooled and passed through one of the water separators (fig. 14-27) where condensed water is separated by centrifugal force and picked up by a pitot tube. The water is then piped from the pitot tube, through a check valve, to the water management system where it is used in the sublimator.

Cabin humidity was high before the standup extravehicular activity and, because the water and structure were cold, the line between the water separator pitot tube and the water management system was cold. Under these conditions, water would condense on the outside of the line (**Fig. 14-27**), and when the cabin was depressurized for the standup extravehicular activity, the water on the outside of the line would boil, freeze, and sublime, thereby freezing the water in the line.

Analysis shows that as little as a 0.01-inch film of water on the outside of the line will freeze the line at cabin depressurization. Freezing within the line will cause the separator to slow down and stall because of excessive water. Separator 2 had not been used. Therefore, no water was in its outlet line to freeze. Consequently, it operated successfully when activated.

Analysis and tests have shown that freezing of the line will not damage any spacecraft hardware. If such freezing occurs, the other separator would be used. Therefore, no corrective action is required.

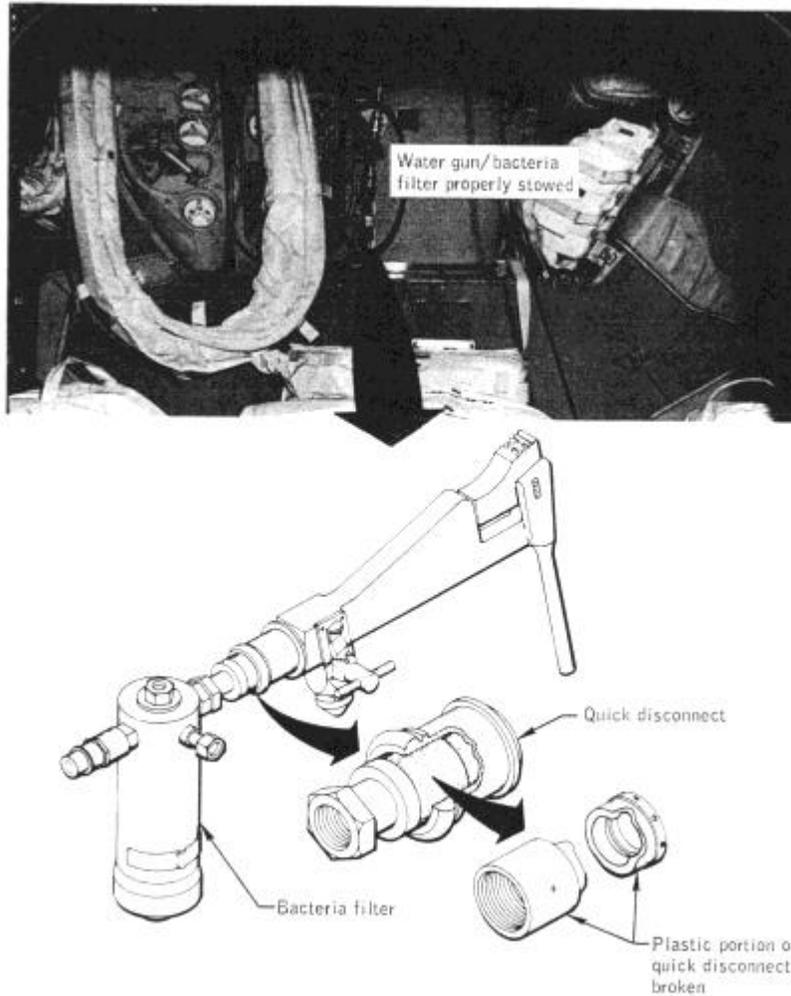
Figure 14-28.- Water gun/bacteria filter.

A water leak occurred at the quick disconnect between the bacteria filter and the water gun (fig. 14-28) shortly after the first extravehicular activity. The leak was caused by the plastic portion of the disconnect being broken and was stopped by removing the filter.

U-shaped boot (**Fig. 14-28**). Both the gun and filter are held in place by straps with the hose protruding above the liquid cooling assembly. Bending the hose can easily exceed the force required to break the quick disconnect between the bacteria filter and the water gun if the filter is not strapped down. A test showed that a torque of 204.6 inch-pounds caused a similar quick disconnect to break in half.

Based on the torque value of 204.6 inch-pounds, a force of approximately 27 pounds applied at the hose quick disconnect interface would break the disconnect between the filter and the water gun.

The plastic parts will be replaced by steel inserts in all locations where the quick disconnects are used in the lunar module and command module.

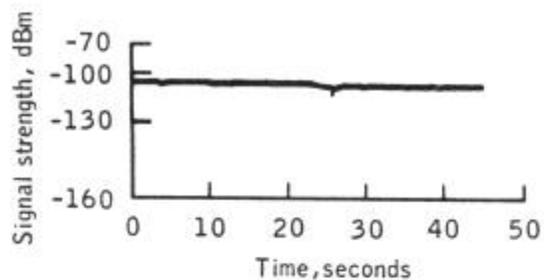
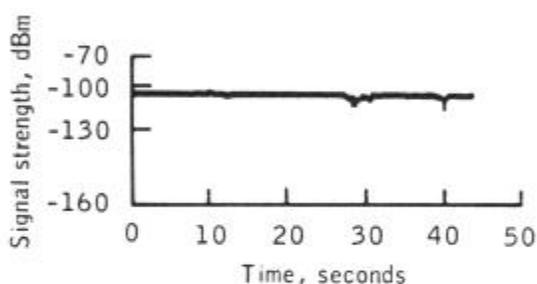
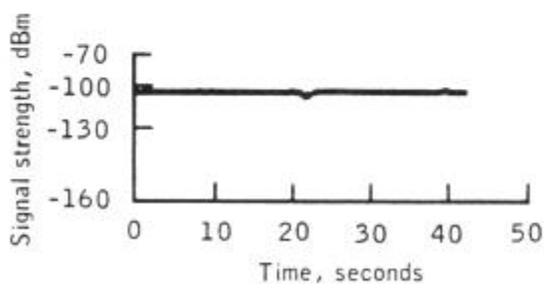
Figure 14-29.- Damped antenna oscillations at random times.

Random oscillations occurred while the steerable antenna was in the auto-track mode. The oscillations were small, and damped without losing auto-track capability (**Fig. 14-29**). The three times when the oscillations became divergent are shown in **Fig. 14-30**.

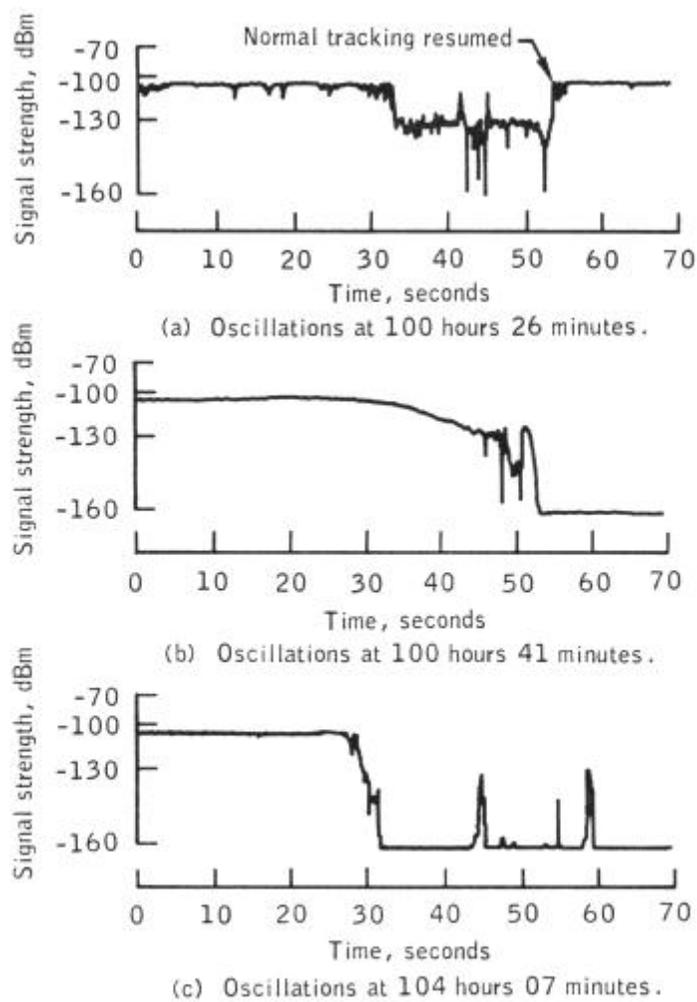
Figure 14-30.- Received signal strength plots associated with divergent antenna oscillations.

100:26 (revolution 12): This divergence occurred prior to separation and was not caused by vehicle blockage or reflections from the command and service module structure.

100:41 (revolution 12): The lunar module maneuver, performed approximately 2 minutes after separation, caused the antenna to track into vehicle blockage, which resulted in the antenna oscillation and loss of lock.

104:07 (revolution 14): Earth look angles for this time period indicate that the antenna was clear of any vehicle blockage.

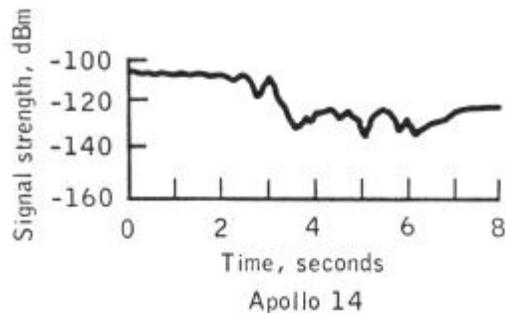
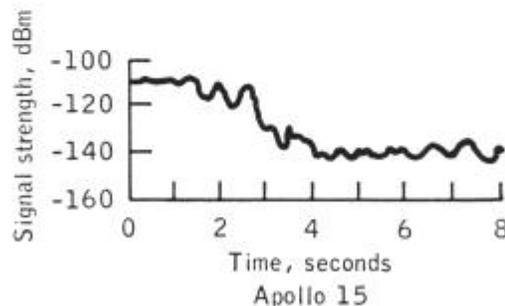
Figure 14-31.- Ground-received signal strength showing spacecraft antenna oscillation characteristics.

All oscillations indicated characteristics similar to the conditions experienced on Apollo 14 (Fig. 14-31). After Apollo 14, one of the prime candidates considered as a possible cause was incidental amplitude modulation on the uplink signal. A monitor capable of detecting very small values of incidental amplitude modulation was installed at the Manned Space Flight Network Madrid site for Apollo 15. The data from this monitor indicated that no amplitude modulation existed on the uplink at the frequencies critical to antenna stability during the problem times. Consequently, incidental amplitude modulation has been eliminated as a possible cause of the antenna oscillations, and the problem must be in the spacecraft.

There are two possible causes of the problem in the spacecraft. The first is that electrical interference generated in some other spacecraft equipment is coupled into the antenna tracking loop. A test performed on the Apollo 16 lunar module showed that no significant noise is coupled into the tracking loop during operation of any other spacecraft equipment in the ground environment. The second is that temperature or temperature gradients cause an intermittent condition in the antenna which results in the oscillations. The acceptance tests of the antennas do not include operation over the entire range of environmental temperatures; therefore, a special test is being conducted on a flight spare antenna to determine its capability to operate over the entire range of temperatures and gradients.

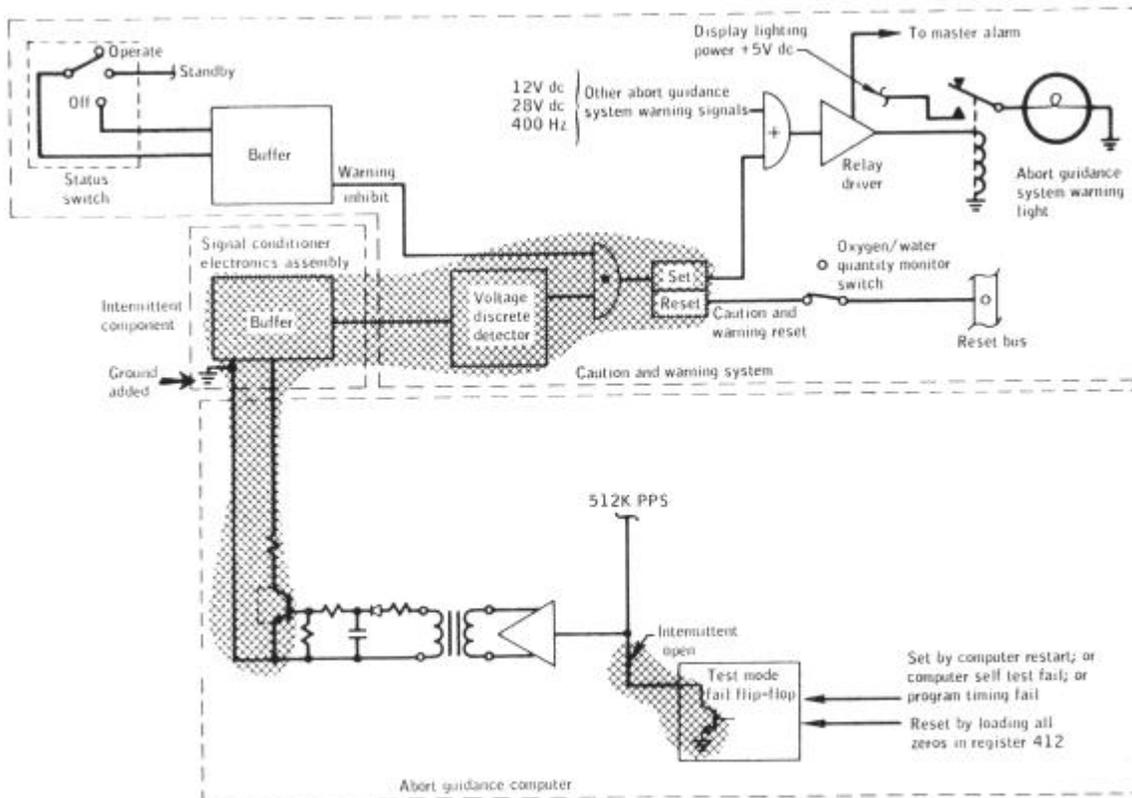
Figure 14-32.- Abort guidance system test mode fail circuitry.

After the warning at insertion, the crew read out the contents of the computer self test address 412, but there was no indication of a test-mode fail. The crew did not, however, reload all zeros into address 412 as is required to reset the flip-flop (fig. 14-32) which controls the test-mode fail output in the computer. Consequently, a second test-mode fail would not have caused an abort guidance system warning. The fact that a second warning did occur restricts the location of the failure to the output circuit of the computer, the signal conditioner electronics assembly, or the caution and warning system.

The abort electronics assembly test mode fail output drives a buffer (**Fig. 14-32**) in the signal conditioner electronics assembly which, in turn supplies the test mode fail signal to the caution and warning system. The test mode fail buffer is the only application in the lunar module where a transistor supplies the input signal to the buffer and where the low side of the input to the buffer is not grounded. Tests have shown that some buffers feed back 10-kHz and 600-kHz signals to the buffer input lines. These signals are completely suppressed when the low side of the buffer input is grounded.

With the noise signal voltages present, the test mode fail driver is more susceptible to electromagnetic interference. An analysis indicates that, with worst-case noise signals present, an induced voltage spike of only about 3.5 volts will cause the test mode fail driver to momentarily turn on and latch the caution and warning system master alarm and abort guidance system warning light on.

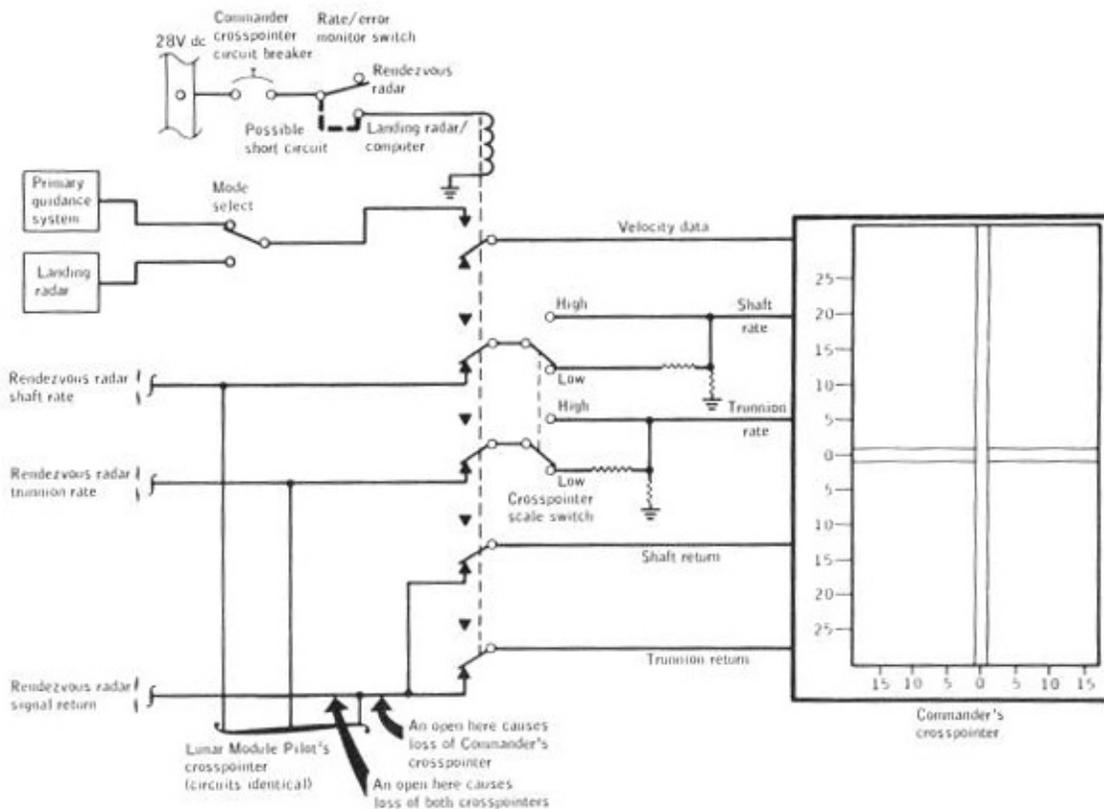
Figure 14-33.- Simplified schematic of crosspointer circuits.

Four possible conditions could have affected the display of radar antenna rate data (**Fig. 14-33**).

- b. Conductive contamination between two contacts in the rate error monitor switch could have had the same effect on the crosspointer display as condition "a". The switch in this lunar module was X-rayed and screened before installation, and no contaminant was found; however, it should be pointed out that present screening techniques might not detect a single wire strand between two contacts.

- c. An open in the return line would cause loss of rate data to one or both meters, depending upon the location of the open. The signal return lead from the Commander's meter in panel 1 is routed to panel 2 where it is connected to the signal return from the Lunar Module Pilot's meter and routed to the rendezvous radar.

- d. An open in the wire in the rendezvous radar electronics assembly which connects 15 volts at 400 hertz to two velocity filters (one each for shaft and trunnion rate) could cause the loss of shaft and trunnion rate data to both sets of crosspointers.

The most probable failure is an open in the signal return line. Information could still be deduced from antenna position data which is displayed on the flight director attitude indicators. Ground tests and checkout may not show this type of failure. If the open is temperature sensitive, a complete vehicle test involving vacuum, temperature, and temperature gradients would be required to insure that failures of this type would not occur in the flight environment. This type of testing is not practical at the vehicle level. Consequently, no corrective action is planned.

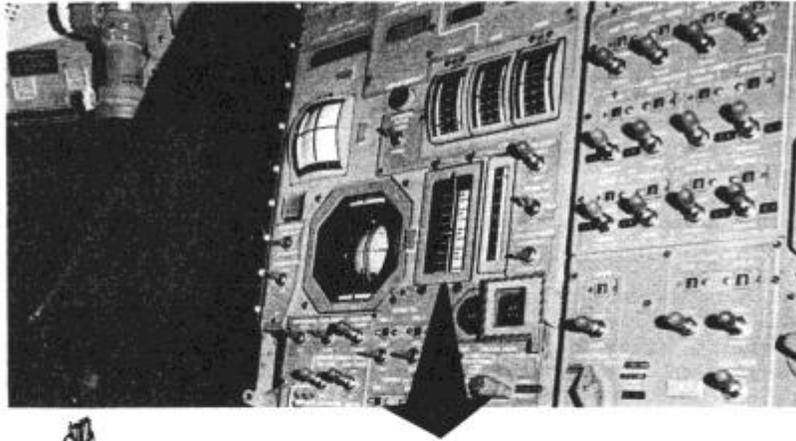
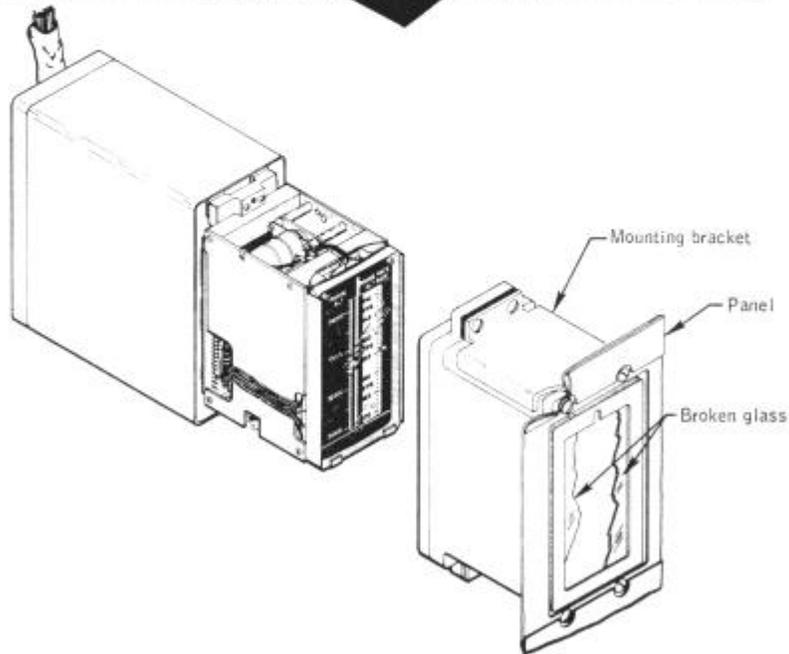
Figure 14-34.- Range/range rate meter mounting.

Sometime prior to ingress into the lunar module, the window of the range/range-rate meter broke (Fig. 14-34). Upon ingress, the crew saw many glass particles floating in the spacecraft, presenting a hazardous situation.

The window is an integral part of the meter case and is made of annealed soda-lime glass 0.085-inch thick. The meter case is hermetically sealed and pressurized with helium to 14.7 psia at ambient temperature. At the maximum meter operating temperature and with the cabin at vacuum, the pressure differential can be as high as 16.1 psi. This pressure differential is equivalent to a stress level of 6680 psi in the glass.

Glass will break when there is a surface flaw large enough to grow at the stress levels present. The threshold flaw size in a dry environment is about the same as the critical flaw size and immediate breakage occurs. The critical flaw size remains the same in a humid environment, but the threshold flaw is much smaller. For annealed soda-lime glass at a stress level of 6680 psi, the critical flaw depth is 0.0036 inch, and for a humid

For future missions, an exterior glass doubler will be added to the flaw depth to 0.0036 inch and the critical flaw depth to 0.032 inch. This should prevent future fatigue failures since there are no reported fatigue failures in soda-lime glass at stresses below 2000 psi. In addition, all similar glass applications in the lunar module and command module were reviewed and changes are being made. In the command module, transparent Teflon shields will be installed on the:

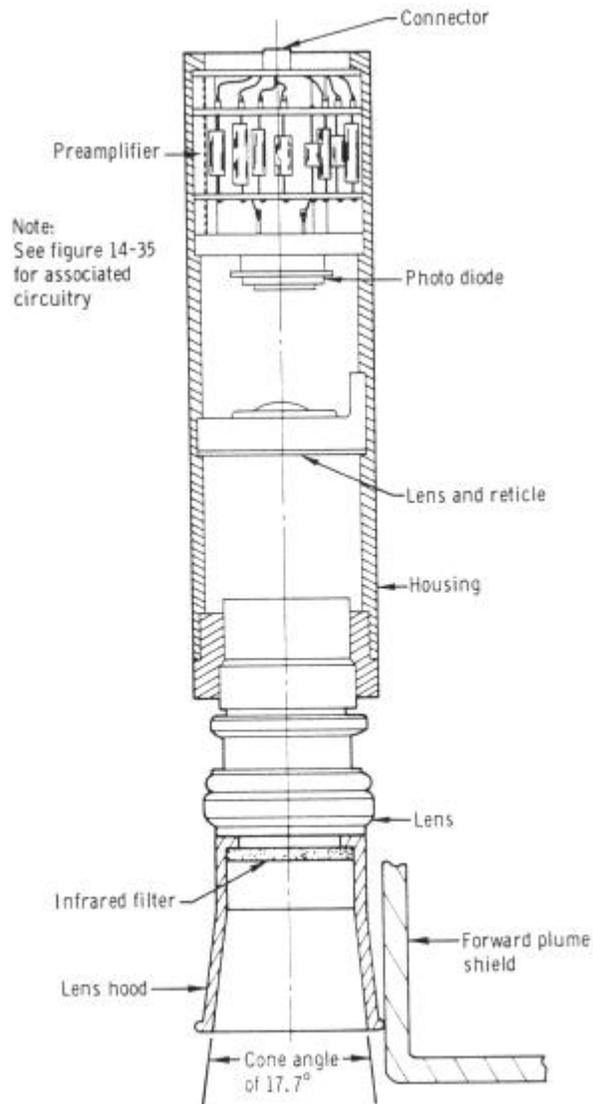
Figure 14-35.- Velocity/altitude sensor assembly.

Telemetry received from the first panoramic camera pass on revolution 4 indicated that the velocity/altitude sensor (**Fig. 14-35**) was not operating correctly.

The velocity/altitude sensor measures the angular rate of travel of the spacecraft relative to the lunar surface. The sensor output is used to control the cycling rate of the camera, the forward motion compensation, and the exposure. The sensor normally operates in the range of 45 to 80 miles altitude. If, at any time, the indicated velocity/altitude is out of this range, the sensor automatically resets to the nominal value of 60 miles. The sensor operated properly for brief periods of time, but would drift off-scale high (saturate), and then reset to the nominal value corresponding to a 60-mile altitude.

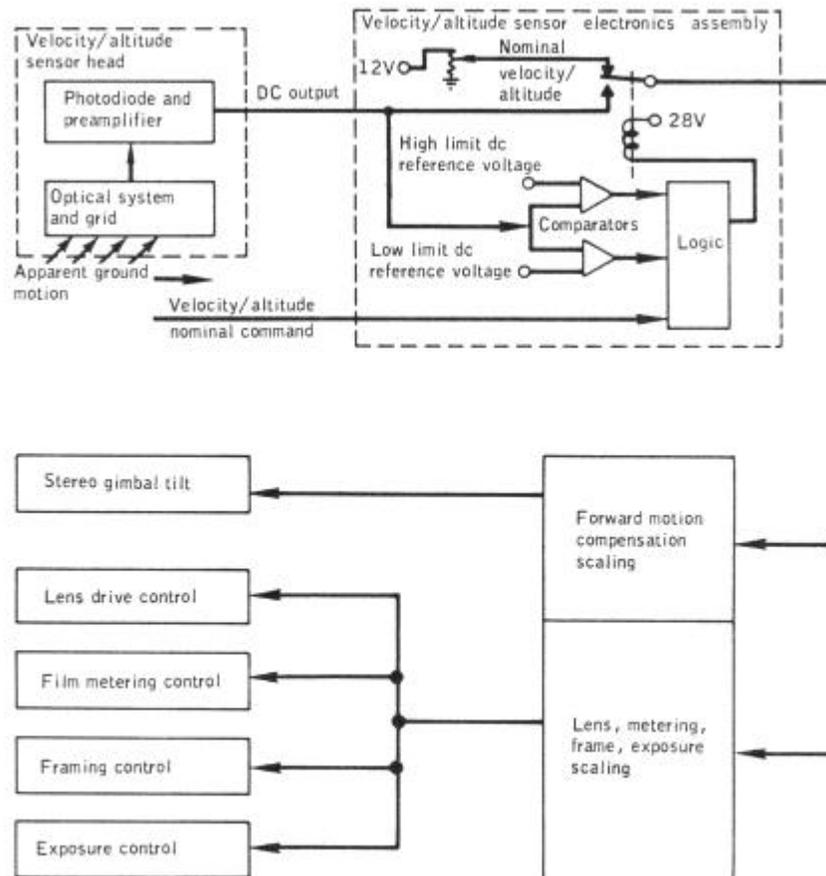
Figure 14-36.- Velocity/altitude output circuitry.

Breadboard tests and circuit analyses of the velocity/altitude electronics (**Fig. 14-36**) did not indicate failure. Tests were conducted in which endless belts of lunar scene photography from Apollo 8 and 15 were passed in front of velocity/altitude sensors. Sensors from the prototype and qualification units, and flight unit number 1 were used. By varying the illumination level, sensor performance somewhat similar to the Apollo 15 anomaly could be obtained.

The results of the tests, coupled with analyses of the basic sensor design, indicate that the problem is related to the optical signal-to-noise ratio. The remaining flight hardware will be modified to improve this ratio. The optical signal will be enhanced by increasing the lens aperture from f/4.0 to f/3-5 and by deleting the infrared filter. The optical noise (reflections) will be reduced by increasing the length of the lens hood and by repositioning the sensor so that the camera's forward plume shield will not be in the field of view of the sensor. In addition, a manual override of the velocity/altitude sensor will be provided on the remaining flight units. By using a three-position switch, two preselected velocity/altitude ratios will be provided, as well as the automatic function.

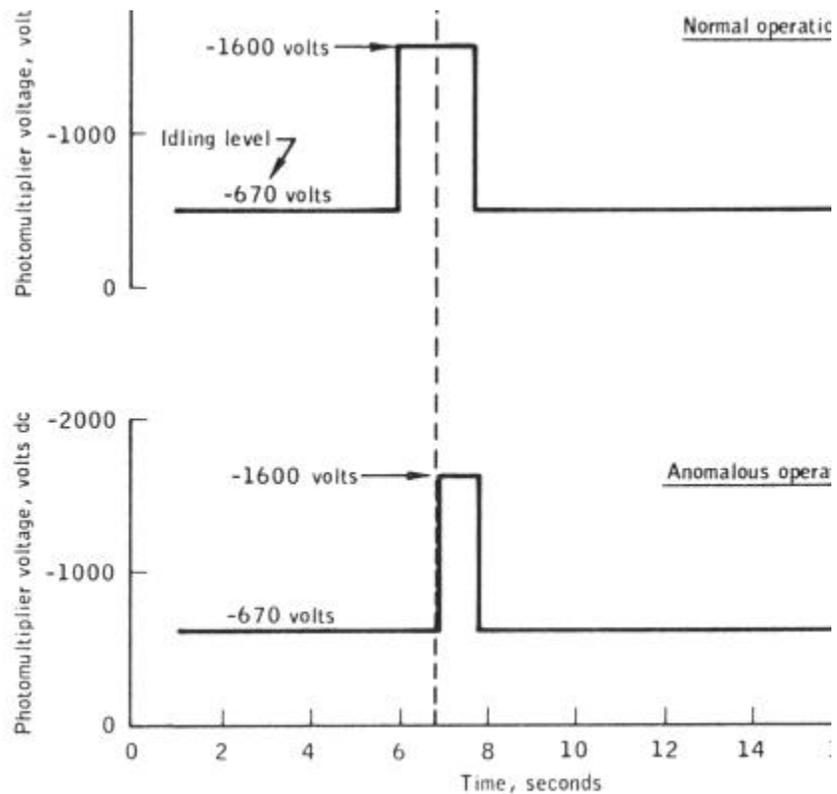
Figure 14-37.- Comparison of photomultiplier power supply volt.

The laser altimeter exhibited two anomalous conditions during the mission:

- a. Altitude data became intermittent after revolution 24 as the result of a decrease in the laser output power.
- b. Beginning with revolution 38, the photomultiplier tube high-voltage power supply was held in the idling (minimum-voltage level) mode until after the laser fired, thereby causing the receiver to miss the return pulse from the lunar surface (**Fig. 14-37**). No altitude data were obtained after this anomaly occurred.

The photomultiplier tube power supply anomaly was duplicated when a relay which had been removed from a flight unit because it had an audible "buzz" was installed in the prototype altimeter. The relay serves no function in flight, but is a safety precaution for ground personnel working on the altimeter (**Fig. 14-38**). The relay contacts close when the altimeter is turned off, discharging the high voltage stored in the pulse forming network capacitors.
