APOLLO 15 MISSION REPORT

MSC-05161

Mission Evaluation Team

NATIONAL AERONAUTICS AND SPACE ADMINISTRATION
MANNED SPACECRAFT CENTER
HOUSTON, TEXAS
December 1971

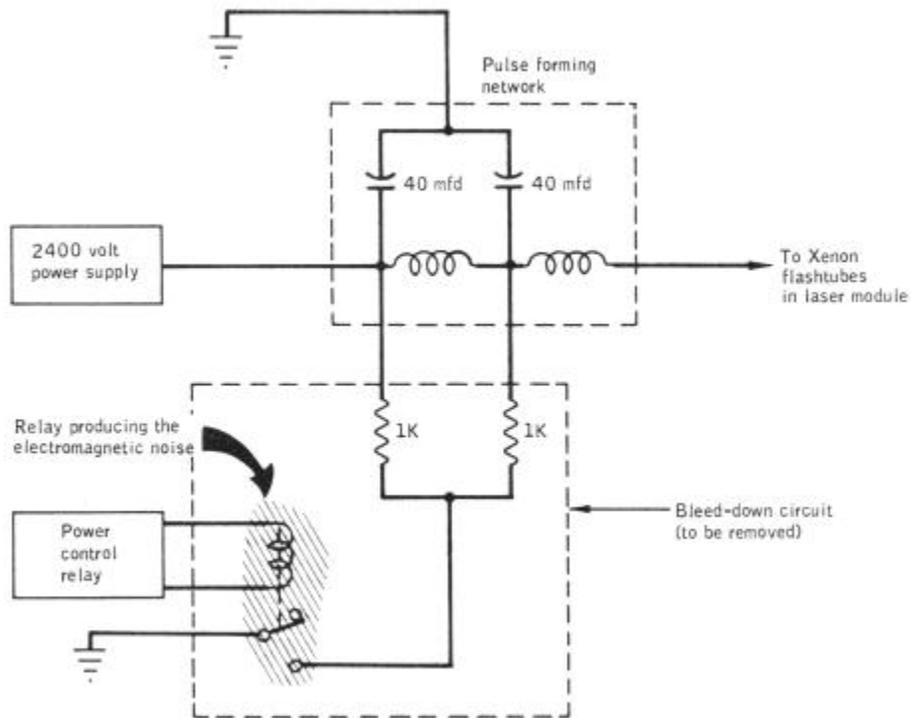
Figure 14-38.- Pulse forming network bleed-down circuit.

The photomultiplier tube power supply anomaly was duplicated when a relay which had been removed from a flight unit because it had an audible "buzz" was installed in the prototype altimeter. The relay serves no function in flight, but is a safety precaution for ground personnel working on the altimeter (**Fig. 14-38**). The relay contacts close when the altimeter is turned off, discharging the high voltage stored in the pulse forming network capacitors.

It is suspected that the audible "buzz" is accompanied by electromagnetic interference that is coupled into the video amplifier in the laser receiver (**Fig. 14-39**). The video amplifier is a principal element in the automatic gain control circuit which controls the output of the photomultiplier tube power supply. The electromagnetic interference from the relay can thereby result in the automatic gain control holding the power supply in the idling mode until the pulse forming network is discharged in firing the laser. The relay and resistors that comprise the bleed-down circuit will be removed from the remaining flight altimeters.

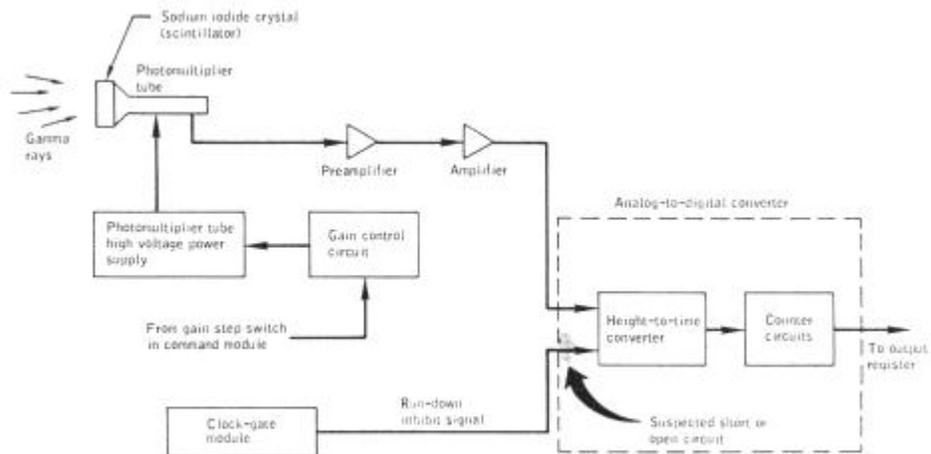
Figure 14-40.- Gamma ray spectrometer circuitry.

Tests conducted with the qualification unit verified that the change in gain was due to aging effects of the photomultiplier tube in the gamma ray detector assembly as a result of high cosmic ray flux rates in lunar operation. The zero shift appears to be associated with the run-down inhibit signal between the clock-gate module and the analog-to-digital converter (**Fig. 14-40**).

Absence of this signal at a particular point in the analog-to-digital converter removes a 3-microsecond offset in the pulse height analyzer. The resulting effect is an overall eight-channel offset in the spectrum. The qualification unit was partially disassembled and tests showed that either an open or a shorted wire within the pulse height analyzer can result in an eight-channel offset. An inspection of the circuit in the qualification unit disclosed no design deficiency which would cause this type of failure. Since the eight channel zero offset does not significantly impact overall data quality, no corrective action is contemplated.

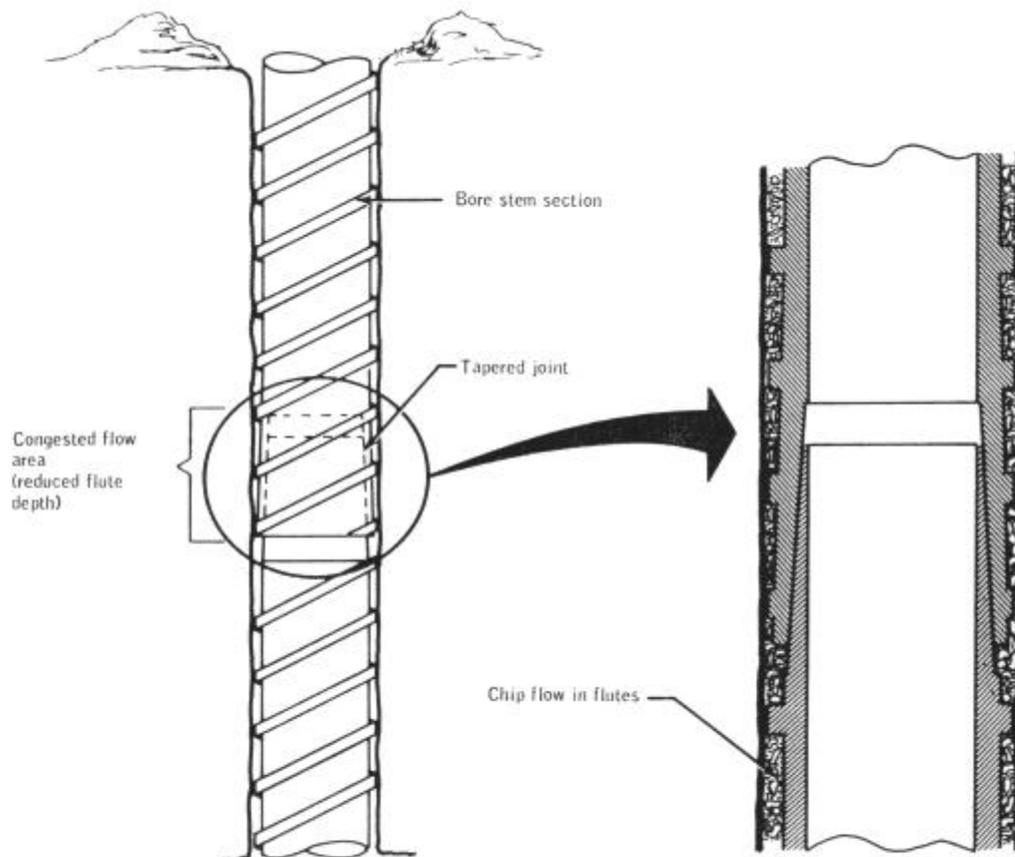
Figure 14-41.- Congestion at bore stem joints.

Although the average penetration rate for the two bore stem holes was reasonable (approximately 120 inches per minute for hole 1, and 18 inches per minute for hole 2), it was necessary to stop both holes at approximately 60 percent of the depth desired.

The bore stem sections are made of a fiberglass and boron filament laminate, chosen for its optimum thermal characteristics as a casing for the heat flow experiment probe. The sections are approximately 21 inches long with tapered male and female joints. One-inch double-thread spiral lead flutes are provided on the exterior surface to transport the soil chips from the drilled hole to the surface. The depth of the flutes is 0.050 inch for about 18 inches, but the flutes almost disappear at the joint area where the wall thickness must follow the taper of the joint (**Fig. 14-41**). As a result, the volume of chip flow to the surface is slowed considerably in looser soil formations, and stalled by the packing of the chips in high-density formations.

In order to reduce the time required, prevent damage to bore stems, and increase the probability of attaining the full depth, the following modifications and corrective actions are being implemented:

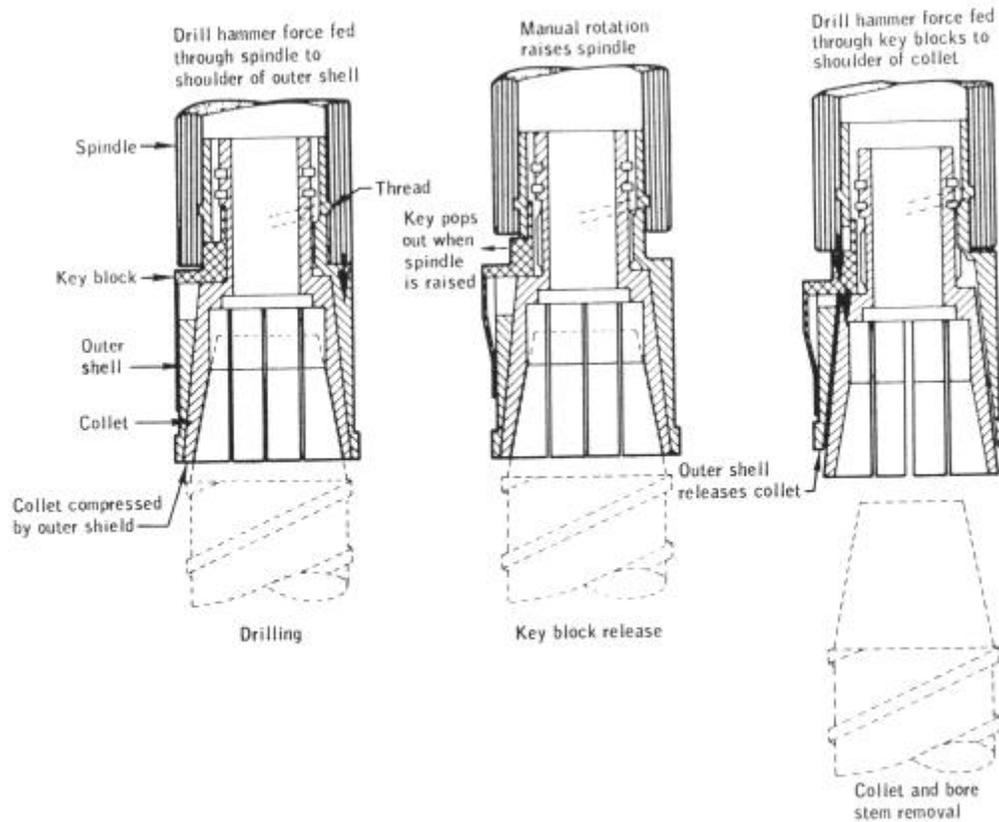
Figure 14-42.- Release of bore stem from drill.

Use of the normal procedure for releasing the lunar surface drill head from the bore stems was hampered by the bore stems turning freely in the lunar soil.

In the bore stem drilling position, the key blocks are restrained inside, and the spindle drives against the shoulder of the adapter outer shell (**Fig. 14-42**). The operational sequence to release the bore stem from the adapter includes the following steps:

The single-purpose core stem wrench is fitted to the 0.983-inch- diameter titanium core stem, but the 1.088-inch throat will admit the 1.075-inch-diameter bore stem. The softer bore stem (boron-fiberglass laminate) can be deformed and present some difficulty in wrench removal, with possible damage to the bore stem. A wrench to fit both bore and core stems will be provided.

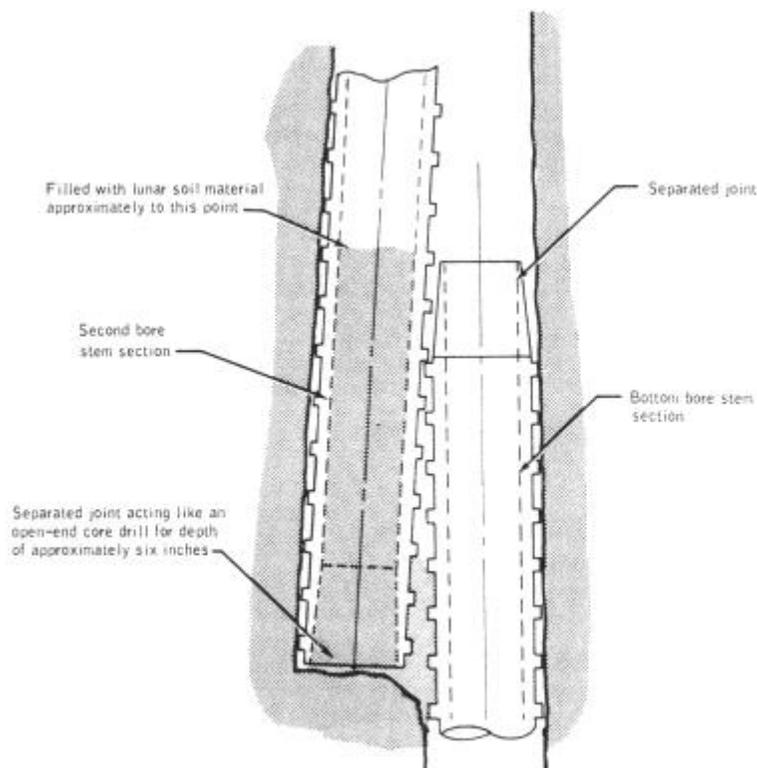
Figure 14-43.- Bore stem joint separation.

The probe would not go to the bottom plug of the bottom bore stem in hole 2, but stopped at a point about 6 inches above the first joint. Examination of photographs and heat flow probe data indicate that, near the end of the bore stem drilling operation, the first joint was separated when the drill and drill string were moved vertically (up and down) in an attempt to improve the drill penetration rate. Easier penetration (for approximately 6 inches) was reported by the crew, but it resulted from the bottom of the second section apparently performing more in a coring manner (**Fig. 14-43**) with the lunar soil entering the second section of the bore stem.

The change from boron/fiberglass to threaded titanium in the bore stem joint will prevent a repetition of such a separation.

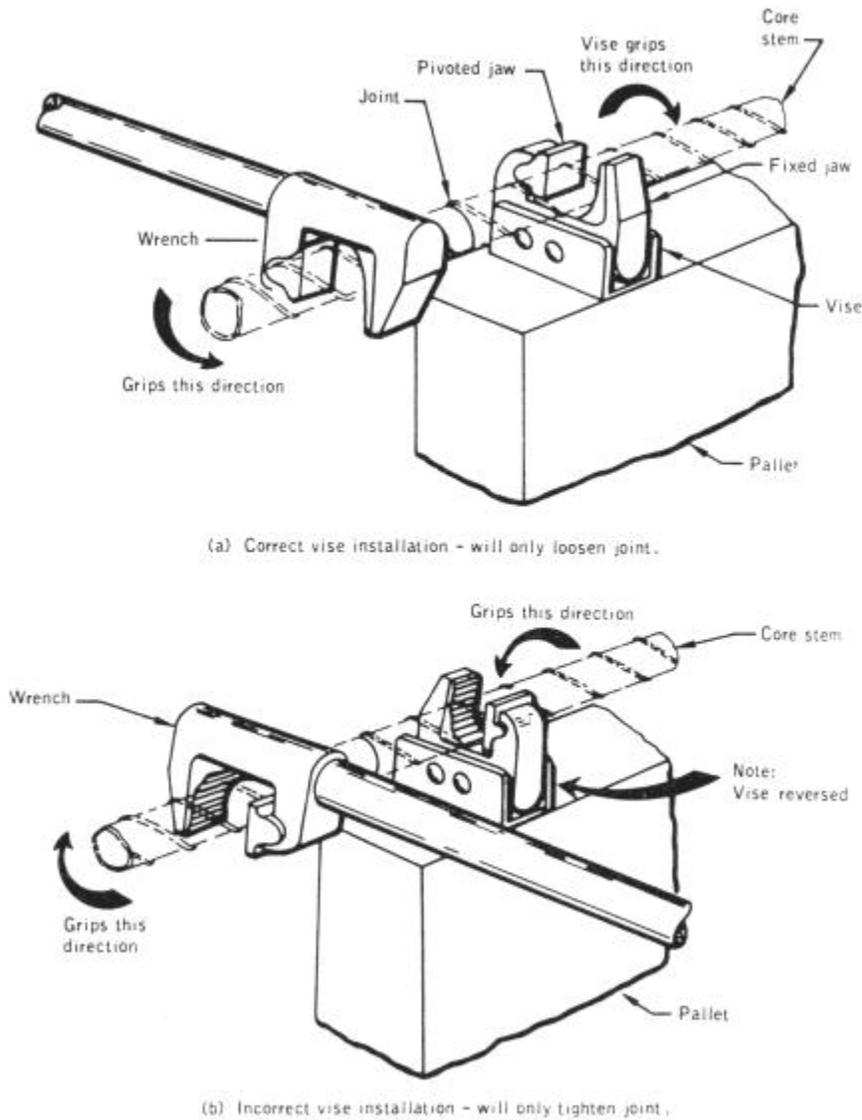
Figure 14-44.- Installation of core stem vise on rover pallet.

As mounted, the vise would hold the core stem so that the joint could be tightened by rotating the wrench on the adjoining section. However, the vise would not hold in the opposite direction so that the joint could be loosened and separated (**Fig. 14-44**). Working on the inboard side of the vise, the core stem could have been held properly for loosening; however, there is insufficient clearance on the inboard side of the vise for

wrench rotation, and the distance to the other side of the lunar roving vehicle is greater than the length of a core stem section.

The installation drawing of the vise was in error and has been corrected to assure correct orientation of the vise for Apollo 16. The training vise was installed backward from the erroneous drawing, but correct for loosening the stems.

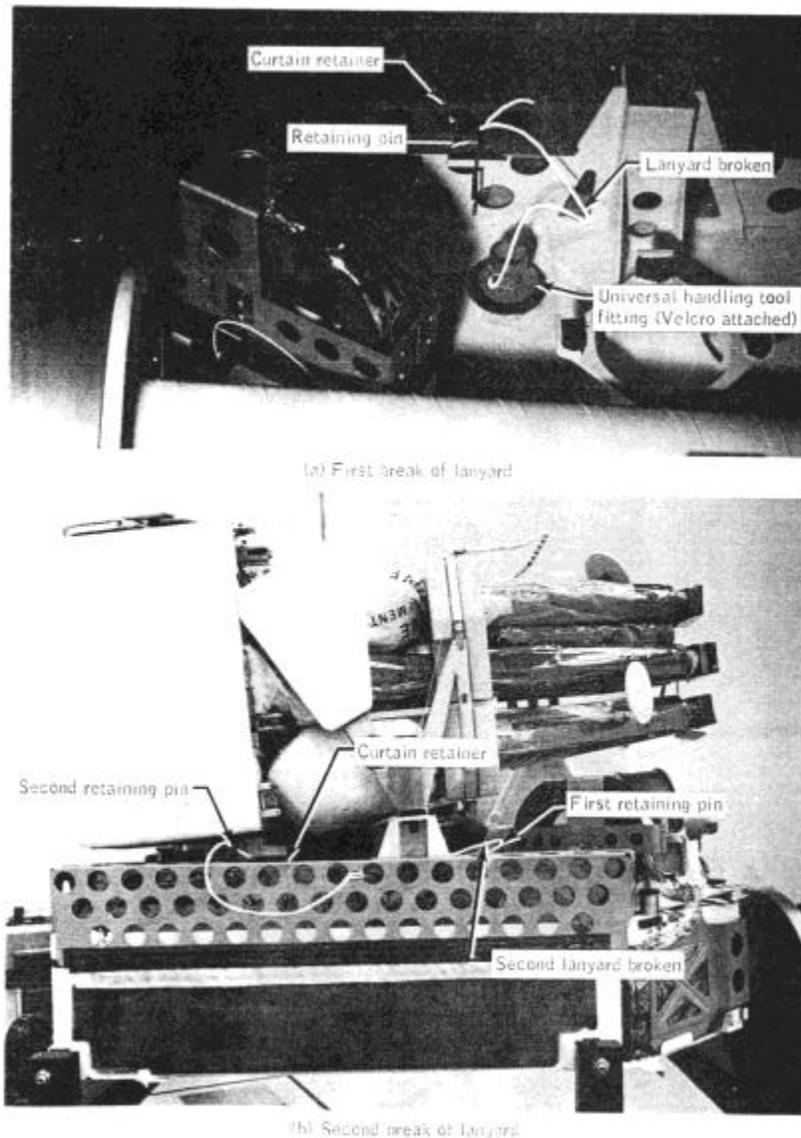
Figure 14-45.- Central station rear curtain retainer removal.

To remove the retainer for the central station rear curtain, added for Apollo 15, it was necessary to remove two retaining pins (**Fig. 14-45**). The two pins, a universal handling tool fitting, and the curtain retainer are joined by a three-section lanyard. When the universal handling tool was inserted in the fitting and raised to remove the first pin, that section of the lanyard broke. When an effort was made to remove both pins simultaneously by inserting the handle under the lanyard joining the two pins, that part of the lanyard broke. The pins and retainer were then removed by hand.

The Dacron lanyard is being changed from a 50-pound test rated material to a 180-pound test rated material with acceptance pull tests being increased to 20 pounds for

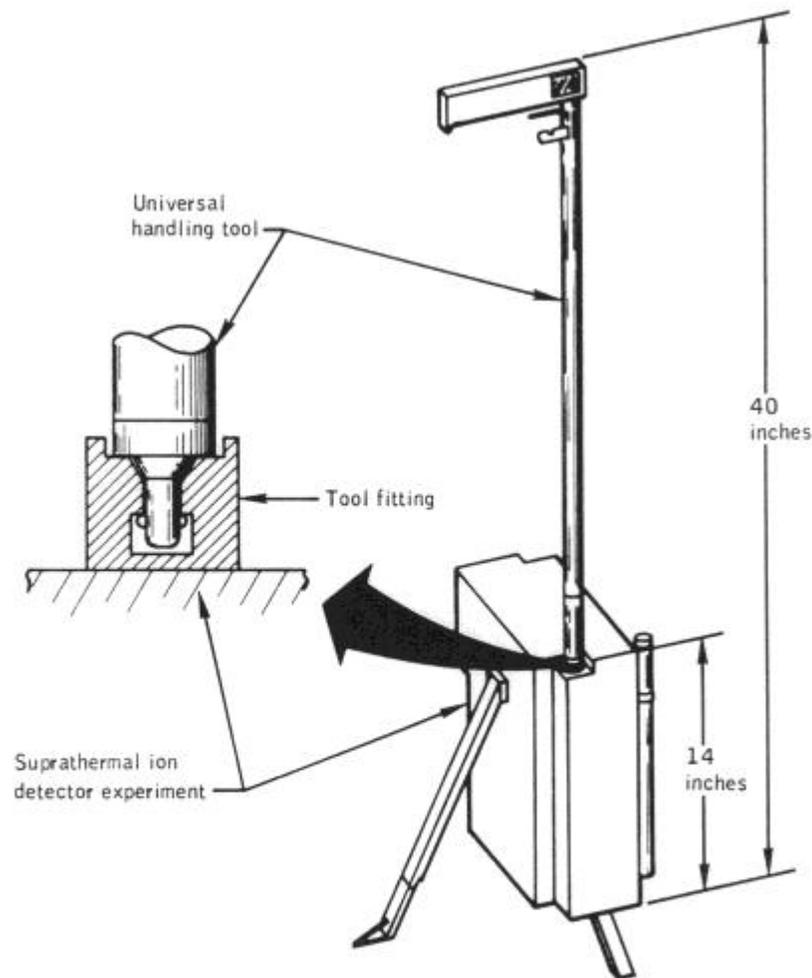
Figure 14-46.- Universal handling tool - suprathermal ion detector experiment interface.

While carrying the suprathermal ion detector experiment from the subpallet to the emplacement site, the experiment fell off the universal handling tool at least twice. The experiment sustained no visible damage and has been operating satisfactorily.

The universal handling tool fitting on this experiment is in the highest location above the lunar surface of any of the fittings and presents an awkward position of the tool for insertion, locking, and maintaining lock in the fitting (**Fig. 14-46**).

Corrective action includes training procedures to avoid inadvertent tool-release triggering because of the position of the tool. There are no present plans for the suprathreshold ion detector experiment to be carried on future missions, and no other scheduled experiments have a similarly located fitting.

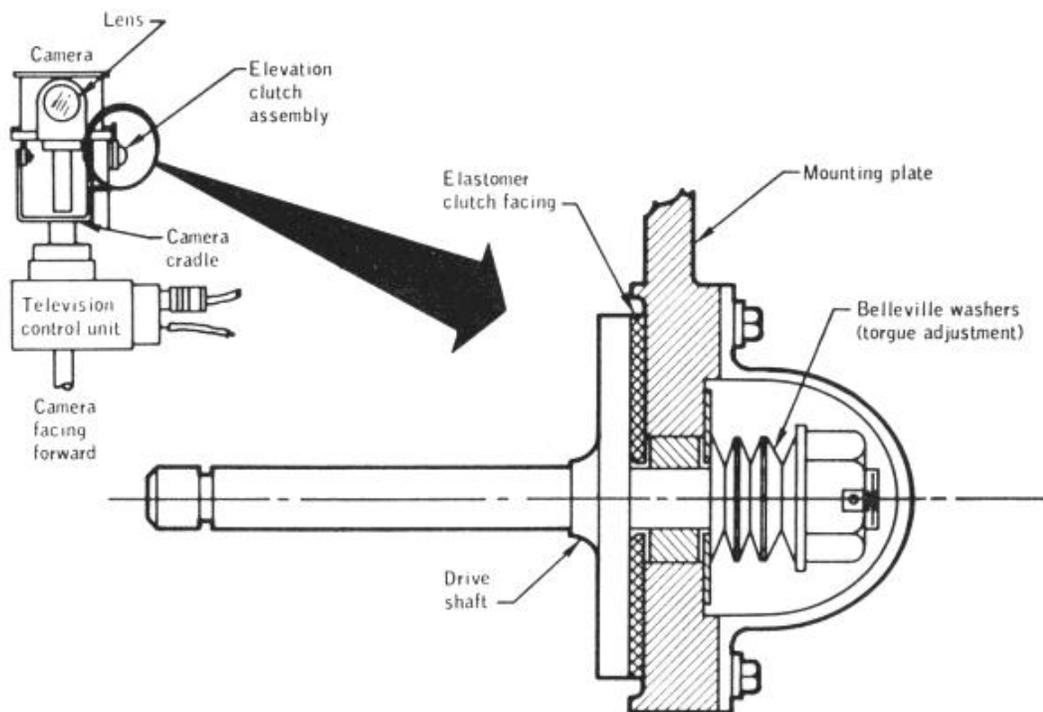
Figure 14-47.- Camera elevation control clutch.

During the second extravehicular activity, the camera could not be elevated as the unit approached the upper or lower limits of angular travel. The condition further deteriorated during the third extravehicular activity.

Elevation control is provided to the camera cradle through a friction clutch (Fig. 14-47) which allows manual override of the ground-commanded camera positioning. The camera-cradle pivot point is approximately 3 inches below the center of gravity of the cradle with the camera mounted. As the camera moves away from the horizontal position, the unbalanced moment becomes progressively greater, and a higher torque load must be supported by the clutch mechanism.

The elastomer clutch-facing material provided the required stable friction properties in the specification and qualification test temperature range (122° F, maximum). However, the maximum temperature on the television control unit during the third extravehicular activity has been calculated as approximately 180° F. Materials specifications show that the compressive strength of the elastomer degrades rapidly at this temperature, and ground tests with flight unit 4 verify severely degraded performance with time at elevated temperature.

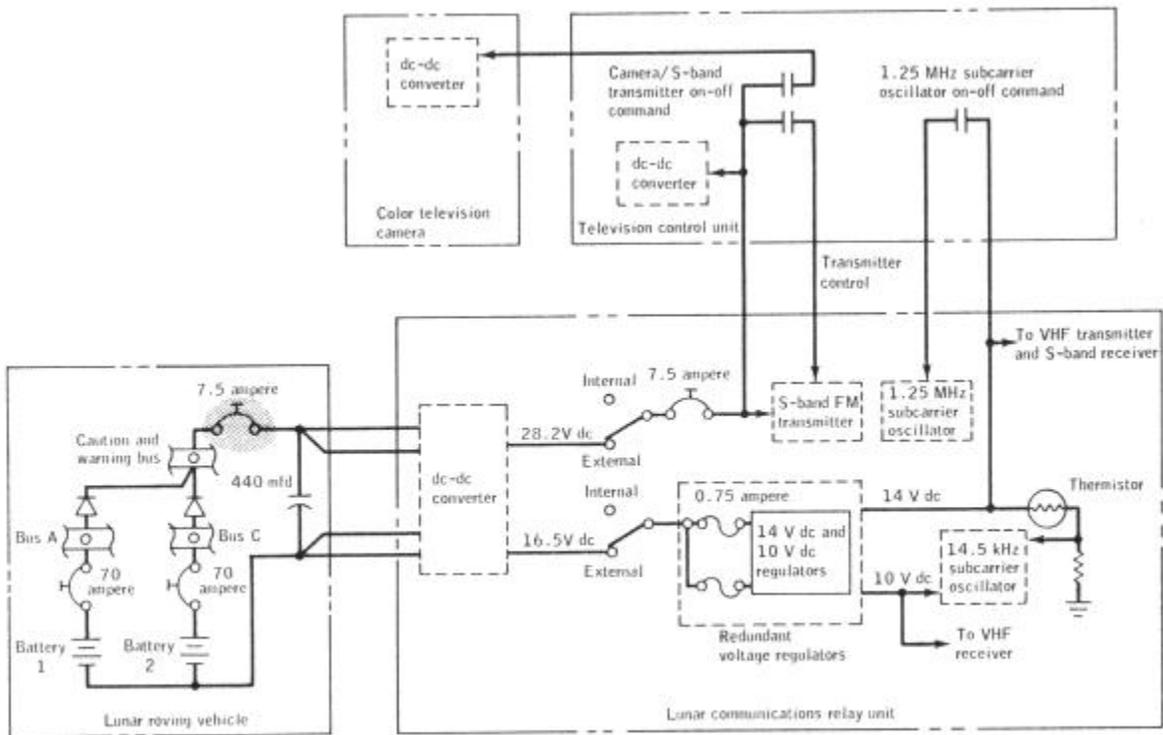
Figure 14-48.- Lunar roving vehicle/lunar communications relay unit/ground controlled television assembly power distribution.

In laboratory tests, the fault which duplicated the flight data was the opening of the lunar roving vehicle power line prior to the 440-microfarad capacitor (figs. 14-48 and 14-49). The tests show that the decay time of the lunar communications relay unit 28-volt and 14-volt power is increased by discharging the 440-microfarad capacitor. Other induced faults resulted in shorter power decay times, affecting the received signal accordingly. The temperature measurement output (see thermistor in fig. 14-48) is proportional to the decay in 14-volt power. Consequently, the 6-percent decay of the flight temperature measurement corresponds to a 1.4-volt decay. This characteristic was duplicated when the lunar roving vehicle power line was opened. The 28-volt power decayed to 21.8

The lunar roving vehicle power line has a 7.5-ampere circuit breaker forward of the 440-microfarad capacitor (fig. 14-48). Testing a 7.5-ampere circuit breaker under elevated temperatures (1800 F) and at vacuum conditions showed that the current capacity is also dependent on the connecting wire size because the wire provides a heat sink to the circuit breaker thermal element. The rover 7.5-ampere breaker used 20-gage connecting wire. Test results show that the breaker, with 20-gage connecting wire, at elevated temperatures and under vacuum conditions, will trip at 3.3 amperes. This corresponds to the calculated lunar communication relay unit load at the time of power failure.

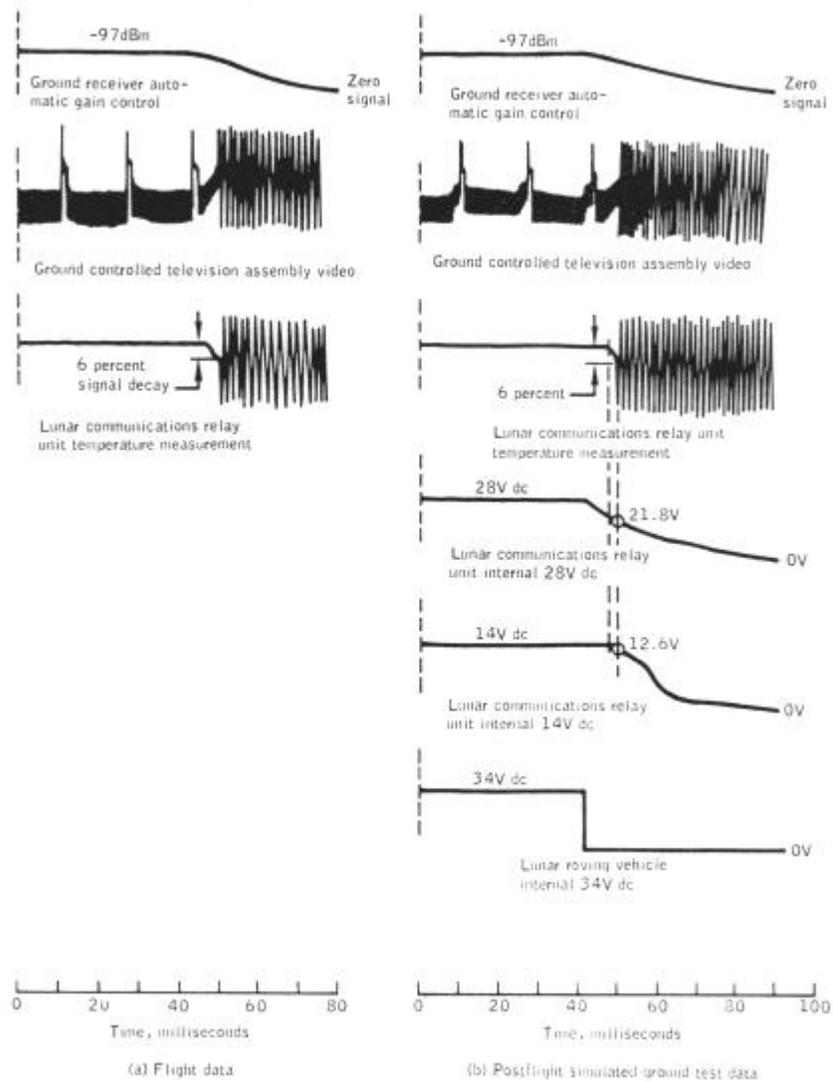
Figure 14-49.- Comparison of signal deterioration characteristics.

The flight data (**Fig. 14-49**) shows that the automatic gain control measurement began to fall followed by the video signal decay. This was followed by the decay of the lunar communications relay unit temperature measurement. The RF signal level then decreased below the ground receiver threshold as indicated by complete signal loss. The overall loss of the downlink signal within 5 milliseconds is indicative of 28-volt d-c power loss. Decay of the temperature measurement is indicative of 16.5 volt d-c power loss. The lunar communications relay unit dc-to-dc converter (**Fig. 14-48**) supplies both the 28-volt and 16.5-volt d-c power. To verify loss of 16.5-volt power, an uplink voice signal was transmitted to key the VHF transmitter on. No signal was received on the Stanford 150-foot VHF antenna which indicates that the VHF transmitter, powered from 16.5 volts dc, was inoperative.

volts dc as the 14-volt power decayed to 12.6 volts. The RF transmitter power at this voltage will be decreased by 6.4 dB, and accounts for the total signal loss at this time since the ground receiver would be below its operating threshold.

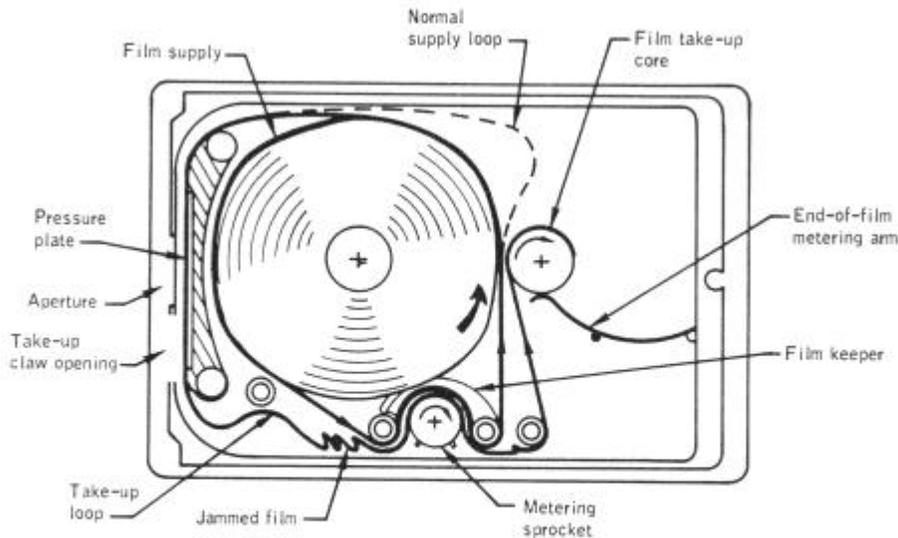
Figure 14-50.- Lunar surface 16mm camera magazine.

advancement varied from five to twenty-one frames in the jammed magazines. The film supply loop (**Fig. 14-50**) normally contains three to five excess frames. The normal procedure is to inspect the magazine for proper frame alignment in the aperture area, and manually advance the film not more than one frame, if required to obtain proper alignment. The excessive manual advancement depleted the film supply loops in all magazines.

Hardware analysis, air-to-ground voice tapes, and crew debriefing indicate that the lunar surface camera functioned properly, and the jammed magazines resulted from procedural errors. Corrective actions are to insure adequate crew training through scheduled prelaunch briefings, stress malfunction procedures and corrective actions, and put a removal flag on the tape.

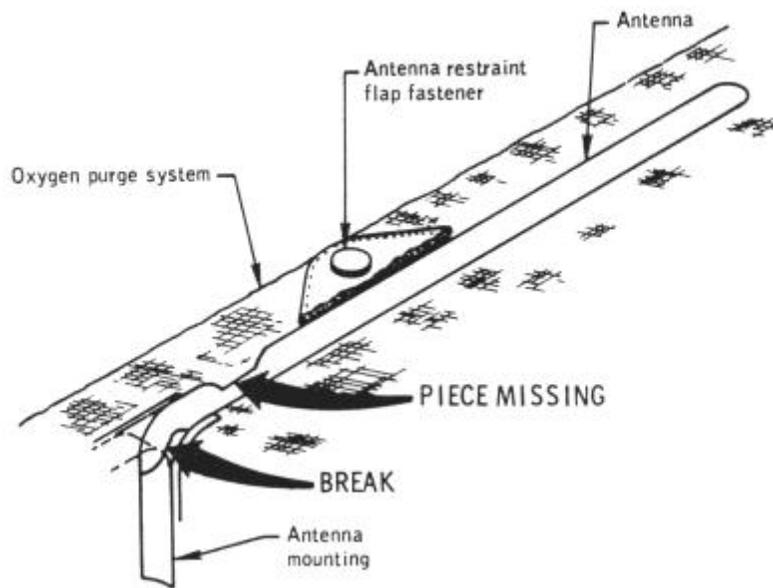
The crew reported that the Lunar Module Pilot's oxygen purge system antenna was broken off near the bottom during communications checkout prior to the second extravehicular activity. Previously, a notch had been observed in the antenna blade (see **Fig. 14-51**).

Antennas broken in training have shown similar flexure breaks. Observation of the notch edges of the returned antenna indicates that the notch started as a partial break in flexure, followed by material being torn out the rest of the way. Test results of the returned antenna indicated that the physical properties of the blade material were satisfactory with no excessive brittleness.

A flap which covers the entire antenna will be added for Apollo 16 to protect the antenna while the oxygen purge system is stowed and during unsuiting after extravehicular activities. The antenna will not be deployed until after egress to prevent it from being damaged inside the cabin or during egress.

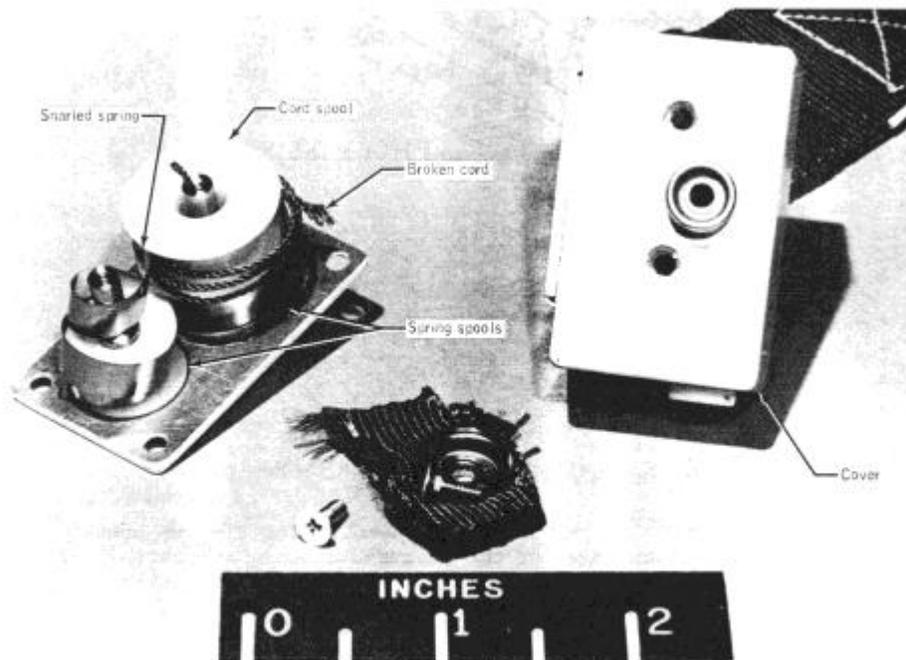
Figure 14-52.- Commander's tether (cover removed).

Both retractable tethers failed during lunar surface operations; the Commander's tether cord broke during the first extravehicular activity, and the tool clamp came off the end of the Lunar Module Pilot's tether. The Commander carried the standard 3/8-pound pull tether which consists of a case, a negator spring wound reel-to-reel on two spools, and a 30-pound cord wound on a spool mounted to one of the spring spools (**Fig. 14-52**).

The cord had broken against a sharp edge of the spring when an attempt was made to extend the tether after the jam. The failure mode with the release of the slack cord is repeatable. Disassembly of the Lunar Module Pilot's tether showed that both the bowline and the figure-eight knot attaching the cord to the clamp had untied (**Fig. 14-53**) and this allowed the cord to retract into the housing. Changing this knot to an improved clinch knot will provide a more secure and permanent attachment. Crew training will emphasize proper use of the tethers.

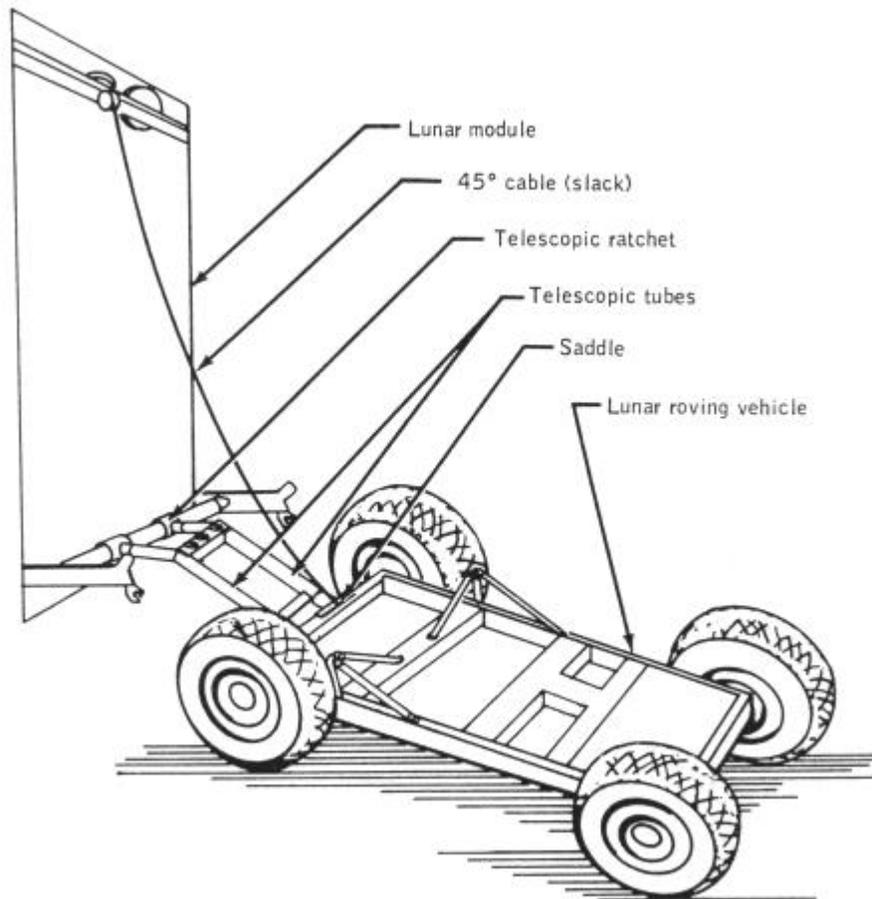
Figure 14-55.- Lunar roving vehicle deployment.

- a. The saddle-to-vehicle connection (**Fig. 14-54**) has close-tolerance interfaces to provide the rigidity required to prevent release-pin distortion and permanent binding. This design requires the vehicle/saddle interface to be completely free of stress to permit easy separation.
- b. The tilt of the lunar module to the rear and sideways, together with an uneven lunar surface, provided some stress preloading of the vehicle/saddle interface. Attempts by the crew to improve the rover position by moving and pulling on it may have aggravated this situation. The crew was aware that the interface had to be free of stress, and when this was accomplished, the saddle separated.

Ground tests have shown that if the partially deployed lunar roving vehicle resting on the surface but not yet detached from the saddle and lunar module, is rolled either to the left or right, the saddle/rover chassis interface will bind. The interface can be released, and the saddle dropped to the ground by one crewman adjusting the roll back to zero while the other taps the saddle with a hand tool. The corrective action is to insure adequate crew training.
