NATIONAL AERONAUTICS AND SPACE ADMINISTRATION

APOLLO 12 MISSION REPORT

HOUSTON, TEXAS
MARCH 1970

Mission Evaluation Team

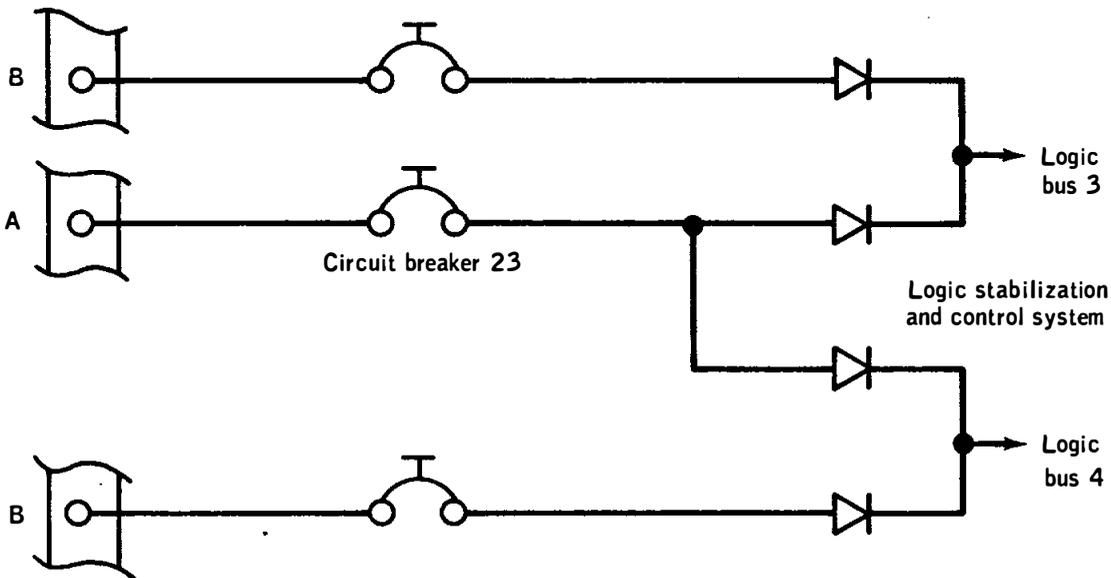
Figure 14-6.- Stabilization and control circuit breaker schematic.

it remained closed throughout the rest of the mission. Complete electrical and mechanical tests were performed and the results were normal. The circuit breaker and associated circuitry showed no cause for the breaker to have opened either because of launch vibrations or an electrical fault.

As shown in the figure, the breaker was supplying power in parallel with two other breakers which did not open. This fact plus no abnormalities indicate that the breaker was probably not set during the prelaunch switch and circuit breaker positioning checks. These breakers are not specifically verified to be in proper position.

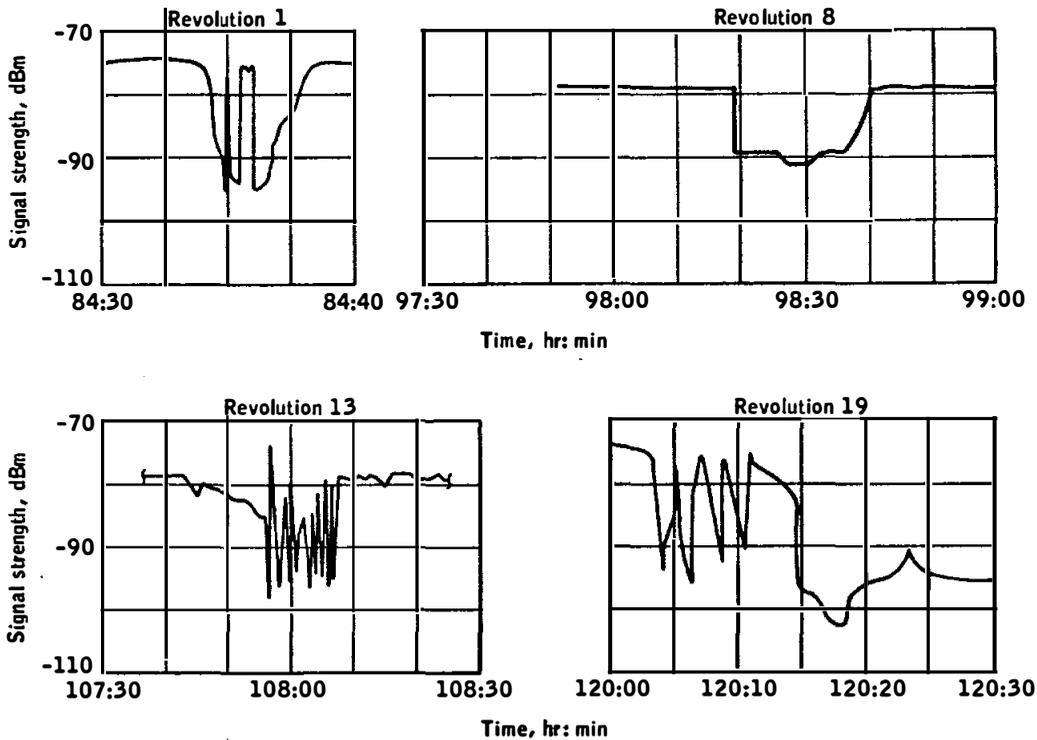
Figure 14-7.- Typical high gain antenna uplink signal strengths during abnormal operations.

Operation of the S-band high gain antenna in the narrow beam mode resulted in a decrease of approximately 10 to 12 dB in both uplink and downlink signal strength on several occasions. Illustrations of the first and other unexpected signal-strength variations are shown in figure 14-7. The first decrease occurred in lunar orbit revolution 1.

Two special tests were conducted during transearth coast with the spacecraft in attitude hold to isolate the malfunction. The sun angle was within approximately a 12-degree cone about the minus X axis to induce thermal stress on the antenna. In both tests, the narrow-beam and reacquisition modes were maintained until fluctuations in the uplink and

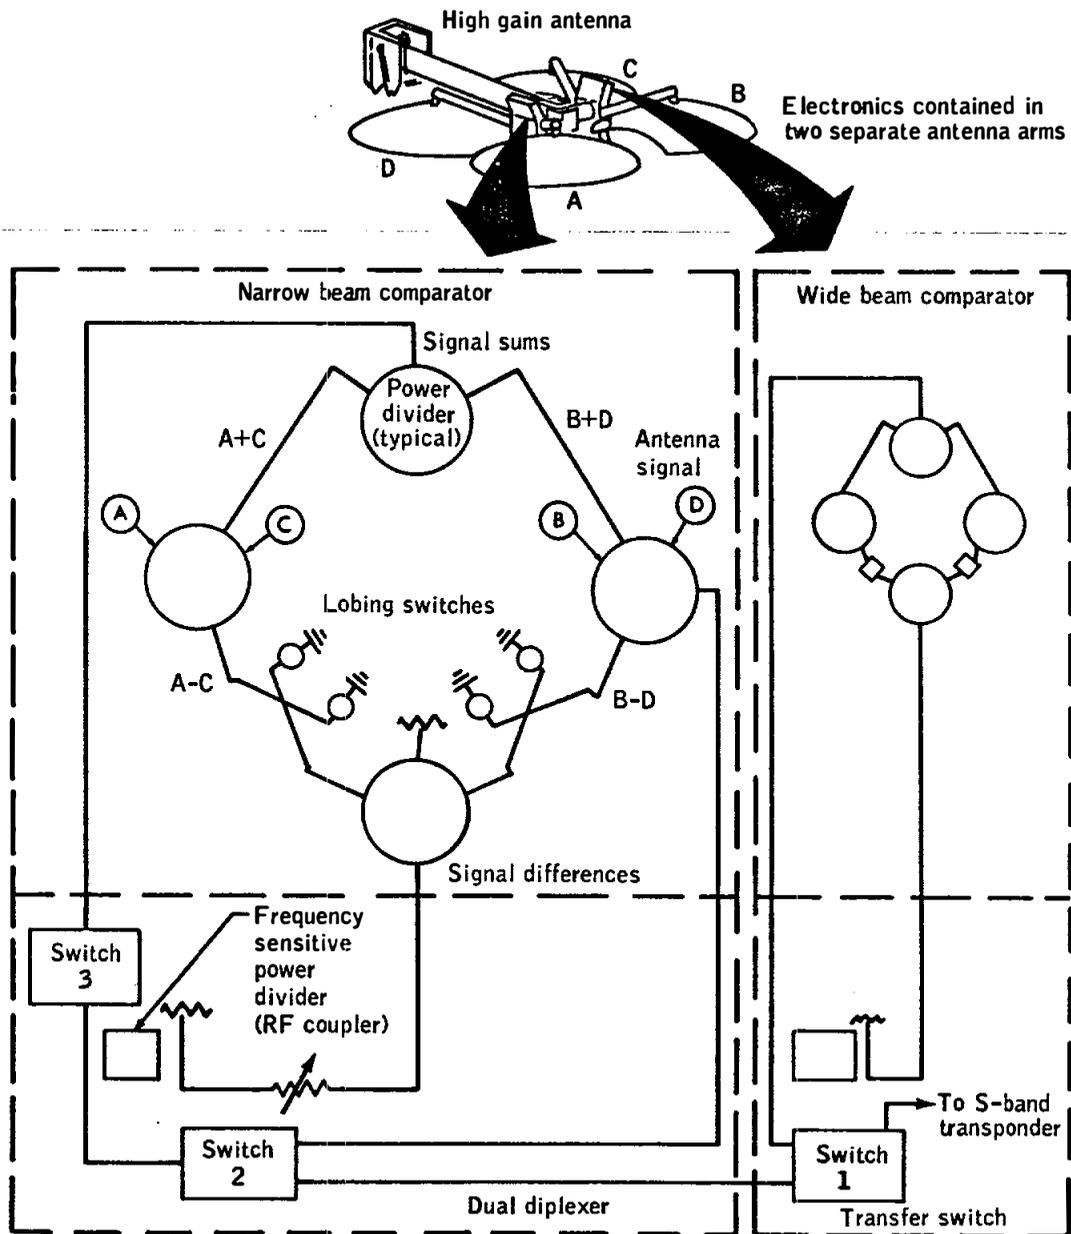
Figure 14-8.- S-band high gain antenna electronics.

There is a total of four stripline units with one contained in each of the following antenna components: narrow-beam comparator, transfer switch, and dual diplexer, as shown in figure 14-8. Based on the inflight tests, the wide beam comparator has been eliminated as a cause of the anomaly. Also, investigation of the circuitry and correlation of data has ruled out the transfer switch as being the anomaly cause. Therefore, the malfunction could only have been in the narrow beam comparator or the dual diplexer.

The narrow beam comparator combines the patterns of four dish antennas to provide the sum and difference patterns which provide the angle pointing information. Two malfunctions that could produce boresight shifts have been identified in the narrow beam comparator. Under normal operating conditions, the lobing switches function as digital phase shifters and provide either a zero or 180-degree phase shift. If a diode fault occurs that changes the phase or amplitude characteristics of either switch, tracking errors can be produced. The opening of one set of diodes would have to be intermittent to produce the observed flight anomaly, thus suggesting the presence of temperature or pressure sensitive connections in the traces that connect the diode switches. Another diode fault which can occur is a loss of the drive voltage to one of the lobing switches. In this case, the switch will provide a constant phase shift. The multiplexed difference signal for the case when the phase shift of switch 1 (fig. 14-8) is constant at 180 degrees results in unsymmetrical lobing. The antenna, in this case, will seek those pointing angles that make the elevation and azimuth angles equal in magnitude, thus suggesting that the resultant tracking error could be large and not repeatable. This condition would give the observed antenna performance characteristics. Therefore, a malfunction in the diode wiring or circuit connections is suggested. The intermittence associated with this malfunction could be explained by a temperature sensitive circuit connection (solder crack or wire break).

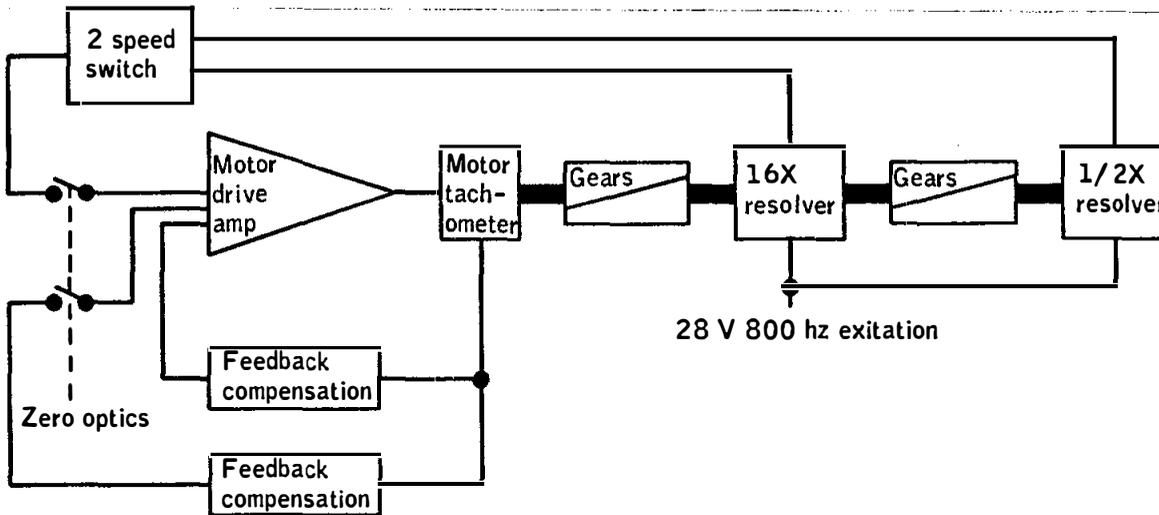
Figure 14-11.- Zero optics mode circuitry.

A number of components in the optics drive servomechanism (fig. 14-11) are used only in the zero optics mode. The optical unit and the power-and-servo assembly were removed from the spacecraft, and the servo assembly was subjected to thorough testing. The flight symptoms, however, could not be reproduced. Because of extensive sea-water corrosion, the optical unit could not be tested, but an analysis and testing of a similar unit demonstrated the cause of the zero optics anomaly to be within the power-and-servo assembly. The flight assembly was installed in a working system and has operated properly under a variety of thermal conditions. The modules associated with the optics servo were also thermally cycled in an oven, operated in a vacuum, and subjected to acceptance test vibration levels with no degradation of their performance. The modules were depotted and examined, but no cause of the anomaly could be isolated.

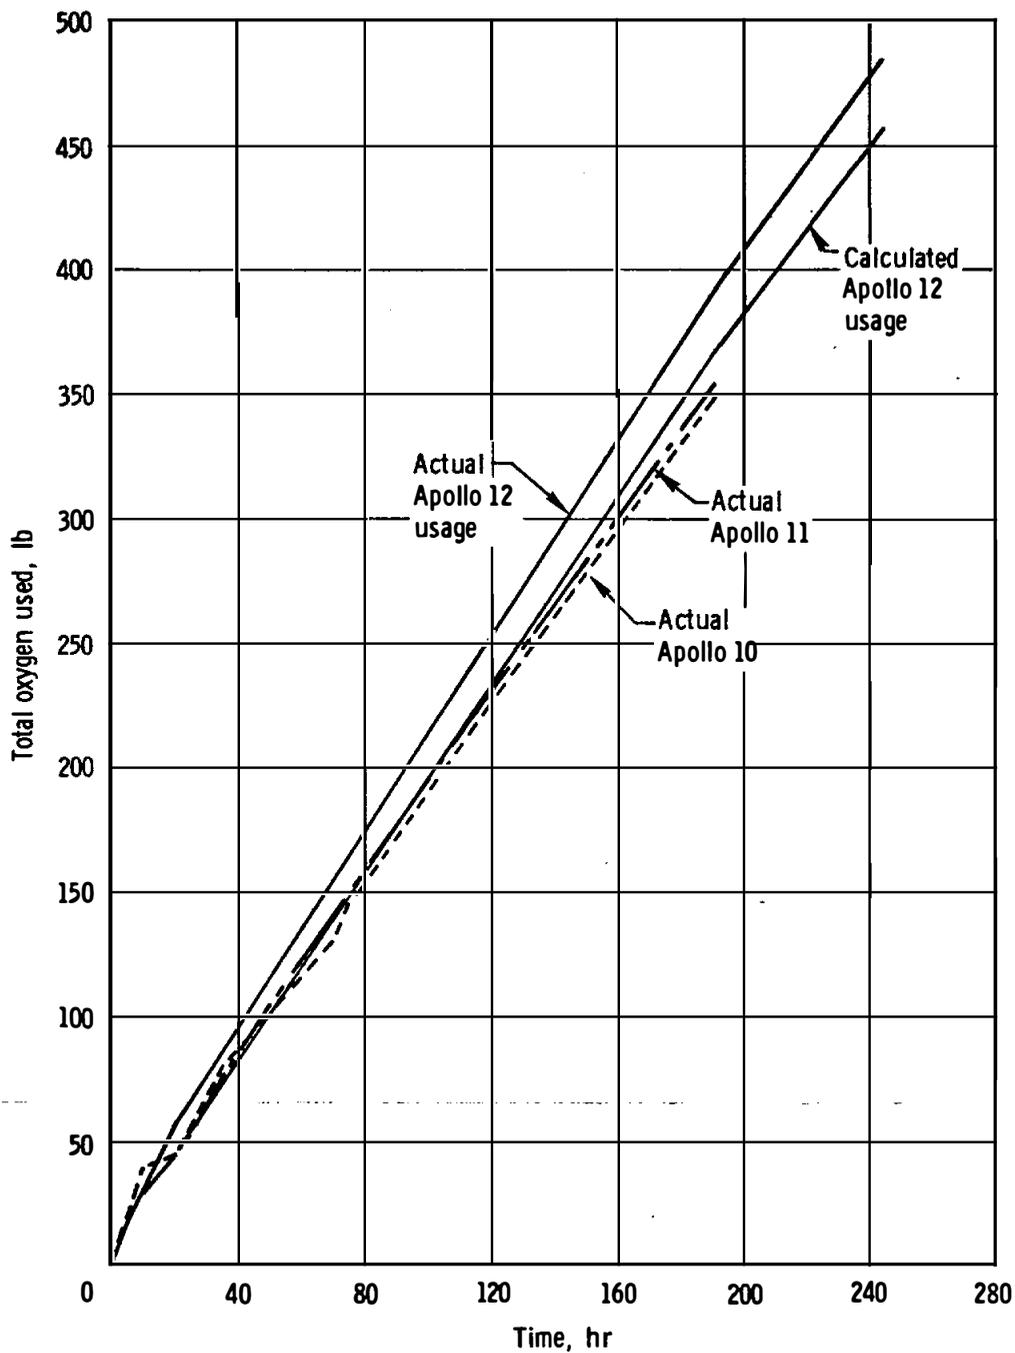
Figure 14-9. - Comparison of oxygen consumption for Apollo 10, 11, and 12.

At the end of the mission there was a discrepancy of approximately 27 pounds of oxygen between the measured total cryogenic oxygen usage and the calculated combined environmental control system and fuel cell oxygen usage, as shown in figure 14-9.

Fuel cell oxygen usage was calculated from the produced electrical current and then verified by comparison with hydrogen consumption data. Environmental control system usage is measured on a flowmeter and compared with calculated usage based on purge rates, cabin leakage rates, metabolic consumption and urine dump losses. Cabin leak rates are determined by ground tests in conjunction with flight pressure decay rates. Purge rates are calculated based on ground tests and known times for purges. Oxygen losses during urine dump operations can only be estimated. Since no excessive flow was detected downstream of the flowmeter, the source of any command module environmental control system leakage is therefore limited to the 900-psi system upstream of the meter. Figure 14-10 shows the 900-psi oxygen system and that portion of the system outside the command module that could have leaked.

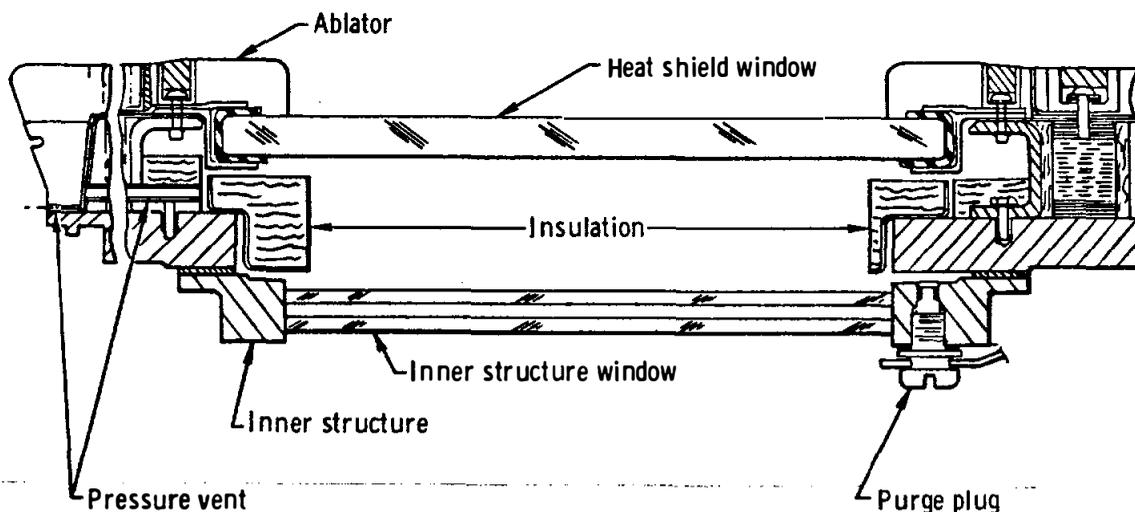
Figure 14-14. - Cross section of hatch window.

Contamination was also noted on the inside surface of the heat-shield panes on the left-hand side and hatch windows. The contamination, which disappeared on the left-hand side window after the first day, probably resulted from water entrapped between the heat shield and pressure structure in the general area of this window. The contamination on the inside surface of the hatch heat shield window remained throughout the flight and varied in size with the thermal cycles of the spacecraft. This contamination could have resulted from either entrapped moisture in the hatch area between the heat shield and the pressure structure or from outgassing of sealant materials in this area (fig. 14-14). Such outgassing has been minimal in the past three flights because the curing processes were changed to alleviate this problem. However, a chemical analysis of the contamination on the inside surface of the hatch window has shown the concentration of silicone oils to be higher than expected. These oils are the outgassed products from the material used to seal the thermal blankets near the window.

For Apollo 13 and subsequent spacecraft, seals will be added to the boost protective cover to prevent leakage of rain water. Prior to flight, the hatch window cavity will be purged with a 35/65-percent mixture of dry nitrogen and oxygen to remove entrapped moisture. To further alleviate the outgassing of silicone oils, the insulation material will be removed from between the outer and inner hatch windows on future spacecraft.

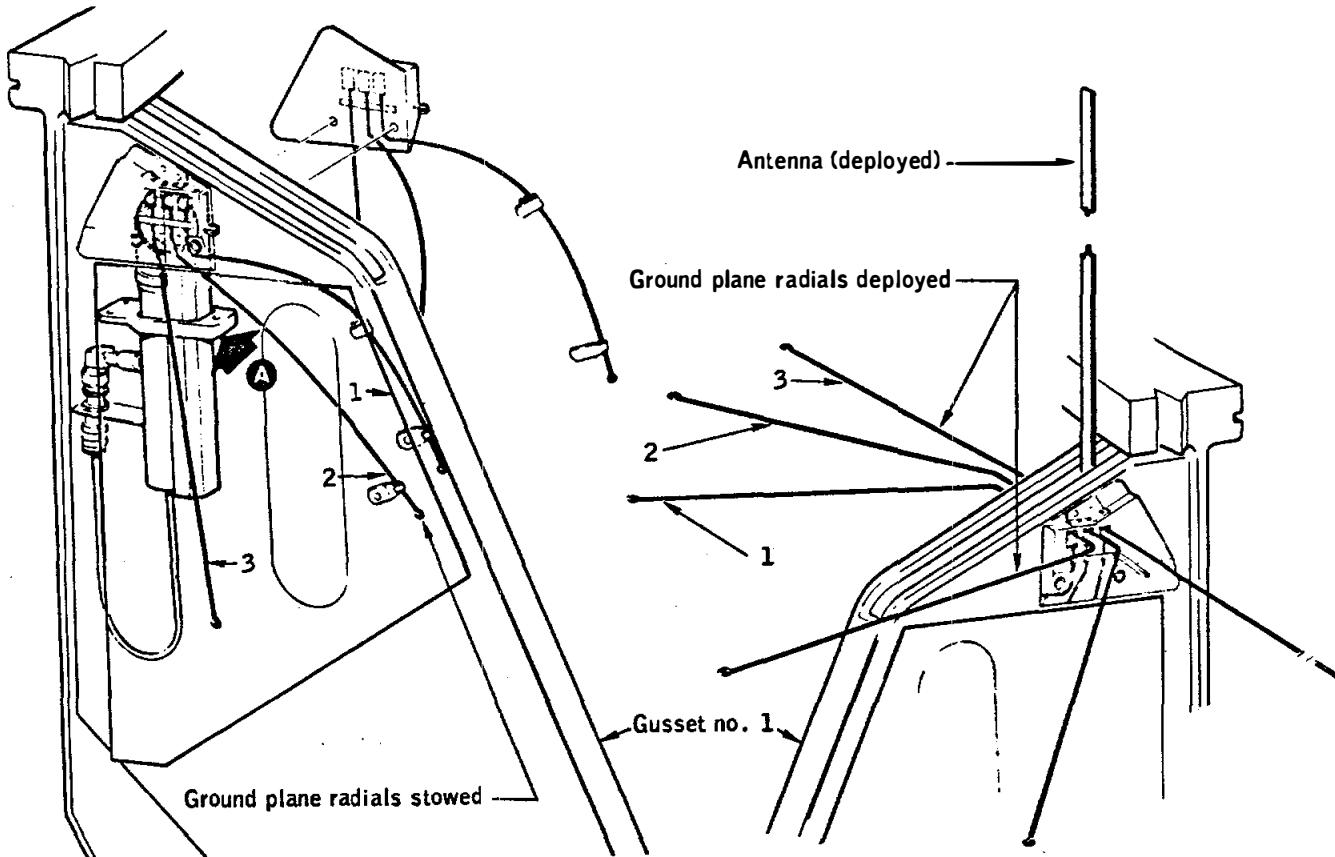
Figure 14-15.- VHF recovery antenna configuration.

During the command module descent on the main parachutes, ground plane radials 1 and 3 of VHF recovery antenna 2 (fig. 14-15) did not properly deploy. However, voice communications with the recovery forces while using this antenna were not significantly affected. Postflight examination of the antenna revealed that the cloth flap which normally covers the radials to prevent entanglement with the parachutes could be made to stick to the gusset by an adhesive substance which was inadvertently present on both the flap and the gusset. The radials would not deploy when the flap had stuck to the gusset; however, radial 1 would not always deploy, even when the flap was not stuck. A slight binding at the spring end or at the retaining clip has been experienced on radial 1.

For Apollo 13 and subsequent missions, recovery antenna 2 will be used for recovery beacon transmissions instead of voice. However, even

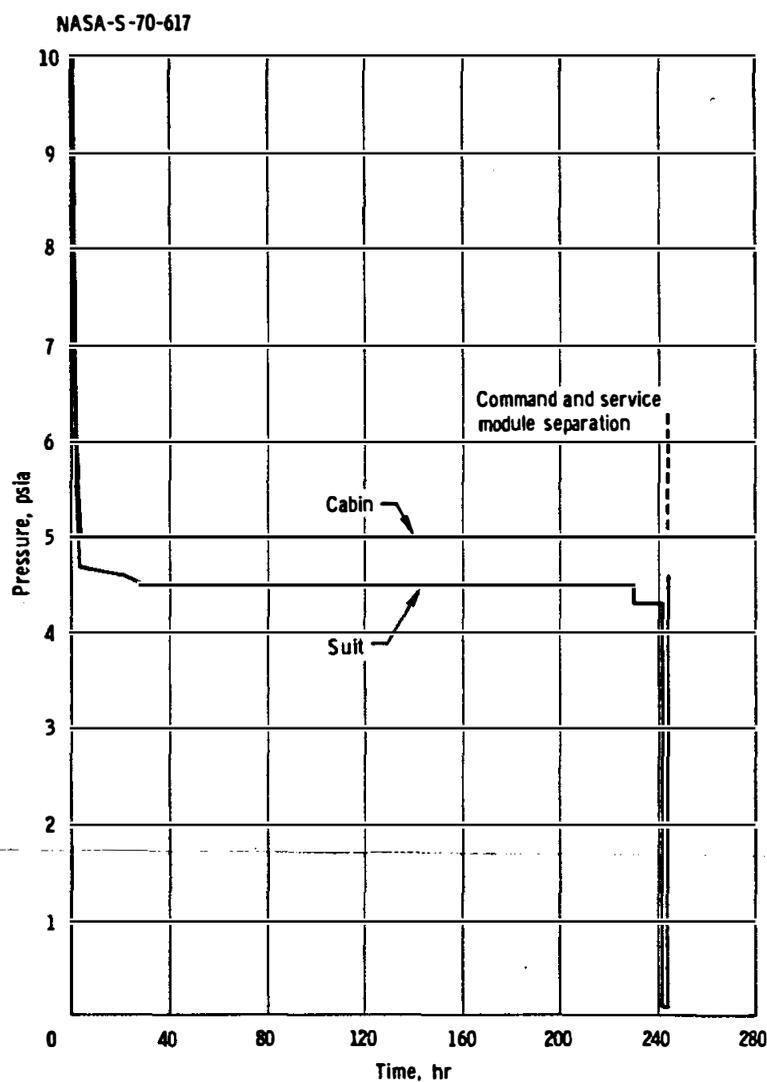
Figure 14-22. - Suit and cabin pressure history

The suit pressure transducer operated properly throughout the pre-launch and launch activities. When the helmets and gloves were removed after launch, the transducer indicated 0.2-psid less than cabin pressure and at approximately 22 hours the differential was 0.4 psid. A 0.4- to 0.6-psid disparity existed between the indicated suit loop and cabin pressures until the final hours of the mission (fig. 14-22).

At 241:41, the suit pressure transducer reading dropped to 0.1 psia, while cabin pressure was stable at 5.0 psia. About 3 hours later, at command module/service module separation, the transducer recovered to 4.6 psia. The transducer indicated a 0.4- to 0.5-psid discrepancy throughout entry. Postflight tests of the installed transducer repeated the flight anomaly. However, during subsequent tests of the removed transducer, the unit operated normally. The transducer was then returned to the manufacturer's facility, where flushing and disassembly revealed internal contamination from metallic nickel-plating particles. These particles could have caused an irregular transducer output by physically interfering with the Bourdon tube movement or by changing the inductance field of the unit. After the transducer was cleaned and reassembled, testing produced satisfactory operation. The noted contamination apparently resulted from either improper cleaning procedures or from self-generated particles within the unit.

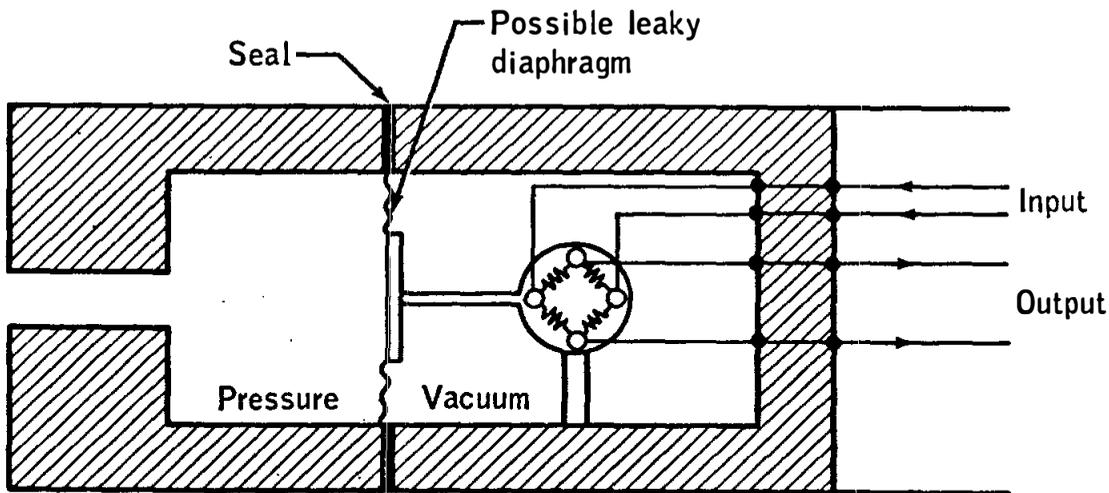
Figure 14-25.- Fuel cell 3 transducer schematic.

The apparent pressure drop has been attributed to a pressure transducer failure, with the most probable failure mode being a small leak through or around the stainless steel diaphragm in the transducer (fig. 14-25). Such a leak would allow hydrogen to enter the vacuum reference chamber of the transducer, thus destroying the normal pressure differential across the diaphragm. This reduction would result in the indicated pressure decay observed during the flight. A similar transducer failure occurred during a production fuel cell pre-test checkout.

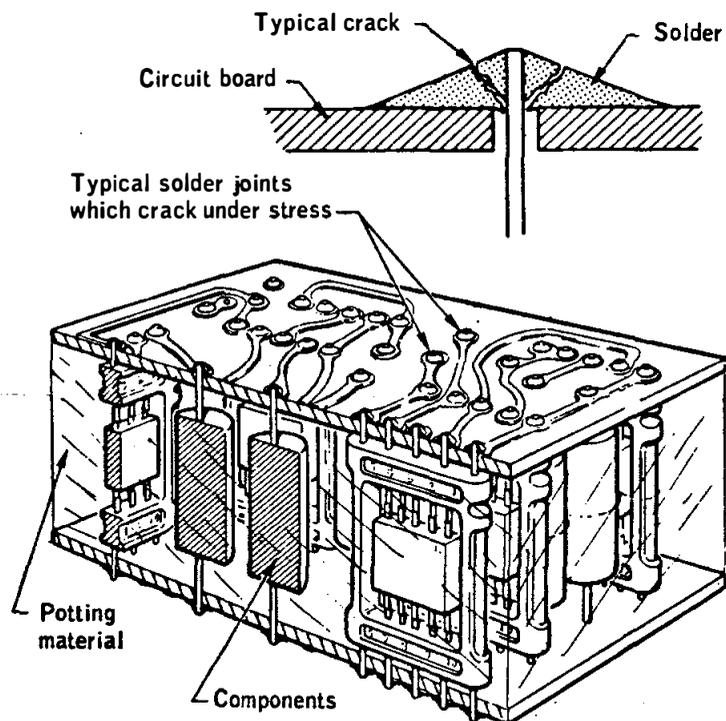
Figure 14-26. - Mission timer construction.

Based on previous mission clock failures, the most probable cause for this anomaly is a cracked solder joint in the cordwood construction. As seen in figure 14-26, electrical components (resistors, capacitors, diodes, etc.) are soldered between two circuit boards, and the void between the boards is filled with potting compound. The differential expansion between the potting compound and the component leads can cause solder joint cracks.

New mission timers, which will be mechanically and electrically interchangeable with present clocks, are being developed for Apollo 13 and subsequent spacecraft. The new clock design eliminates the cordwood construction and is less susceptible to electromagnetic interference.

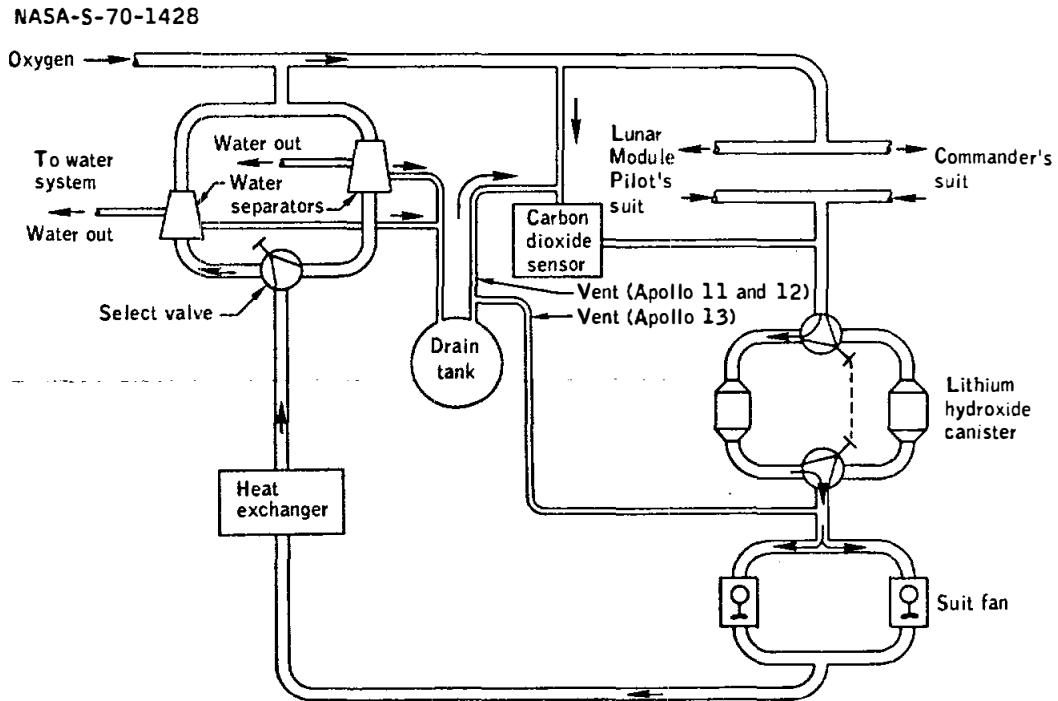
Figure 14-33.- Simplified suit loop schematic.

The carbon dioxide sensor is sensitive to free water, and the malfunction was probably caused either by water from the water separator sump tank entering the sensor or by water bypassing the water separator and entering the sensor. The water separator sump tank vent line joins the carbon dioxide sensor inlet sense line (fig. 14-33). This vent line has been rerouted for Apollo 13 and subsequent vehicles.

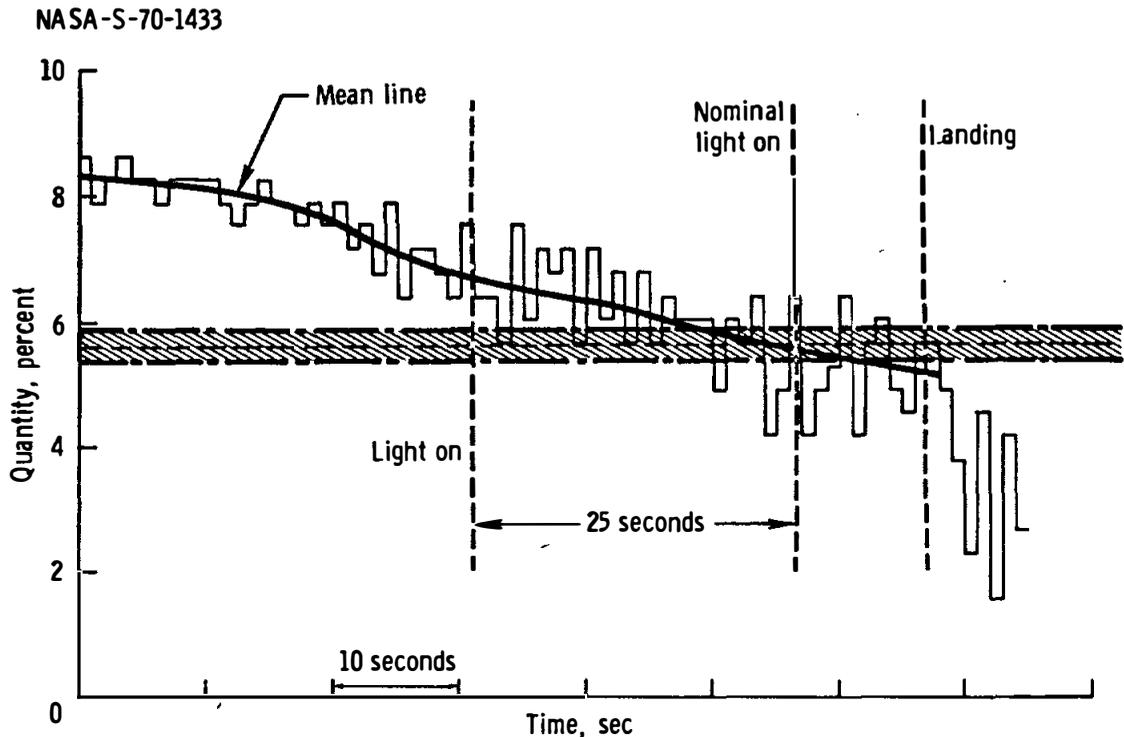
Figure 14-38. - Descent propellant quantity just prior to landing.

The quantity warning light should illuminate when the lowest indicated propellant level remaining in any tank reaches a value of $5.6 \pm 1/4$ percent. Since the light came on when the averaged quantity measurement indicated 6.7 percent with an oscillation of ± 1.1 percent, the

lowest excursion of the quantity reading was 5.6 percent and the display operated properly. The averaged propellant quantity reached 5.6 percent about 25 seconds later.

For Apollo 13, the quantity measurements for the four descent propellant tanks have been increased in sampling rate from 1 to 100 samples per seconds. These data will be averaged automatically and used to determine the low-level point from which the remaining firing time can be calculated. The 100 samples per second rate will provide data that will permit an understanding of the particular dynamics of the fluid in the tanks.

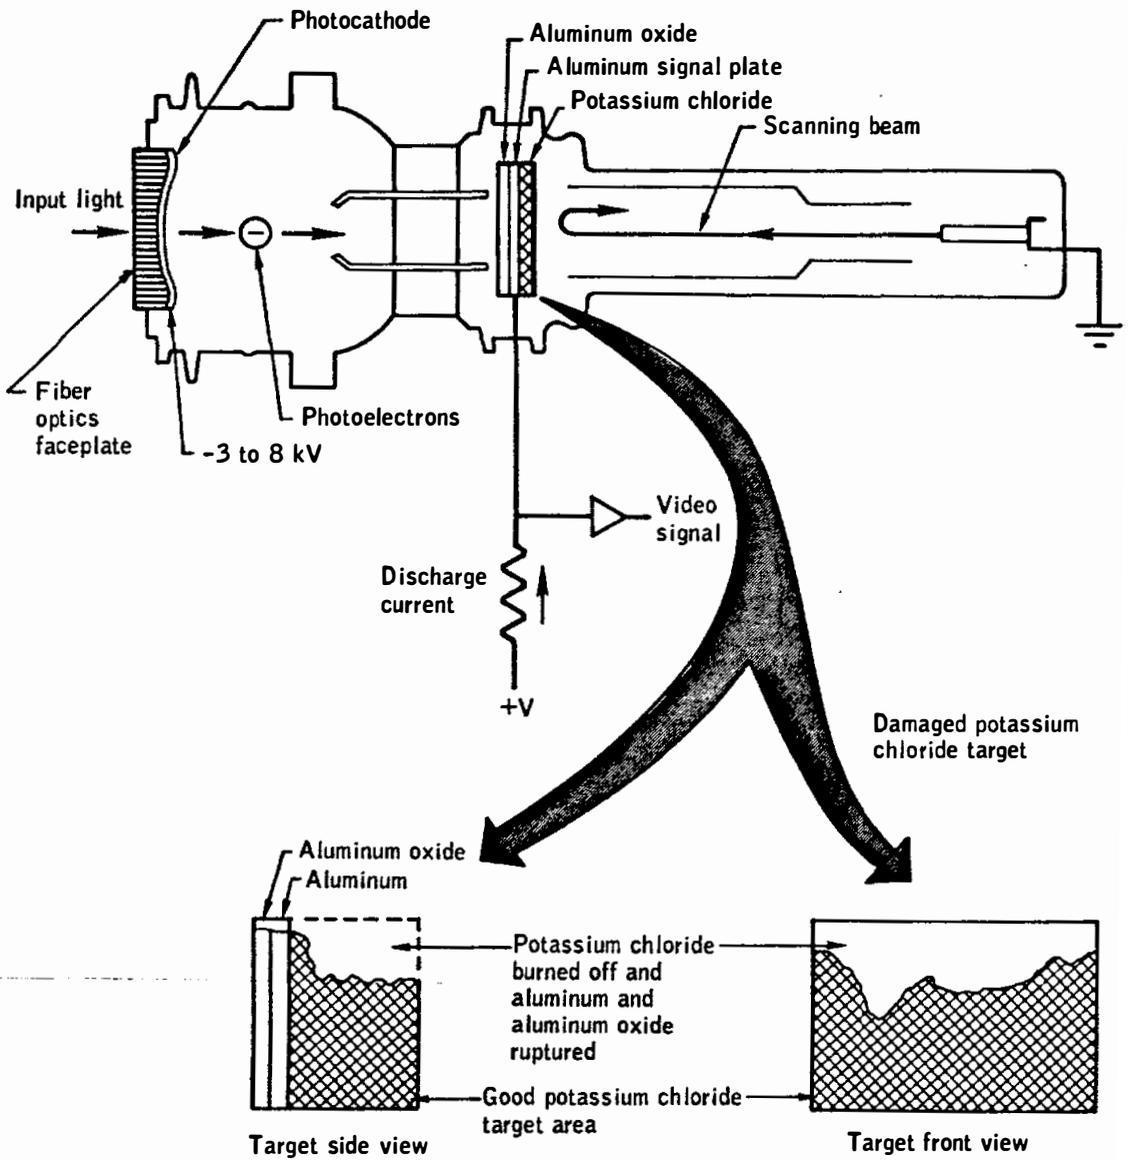
Figure 14-39.- Secondary electron conductivity tube in the color television.

Ground tests using an Apollo-type image sensor (secondary electron conducting vidicon tube) exposed the camera system to extreme light levels. The resulting image on a monitor was very similar to that seen after the flight camera failure.

After decontamination and cleaning, the flight camera was inspected and power was applied. The image, as viewed on a monitor, was the same as that last seen from the lunar surface. The automatic light-level control circuit was disabled by cutting one wire. The camera then reproduced good scene detail in that area of the picture which had previously been black, verifying that the black area of the target was undamaged, as shown in figure 14-39. This finding also proved that the combination of normal automatic light control action and a damaged image-tube target caused the loss of picture. In the process of moving the camera on the lunar surface, a portion of the target in the secondary-electron conductivity vidicon must have received a high solar input, either directly from the sun or from some highly reflective surface. That portion of the target was destroyed, as was evidenced by the white appearance of the upper part of the picture.

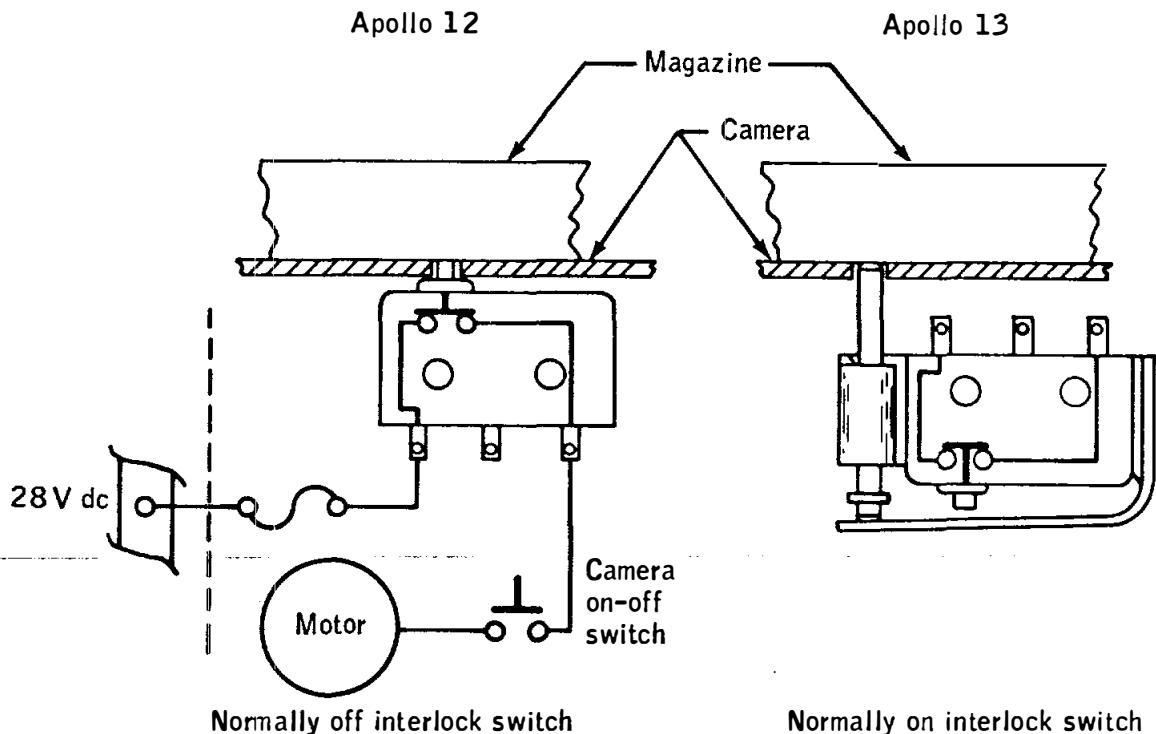
Figure 14-40.- Sequence camera interlock switch modification.

The 16-mm camera was turned on just before lift-off, but it stopped after a brief period of operation. During ascent, it was activated two additional times, and each time it stopped after 20 or 30 seconds of operation. During rendezvous, the camera was operated by constantly depressing the triggering button, thereby overriding the automatic shutoff.

Although postflight tests showed the 16-mm camera and magazine to be in satisfactory operating condition, the characteristic sensitivity of the magazine interlock microswitch installation is such that the operating limits of the switch could cause intermittent actuation. The intermittent operation was duplicated on the flight and similar equipment by the application of pressure to the end of the magazine. The problem will be resolved by changing the interlock switch (fig. 14-40) to a configuration that is much less sensitive to variation in switch settings.

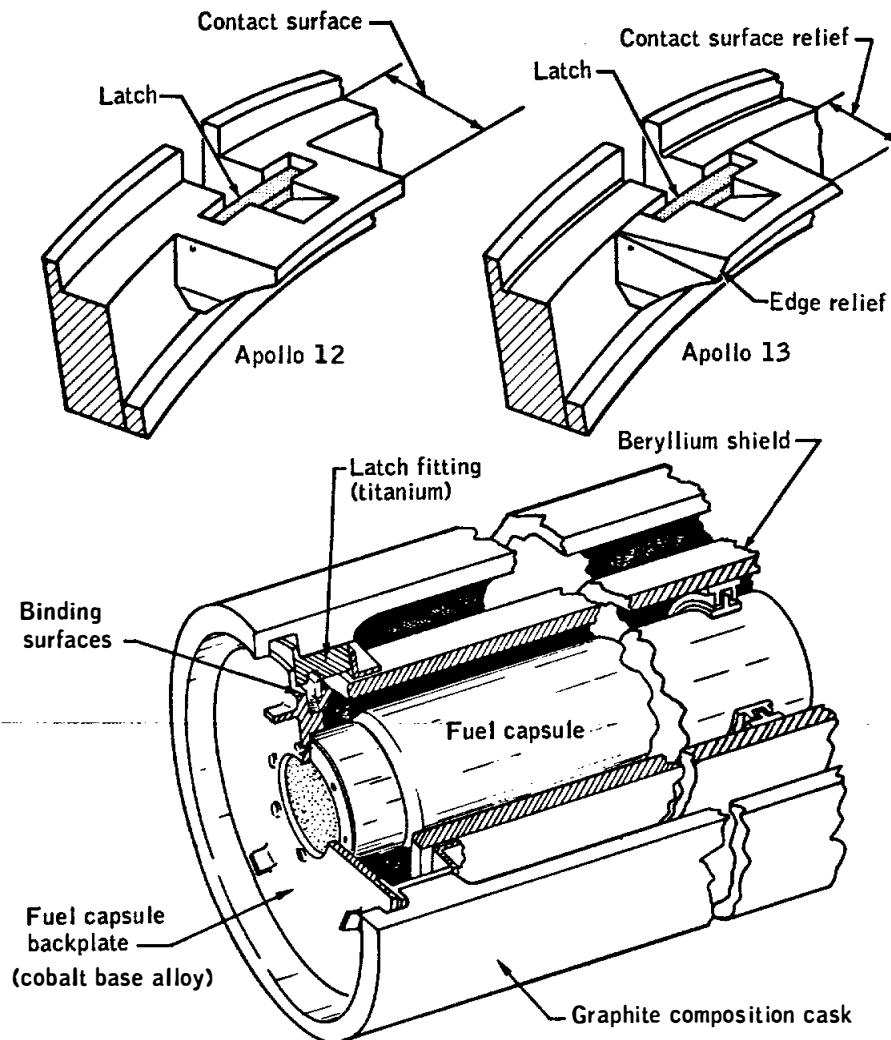
Figure 14-41.- Radioisotope fuel capsule configuration.

Thermal tests and analyses show that dimensional tolerances can diminish with temperature and result in binding between the latch fitting (C-ring) on the cask and the contact surface of the backplate on the fuel capsule (fig. 14-41). The longitudinal contact distance for these two surfaces is approximately 0.6 inch, and extraction was easily accomplished once this distance was negotiated.

As a result of the dimensional checks, the thermal tests, and analyses performed with both the qualification and Apollo 13 flight hardware, the contact surfaces of the fuel capsule backplates are being reworked as indicated in the figure. The outside diameter of the 0.10-inch long contact surface, while remaining within design limits, may be reduced as much as 0.005 inch for ease of capsule extraction. All existing capsule backplates will be reworked in this manner.

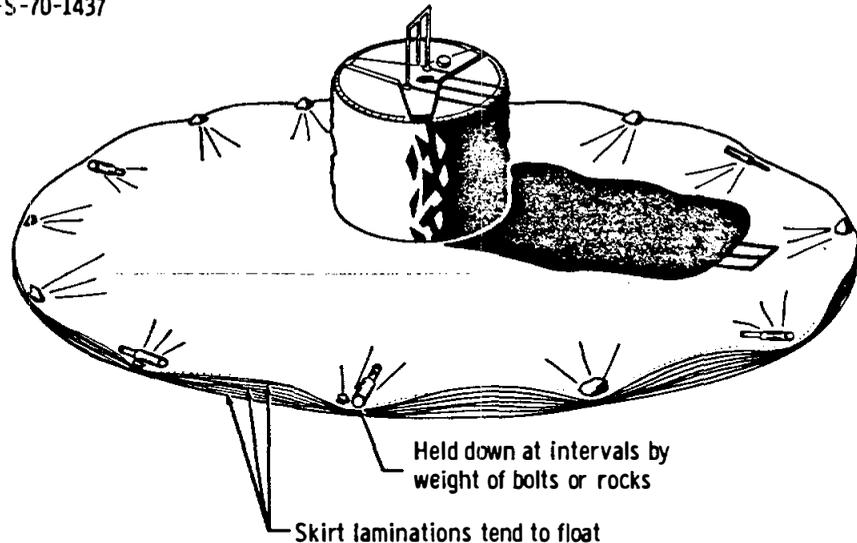
Figure 14-42. - Passive seismic experiment deployed.

The lunar surface material at the deployment site for the passive seismic experiment was soft and irregular, and a crewman had to use his boots to tamp a depression in the surface material in preparation for deployment. This procedure, however, was in accordance with the pre-flight plan for this surface condition.

The thermal shroud tended to delaminate and rise up off the lunar surface. This condition had been anticipated, and lunar soil was placed on the periphery of the shroud to hold it down. When this operation proved difficult, tie-down bolts, which had been removed from the pallet during deployment of the experiments package, were placed on the shroud with satisfactory results (fig. 14-42).

For Apollo 13 and subsequent spacecraft, the shroud laminations will be spot-sewed together at intervals around the periphery, a weight will be sewed to each of the six attach-pullout points on the shroud, and a 5-foot diameter Teflon blanket will be added for thermal control to decrease solar degradation.

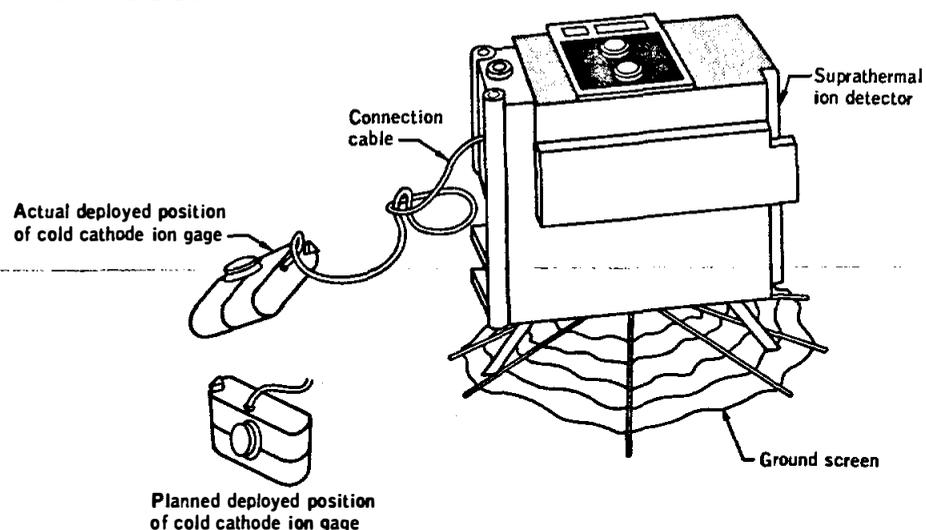
Figure 14-43.- Cold cathode gage deployed.

The cold cathode ion gage would not remain upright when deployed. Its final position was on its back with the sensor aperture at an angle of approximately 60 degrees from the horizontal but was satisfactory (fig. 14-43).

The cable connecting the cold cathode ion gage with the suprathemal ion detector was quite stiff. The combination of the spring effect in the cable, the reduced weight of the cold cathode ion gage under lunar gravity, and the softness of the lunar surface was apparently sufficient to cause the equipment instability during deployment. Final positioning of the equipment requires that the sensor aperture does not point directly at the surface nor directly at other experiment package components. The final positioning fulfilled this requirement.

The combination of the suprathreshold ion detector with the cold cathode ion gage will not be included for Apollo 13. For Apollo 14 this equipment will be flown, and the wires of the connecting cable will be tied at 6-inch intervals instead of being wrapped with heavy Mylar tape. This modification not only reduces cable stiffness by 70 percent, which decreases the spring effect, but also decreases cable bulkiness to permit easier stowage.

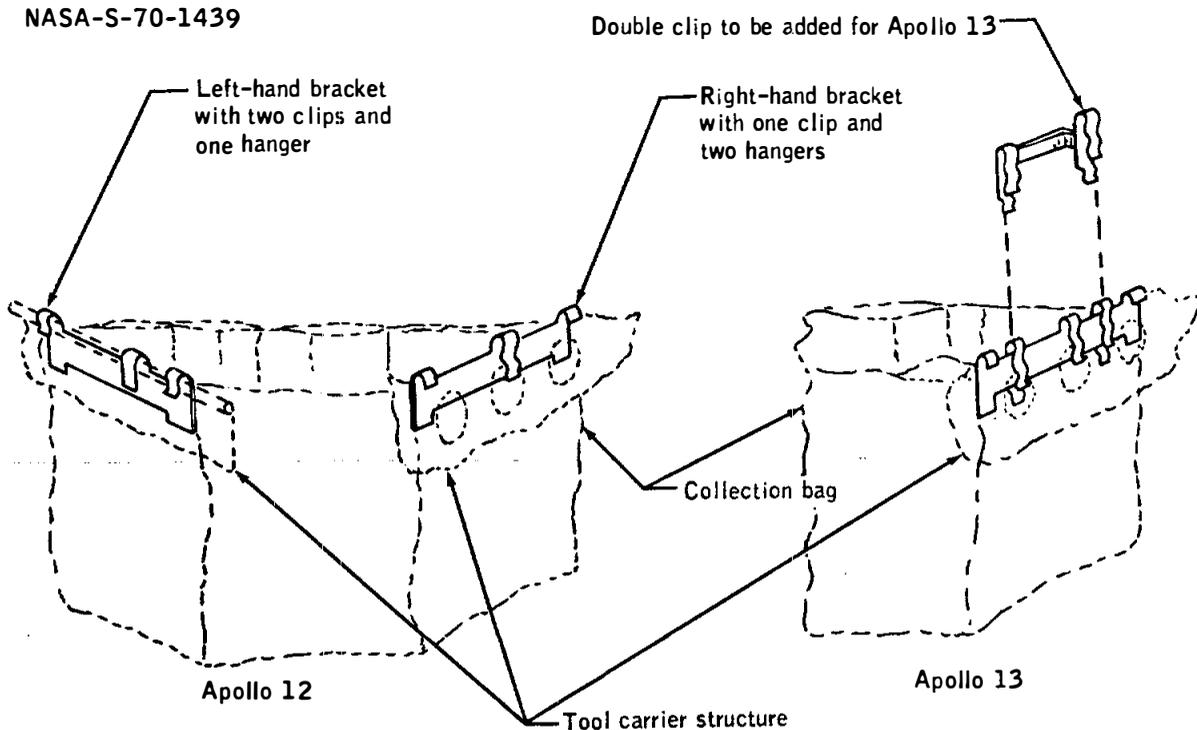
Figure 14-44.- Tool carrier collection bag retention.

At the beginning of extravehicular activity, the empty tool carrier collection bag tended to rise out of the tool carrier until some lunar surface soil was put in to hold it down. The bag is attached to the carrier structure by three aluminum spring clips (fig. 14-44). The weight of the loaded bag is shared by these clips and three hangers. The retention force is limited so that the loaded bag may be easily lifted out of the carrier.

The retention characteristics of the left side, with two spring clips over the 0.37-inch diameter rolled bead of the carrier structure, is satisfactory. However, the single spring clip over the 0.18-inch lip of the carrier on the right side did not provide sufficient positive retention. A separate double spring clip, which reaches over both the bag hanger and tool carrier structure, will be added for Apollo 13 to provide the necessary retention force as shown in the figure.

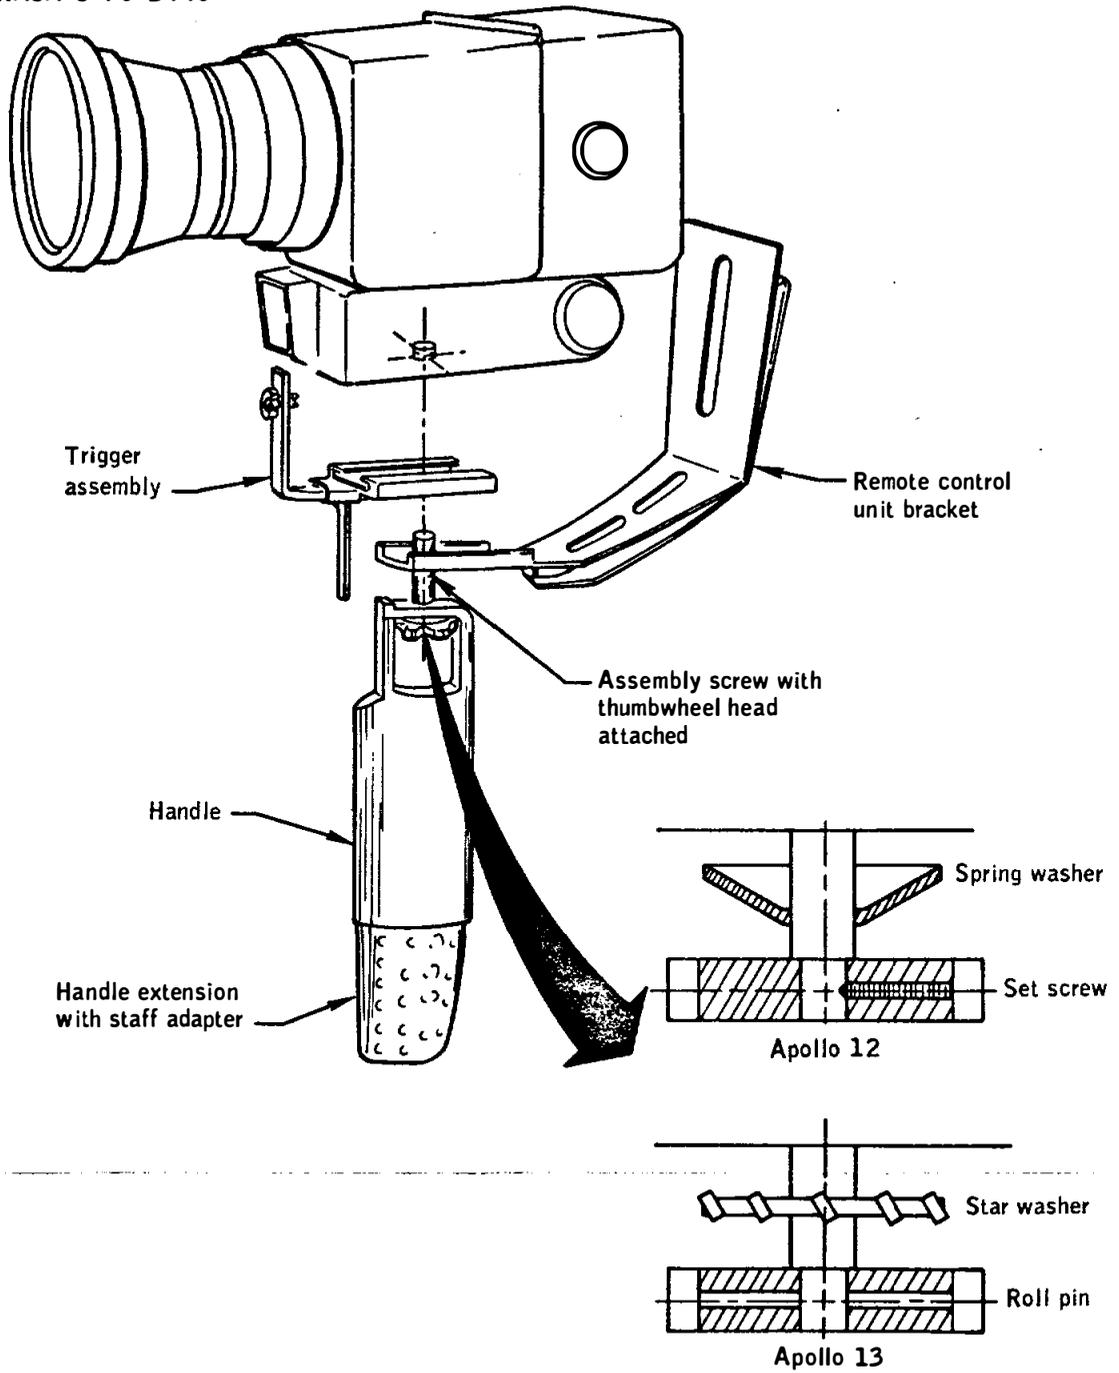
Figure 14-45.- 70-mm camera handle assembly.

During the second extravehicular period, the Commander's camera did not advance and count every time the trigger was squeezed. Shortly afterwards, when both the camera assemblies were being removed from the remote control units in order to exchange them, both assemblies were loose, although they had been well tightened before egress. In the process of retightening on the lunar surface, the thumbwheel fell off the Lunar Module Pilot's camera assembly, making reassembly impossible (fig. 14-45). The empty camera and faulty assembly were then discarded. The Commander's camera assembly was retightened and performed satisfactorily during the remainder of the extravehicular activity.

The intermittency experienced by the Commander in the shutter, counter, and film advance actions was the result of excessive trigger play caused by the loose assembly. The loss of the thumbwheel experienced by the Lunar Module Pilot was apparently the result of the improper installation of the thumbwheel setscrew.

For future missions, the cupped spring washer will be replaced by a star washer to resist rotation and loosening of the assembly screw, and the thumbwheel will be secured to the screw with a roll pin, instead of a setscrew.
