NATIONAL AERONAUTICS AND SPACE ADMINISTRATION

APOLLO 12 MISSION REPORT

HOUSTON, TEXAS
MARCH 1970

Mission Evaluation Team

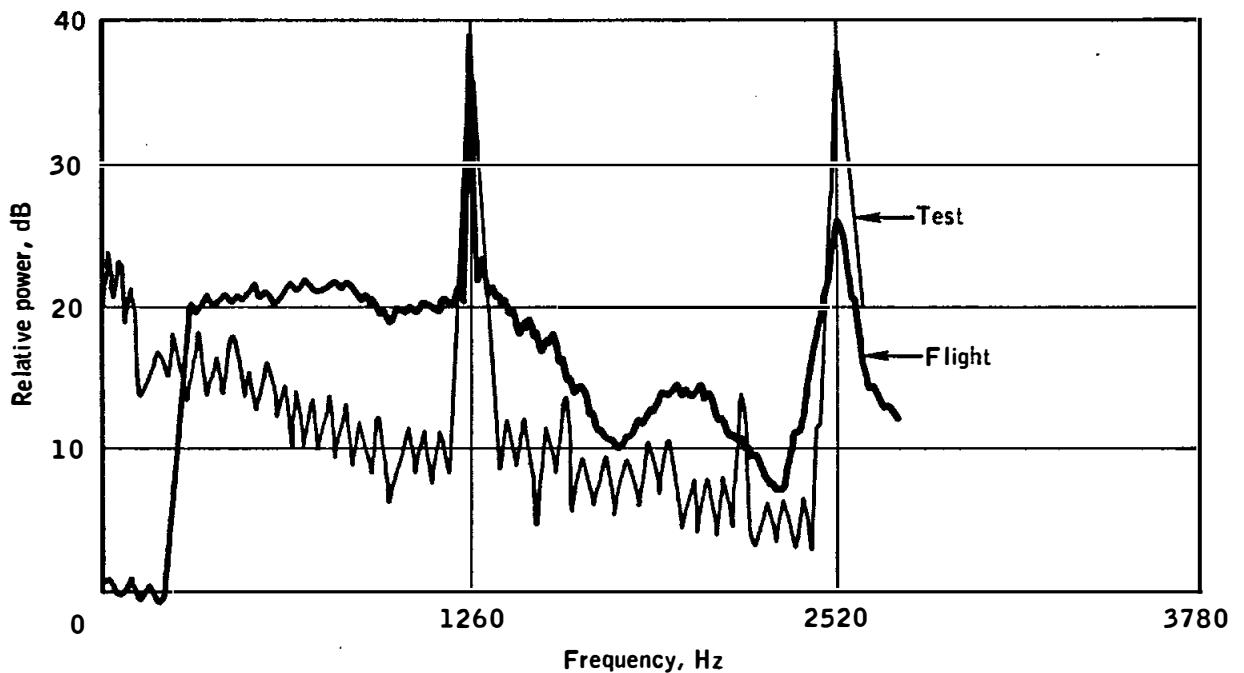
Figure 14-46.- Tone power spectral density.

An undesirable tone, accompanied by a random impulse noise signal, was present intermittently for the first 1-1/2 hours of initial extravehicular activity. The same tone, but without the noise, was present for approximately 12 seconds during the second extravehicular period. This condition did not degrade voice communication but was annoying to the crewmen.

A subsequent analysis of the telemetry data transmitted from the extravehicular mobility unit did not show any degradation of data quality as a result of the noise. Power spectral density plots, however, revealed a fundamental frequency of approximately 1260 hertz and a harmonic frequency of 2520 hertz. Postflight interference tests of an equivalent extravehicular mobility unit revealed the same 1260-hertz tone on the battery-bus leads and shield which originated from the fan-motor ripple current. This condition is normal and has been noted during qualification testing of the extravehicular mobility unit. Figure 14-46 illustrates the tone interference generated by the fan motor. However, during these initial tests, the noise interference could not be made to enter the audio system such that the audio tone heard in flight was simulated.

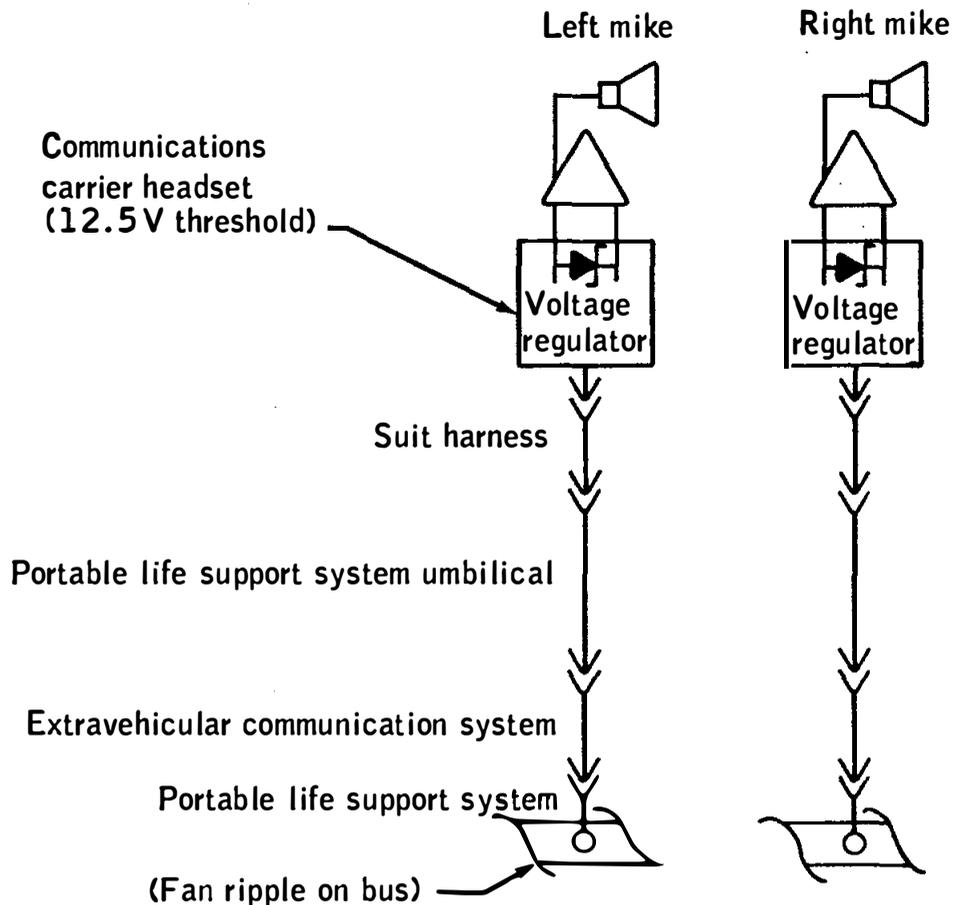
Figure 14-47.- Communications carrier headset power path.

Later laboratory testing of the communications carrier headset demonstrated that lowering a microphone amplifier supply voltage below the regulator threshold of 12.5 volts caused tone interference to enter the audio system. Subsequent analysis showed that a high resistance or the failure of a regulating diode or a transistor in the microphone amplifier regulator could result in a loss of regulator filtering action. The normal operating voltage for the microphone amplifier is from 15.7 to 20.5 volts. When the microphone amplifier supply voltage is above the regulator threshold of 12.5 volts, the tone interference does not enter the audio system.

Postflight tests of the flight communications carriers revealed that the Commander's left microphone was intermittent. Although this failure

could not be correlated to the tone phenomena, the random impulse noise heard inflight could be related to the intermittent microphone because a failure analysis has revealed an intermittent open-circuit condition in the primary winding of the amplifier transformer. Additional tests showed no further malfunctions in the communications carriers or harnesses.
