Reusable Solid Rocket Motor STS-114 Flight Readiness Review/CoFR

Motor Set RSRM-92

29-30 June 2005

092-FRRK

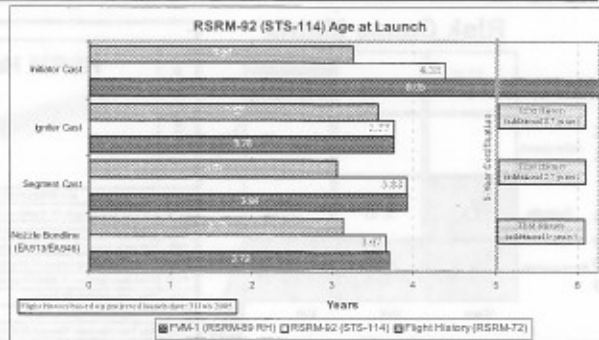
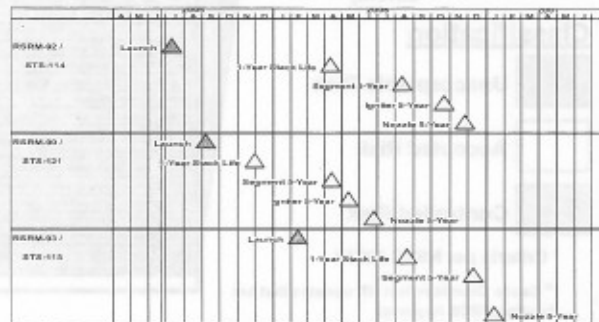
- The age of the STS-114 (RSRM-92) hardware exceeds previous flight history by roughly one year—*hardware remains within 5-year age life certification*
 - Hardware certification basis reviewed/scrubbed—no issues, certification includes static test of up to 8-year-old SRM motors
 - Archived RSRM-92 witness panels and material samples tested with no issues
 - Sister RSRM of similar age static tested 17 Feb 2005 (FVM-1)—hardware in excellent condition, performance as expected
- STS-114 (RSRM-92) RSRMs are ready for flight
- STS-121/300 (RSRM-90) RSRMs ready to support
- Review/concurrence: MSFC Hardware Aging TIM (03/04), Project DCR, Systems DCR
