NASA TN D-6722

APOLLO EXPERIENCE REPORT -  
LUNAR MODULE DISPLAY AND  
CONTROL SUBSYSTEM

*by Andrew J. Farkas*  
*Manned Spacecraft Center*  
*Houston, Texas 77058*

NATIONAL AERONAUTICS AND SPACE ADMINISTRATION • WASHINGTON, D. C. • MARCH 1972

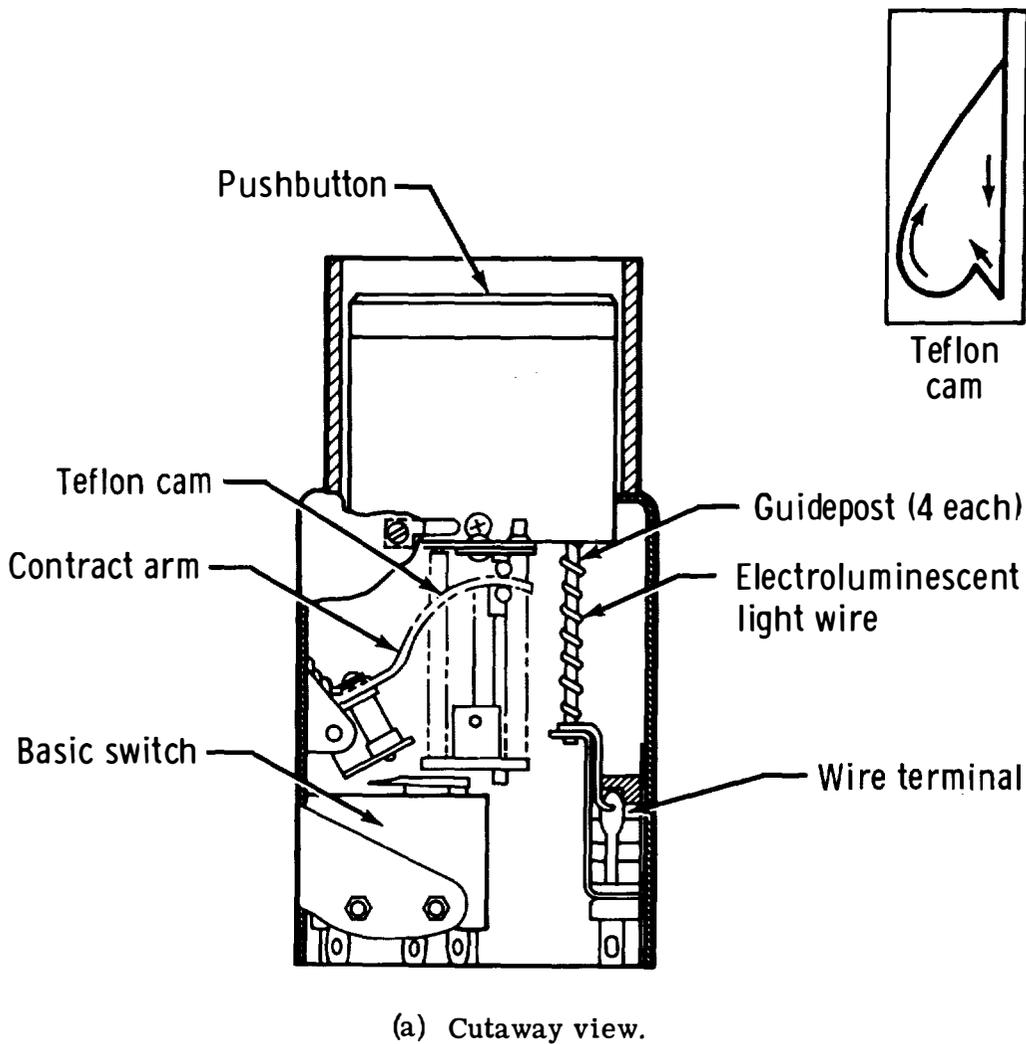
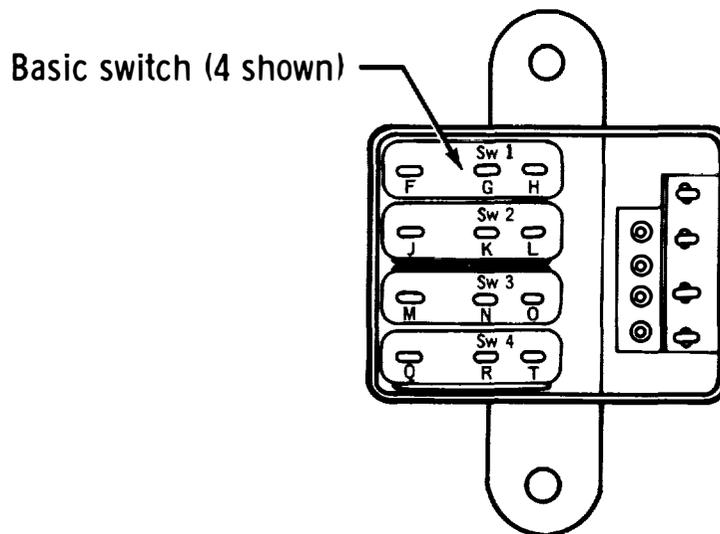
Figure 2. - Schematic diagram of a typical pushbutton switch.

In addition to these minor problem areas, more significant failures were experienced: contamination and stop-switch latching.

Contamination found in many of the switches prohibited proper switch actuation. Contamination included the following.

During vehicle testing, it was determined that when the engine stop switches were depressed, they could be inadvertently reset, which caused the engine to start again. To preclude this action, an external latch mechanism was added to this switch. The external latch mechanism was designed so that two actions were required to reset the stop switch, thereby eliminating the possibility of an engine restart. The design of this latch mechanism created many other problems before the latch could be properly installed in the vehicle. At present, this mechanism is working properly and has not caused any problems.

2. A new design rubber (Silastic) seal was added at the rear of the switch. This rubber seal provided better adhesion to the cement, therefore preventing a flow of the potting which could cause contamination.

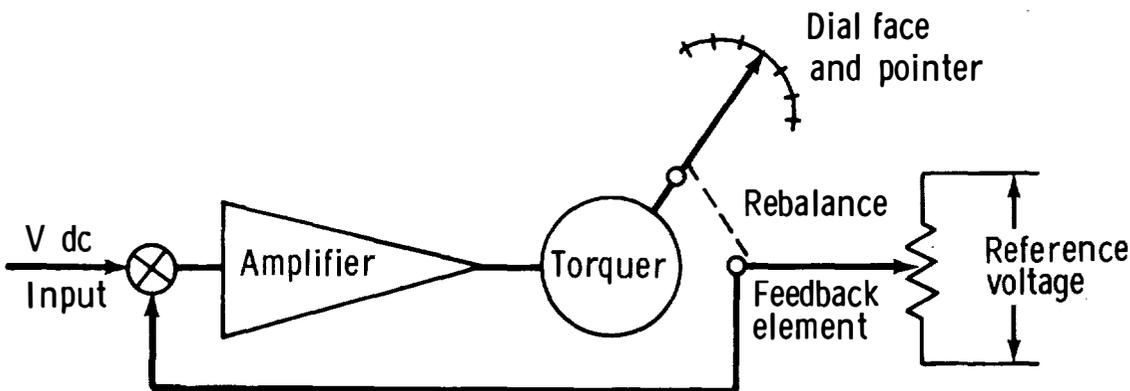
Figure 3. - Servomatic meter concept.

4. Sealing cases — The most significant problem during early testing of meters was in sealing the front glass within the case. Failures occurred during thermal vacuum testing. Specifically, breaks occurred in the bond between the glass and the case. During the thermal vacuum test, stresses developed which pulled the bond apart. Changing the potting to a stronger, more rigid material improved the bond, but caused the glass to crack. In analyzing the problem (fig. 4), the determination was made that a material had to be selected that had the proper shear strength, yet was flexible. The potting material between the meter case seal, the glass, and the case was changed to a flexible polyurethane, and the glass was made smaller to allow more potting. This change reduced the stress at the bond line so that seal breaking was prevented and the bond was flexible enough at a low temperature to prevent the glass from breaking.

3. Sticking meter pointer — A sticking meter pointer is the most significant meter problem. After qualification and shipment of many meters, the pointers were found to be sticking. Sticking occurred at either end of the meter scale or in the middle. Many corrective actions were incorporated into the meters to correct this problem, but none have been completely successful. Corrective actions include the following.

a. Sticking in the center of the scale was caused by inadequate clearance between the dial and dial-holder tabs, causing the dial holder to raise in the center when expanded. Distortion of the dial was caused by unequal pressure between the dial-holder tabs and the bezel. Corrective action for these problems included changing the dial-holder and dial dimensions to provide adequate clearance for expansion. In addition, the center of the dial was cemented to prevent movement.

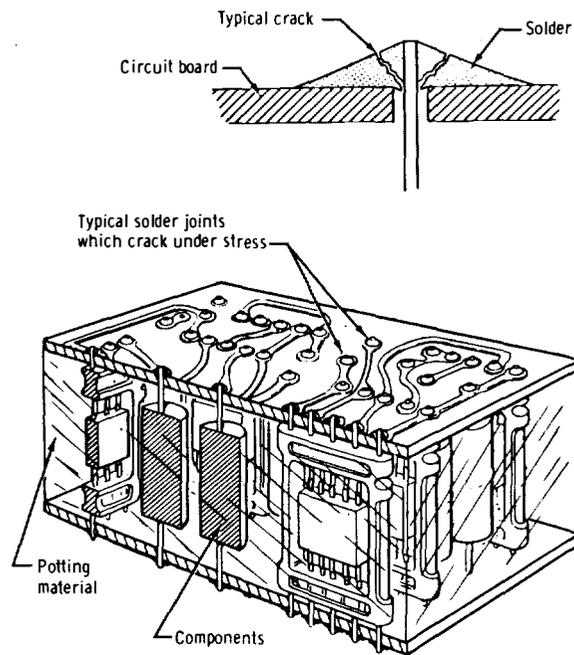
Figure 6. - Typical modular construction.

The mission timer program is notable for numerous problems that eventually required complete redesign and repackaging by a different manufacturer. The basic design of the original mission timer was of modular cordwood construction. This type of construction has electrical components (resistors, capacitors, diodes, etc.) soldered between two circuit boards. The void between the boards is filled with a potting compound (fig. 6). Differential expansion between the potting compound and the circuit boards caused the solder joints to crack, thus breaking electrical contact. Initiation of thermal acceptance testing accelerated the interaction, causing failures to occur. Corrective action, whereby the timers were disassembled and additional solder was added to the connections, was attempted. This work created many new problems and did not solve the original problem. After many additional ground failures and a flight failure during the Apollo 11 mission (LM-5), a decision was reached to procure newly manufactured timers. The new timers were mechanically and electrically interchangeable with the old timers. The new timers, in addition to correcting the solder problem, included design changes to correct other timer problems.

The basic design of the new timers used integrated circuits welded on printed circuit boards instead of cordwood construction. Other timer problems and their resolution were as follows.

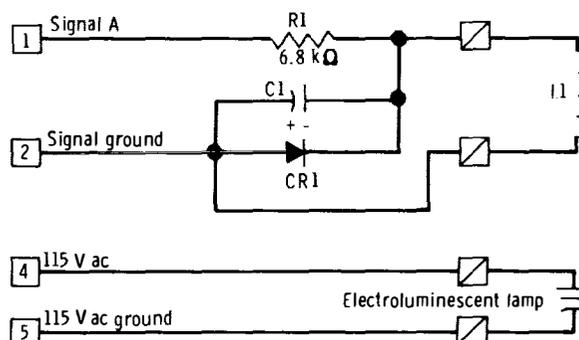
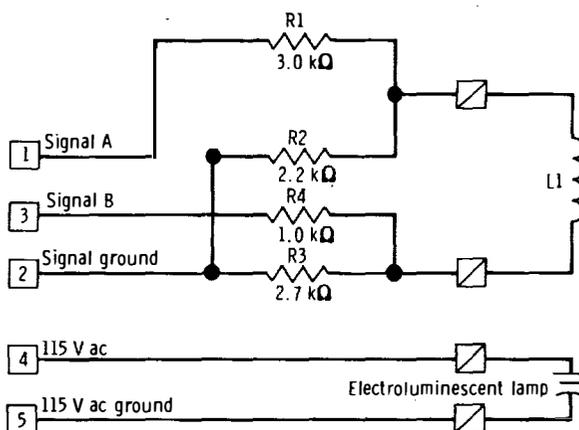
Figure 9. - Flag indicator circuit diagram.

The flag program, from initial development to present usage, has had many problems. The most annoying problem has been flag hangup, or hesitation. Although many corrective actions have been taken, this problem has never been solved. An analysis of acceptance and qualification failures identified the following failure modes.

1. Bearing bridge resonance — The bearing bridge resonated under random vibration, causing the flag to hang up. Design changes were made to the bridge to increase the resonant frequency above the critical level.
2. Coil clearance — The clearance between the coil and the pole piece or magnet (or both) was not sufficient; under random vibration, the coil would bind. Corrective action included increasing clearance and more accurate part alinement.
3. Spring system — Many flag hangups were caused by improperly formed springs. Procedures were implemented for proper spring formation and for spring tension measurement.

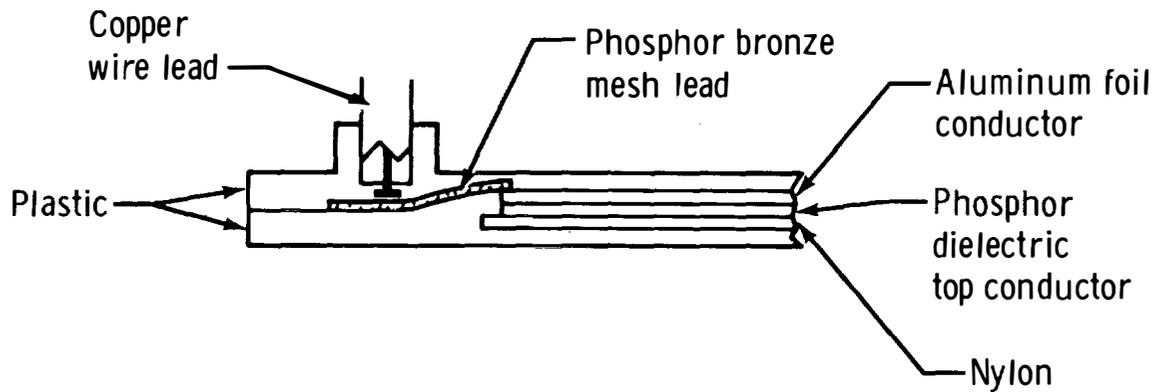
Figure 10. - Electroluminescent panel.

The procurement of electroluminescent lamp panels has been relatively free of problems since the start of the program. Initially, electroluminescence was state of the art, which led to problems in manufacturing techniques. When these initial problems were corrected, only two additional difficulties developed. The first concern was the development of dark spots in the electroluminescent lamps after extensive periods at high temperature. This problem was brought to the attention of the manufacturer, and corrective action was taken. Because fabrication of electroluminescent lamps is proprietary information, corrective action details could not be obtained. The only other concern was high-resistance shorts that developed around the leads. This problem was caused by the phosphor bronze mesh lead floating to the top of the plastic covering during processing. Corrective action included process specification revision and changing of the mesh material. Testing has proved this and all other corrective actions acceptable.

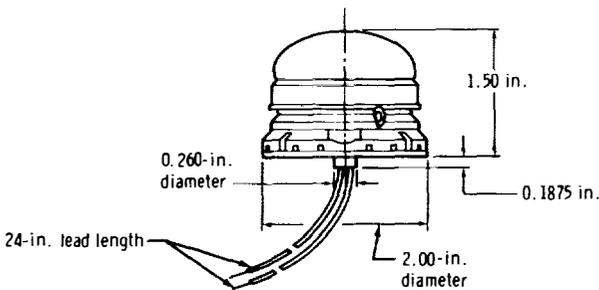
Figure 11. - Exterior docking light.

This program has been quite successful. Three failures that occurred during qualification tests were attributed to an easily corrected manufacturing defect. There have been no failures on vehicles during testing or in flight. The initial contract for docking lights was terminated after many serious design problems occurred. The history outlined relates only to the second contractor.
