## APPENDIX A - WIRE VISUAL AIDS AND ILLUSTRATIONS

### WIRING: CONNECTORS, CABLING, AND HARNESSING - WIRE DRESS TO CONNECTORS

## APPENDIX B - CRITICAL PROBLEMS IN COAXIAL CABLE ASSEMBLY

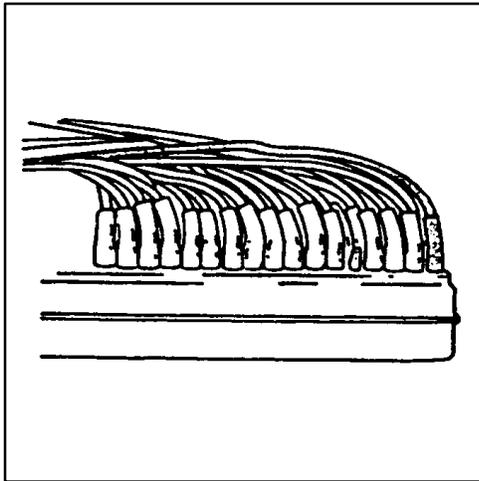
FIGURE A-1

#### PREFERRED

All wires dressed with even bends to terminate in solder cups.

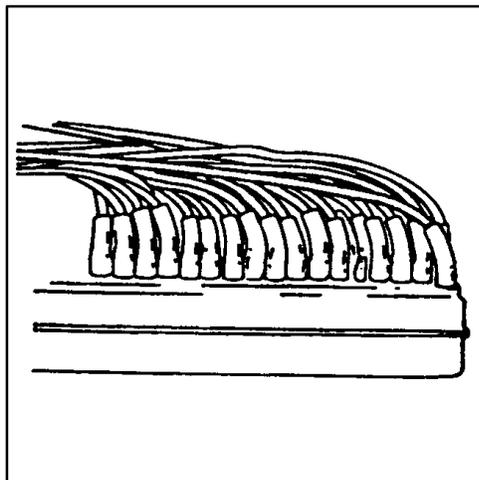
FIGURE A-2

#### NONCONFORMING

End wire on the right is taut with no stress relief.

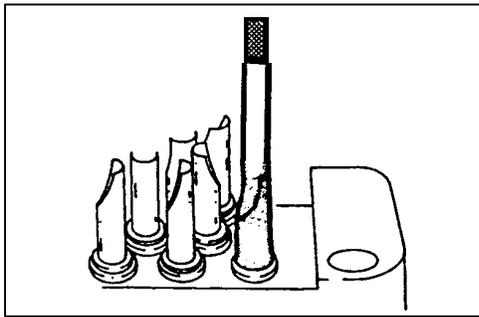
FIGURE A-3

PREFERRED

1. Sleeving on wire covers solder cup and provides support over wire insulation (see controlling specification)
2. Sleeving is fully shrunk over the insulation, wire, and solder cup.
3. Sleeving is sufficiently rigid to provide stress relief and prevent wire bending at the solder joint.

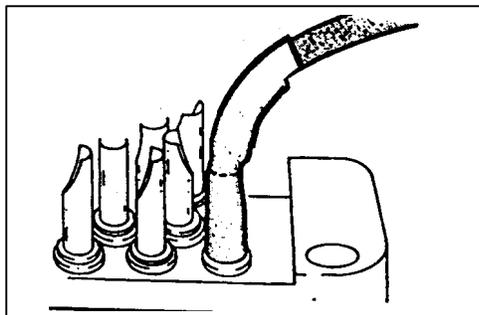
FIGURE A-4

NONCONFORMING

The sleeving is not fully shrunk and permits wire bending and flexing at the joint.

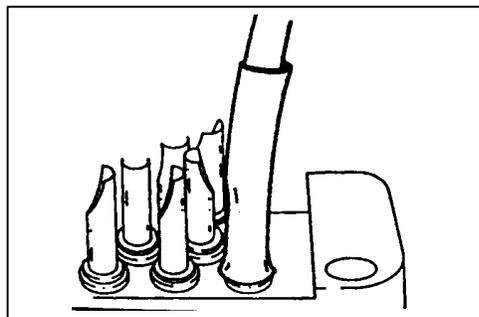
FIGURE A-5

NONCONFORMING

The sleeving is not fully shrunk.

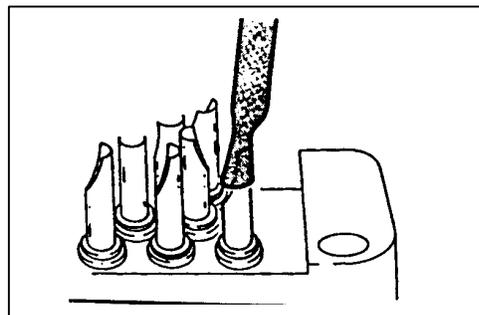
FIGURE A-6

NONCONFORMING

Sleeving does not grip at least half of the cup barrel below the opening.

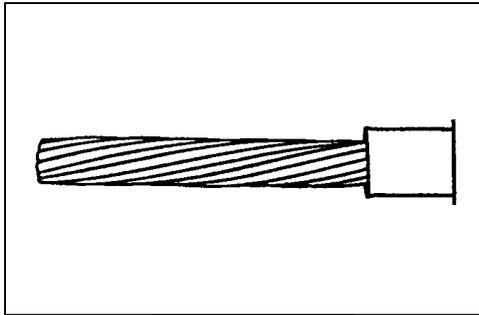
FIGURE A-7

PREFERRED

1. Insulation has been removed from the conductor with no visible damage to the wire strands.
2. Normal lay of wire, if disturbed, shall be retwisted to the original wire lay.

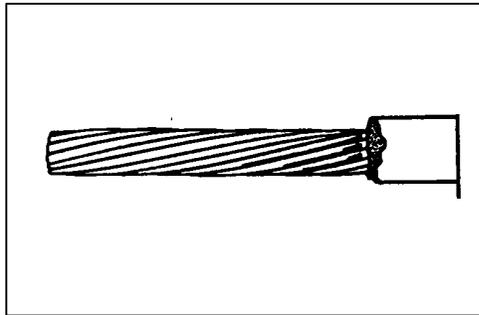
FIGURE A-8

ACCEPTABLE

Minor burnishing and indentation; base metal not exposed.

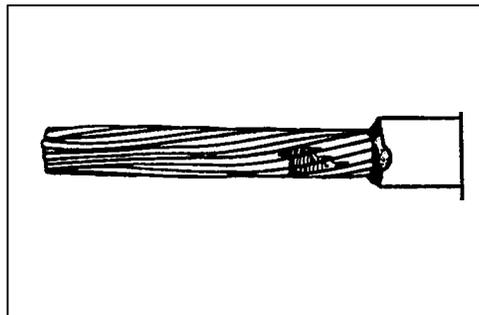
FIGURE A-9

NONCONFORMING

1. Wire strands are gouged and scraped exposing base metal.
2. Original lay of stranding has been straightened and distorted.

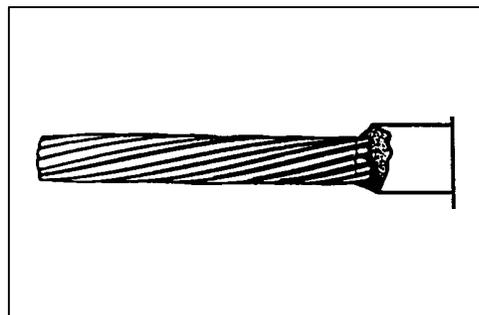
FIGURE A-10

NONCONFORMING

Wire strands show evidence of a nicked condition caused by stripper blades.

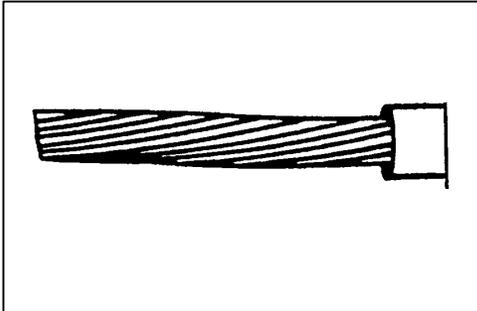
FIGURE A-11

ACCEPTABLE

Wire lay undisturbed; no visible damage to wire strands.

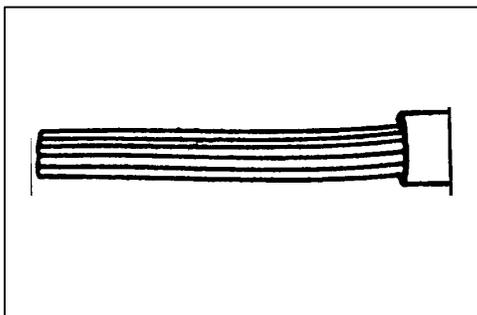
FIGURE A-12

UNACCEPTABLE

Wire strands combed straight. If retwisted to original lay, may be acceptable.

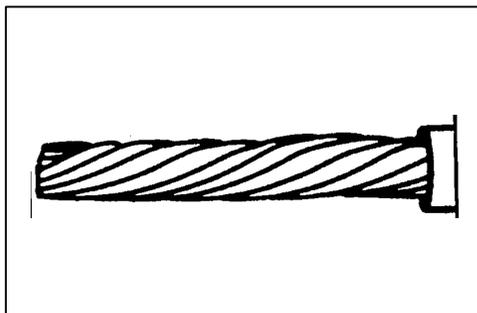
FIGURE A-13

UNACCEPTABLE

Excessive retwist.

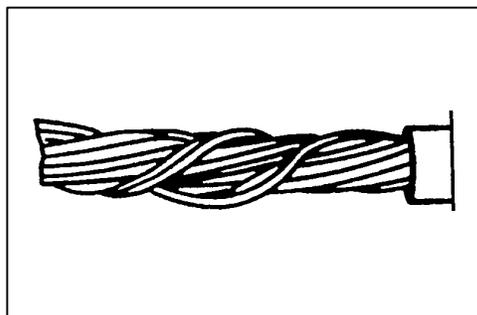
FIGURE A-14

UNACCEPTABLE

Wire strands retwisted in excess of normal lay and overlapped.

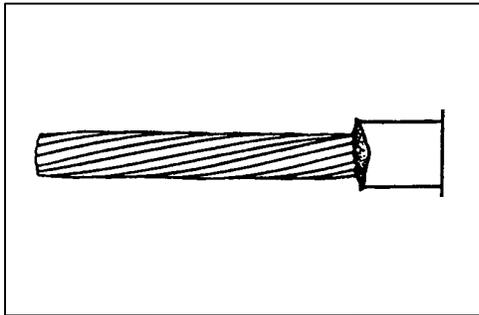
FIGURE A-15

PREFERRED

Insulation stripped by thermal stripping shall have minimum edge flash with no damage to the wire strands.

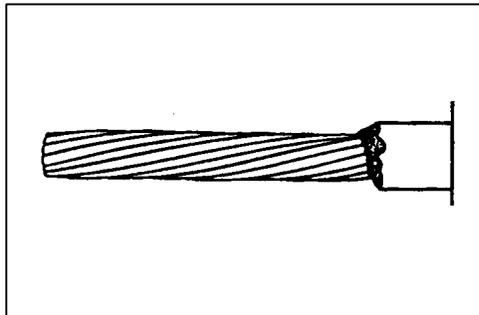
FIGURE A-16

ACCEPTABLE

Mechanical or thermal stripped insulation irregularity is acceptable if it does not exceed 1/4 of the outside diameter of the wire with insulation.

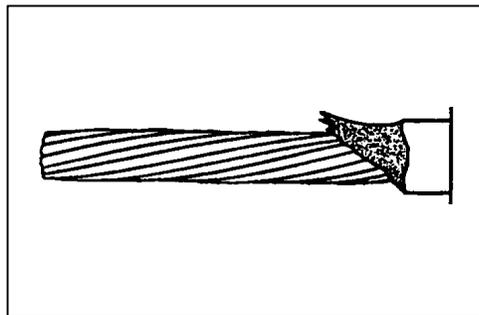
FIGURE A-17

ACCEPTABLE MINIMUM

Edge flash, due to improper stripping, should not exceed 1/4 of the outside diameter of the wire with insulation.

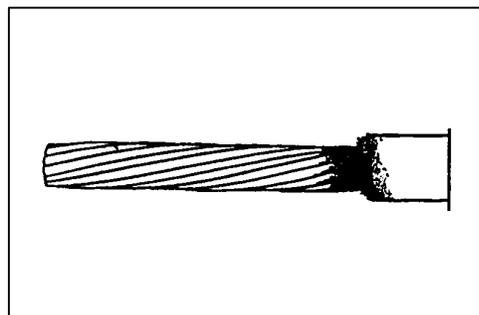
FIGURE A-18

NONCONFORMING

Burned or charred insulation, as shown, is the result of improper application of heat.

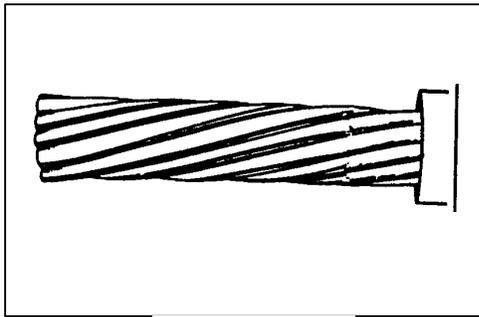
FIGURE A-19

PREFERRED

1. Complete wetting of the tinned area has resulted in a bright, thin, and even tinning of the strands
2. Tinning has reached insulation, but wicking is minimal.

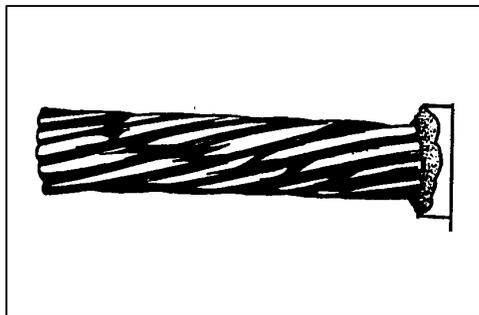
FIGURE A-20

ACCEPTABLE

Traces of solder wicking under insulation, but the contour of the stranding is easily discernible.

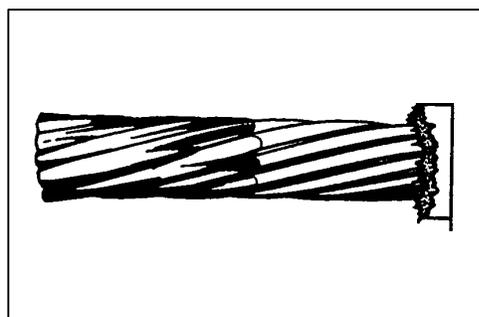
FIGURE A-21

ACCEPTABLE

Length of tinning is determined by type of termination; however, it should be sufficient to prevent separation of strands when wire is wrapped around a terminal.

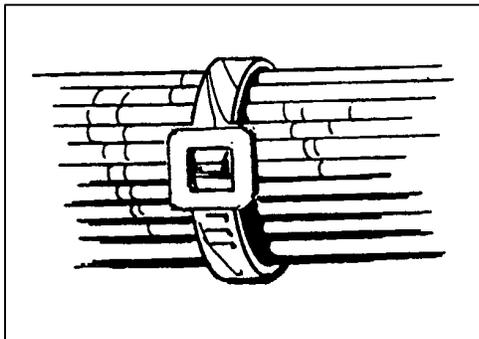
FIGURE A-22

ACCEPTABLE

1. Conductors secured with a plastic strap.
2. When tightened correctly, strap will not move laterally along the bundle under normal handling but can be rotated in place.

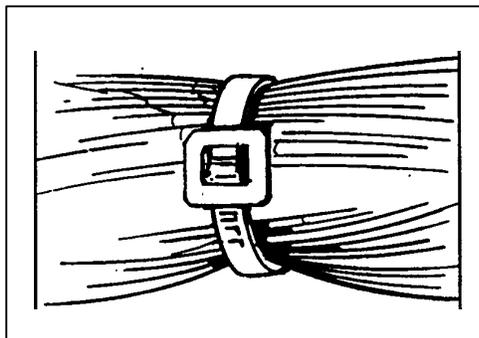
FIGURE A-23

UNACCEPTABLE

Strap is too tight and is deforming the insulation on the wire.

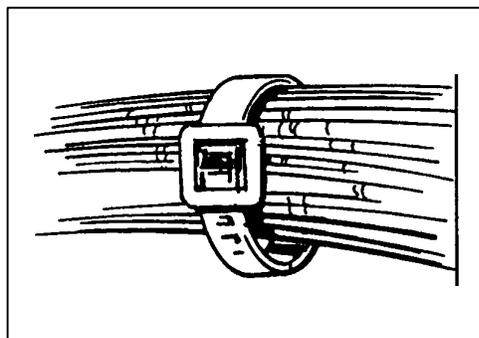
FIGURE A-24

UNACCEPTABLE

Strap is too loose and will slip easily along the bundle with normal handling.

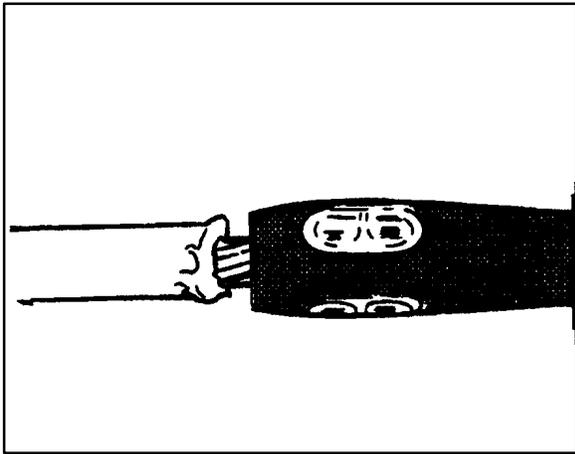
FIGURE A-25

#### MINIMUM CONDUCTOR EXPOSURE

Insulation terminates 0.010 in. minimum from contact crimp barrel.

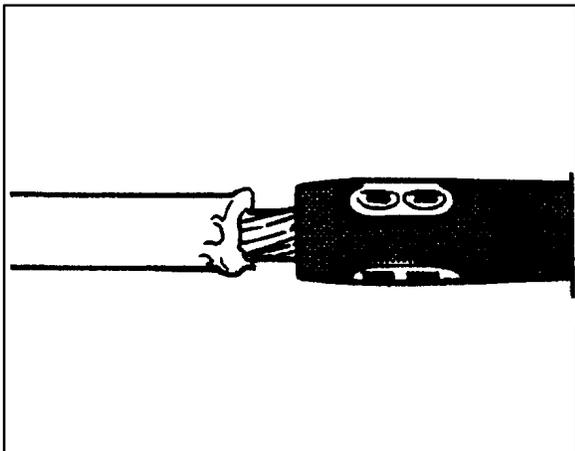
FIGURE A-26

#### MAXIMUM CONDUCTOR EXPOSURE

Amount of exposed bare wire between the insulation and the contact crimp barrel does not exceed 0.03 inch maximum for No. 20 AWG wire and smaller, and 0.05 inch maximum for No. 18 AWG wire and larger.

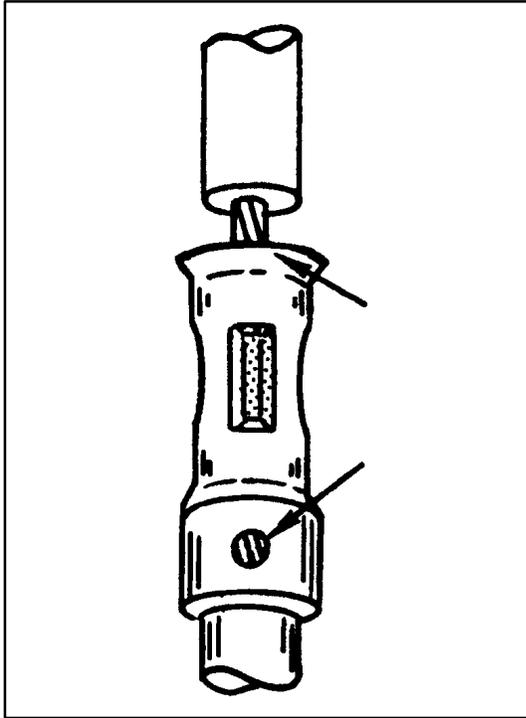
FIGURE A-27

ACCEPTABLE

Care should be taken when seating contacts in the crimping tool. The tool indentors should crimp the contact midway between the shoulder of the insulation support and the inspection hole. The wire is visible in the inspection hole.

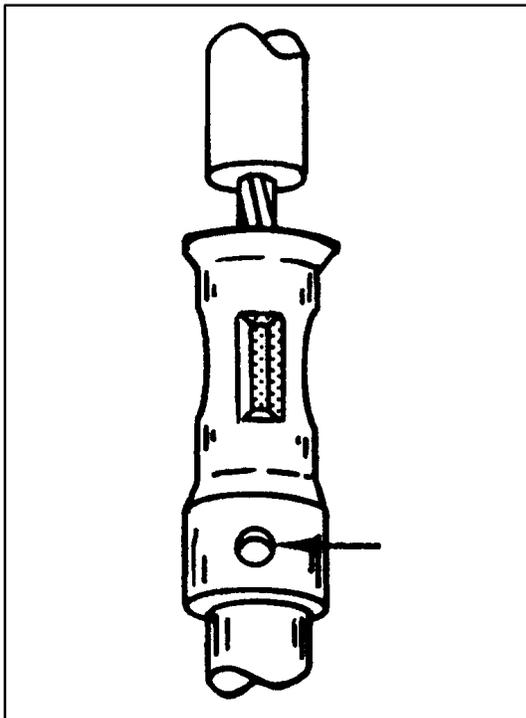
FIGURE A-28

UNACCEPTABLE

If the wire is not stripped back far enough or incorrectly seated in the contact, the wire will not be visible in the inspection hole, as shown.

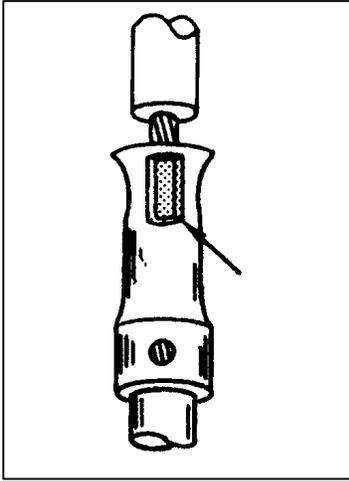
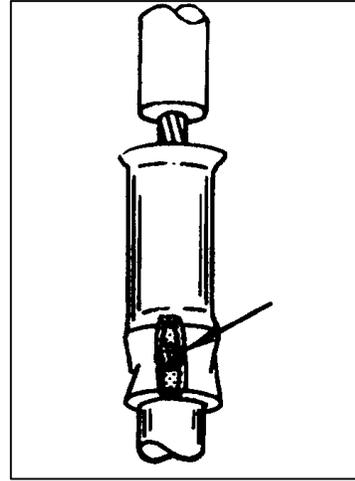
Failure to properly seat contact in crimping die, or use of incorrect crimping tool will result in improperly crimped contacts. Crimping over the inspection hole or on the radius of the shoulder as shown in Figures A-29A and A-29B is unacceptable.

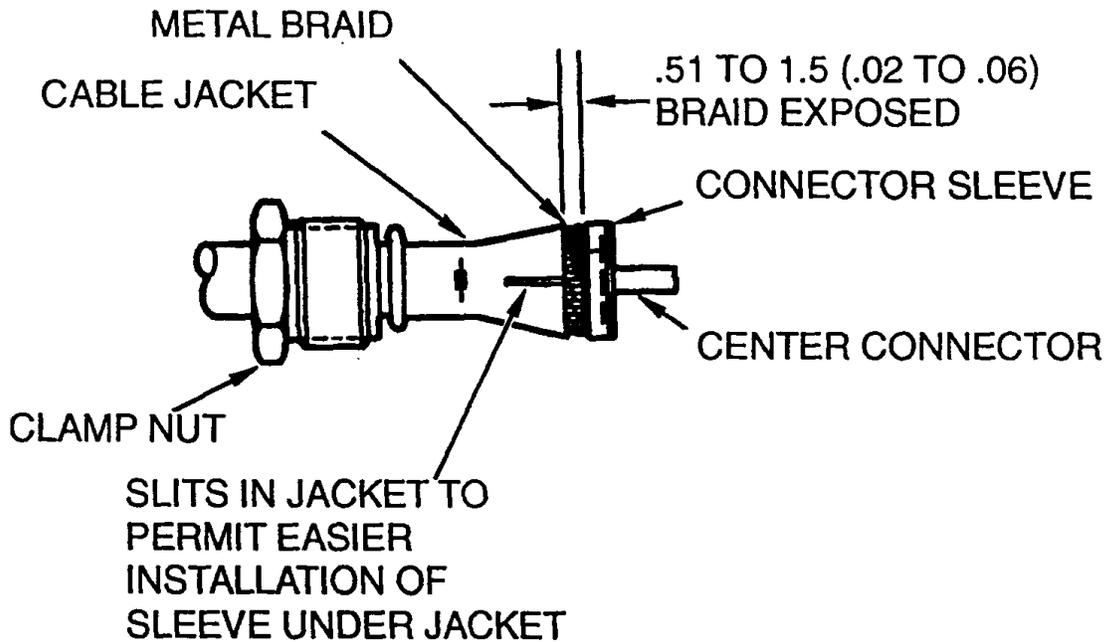
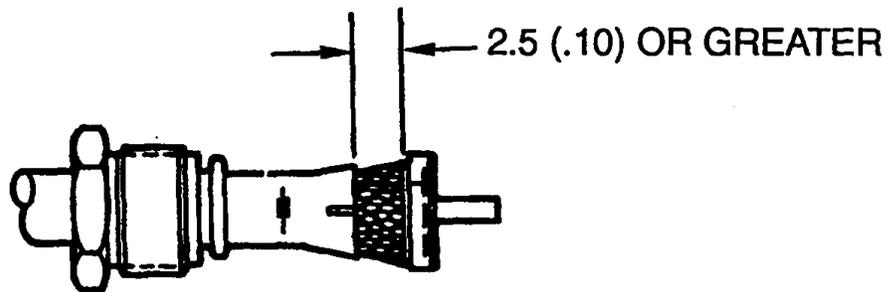
**A. INADEQUATE EXPOSURE OF METAL BRAID. JACKET MAY BE IN CLAMPING SYSTEM**

**B. PROPER EXPOSURE OF METAL BRAID SO JACKET WILL NOT BE IN CLAMPING SYSTEM**

Figure B-1. Illustration of Proper Trimback of Jacket to Isolate it from the Clamping System

**Plastic Jacket Layer in the Compression System.** Certain manufacturers' RF-connector designs or assembly instructions allow the jacket to be in the clamping system. For example, the metal clamp nut presses against the teflon cable jacket, which presses against the metal braid, which presses against the metal cable barrel of the connector. The problem encountered with this arrangement is that after torquing, the teflon jacket cold-flows, and the connection becomes loose. Intermittent circuits and system failure can result. Either this type of connector should not be used, or the plastic jacket should be trimmed back so that only metal-to-metal compression exists (see Figure B-1). If the connector design is such that satisfactory metal-to-metal compression cannot be achieved after torquing, the connector should not be used.

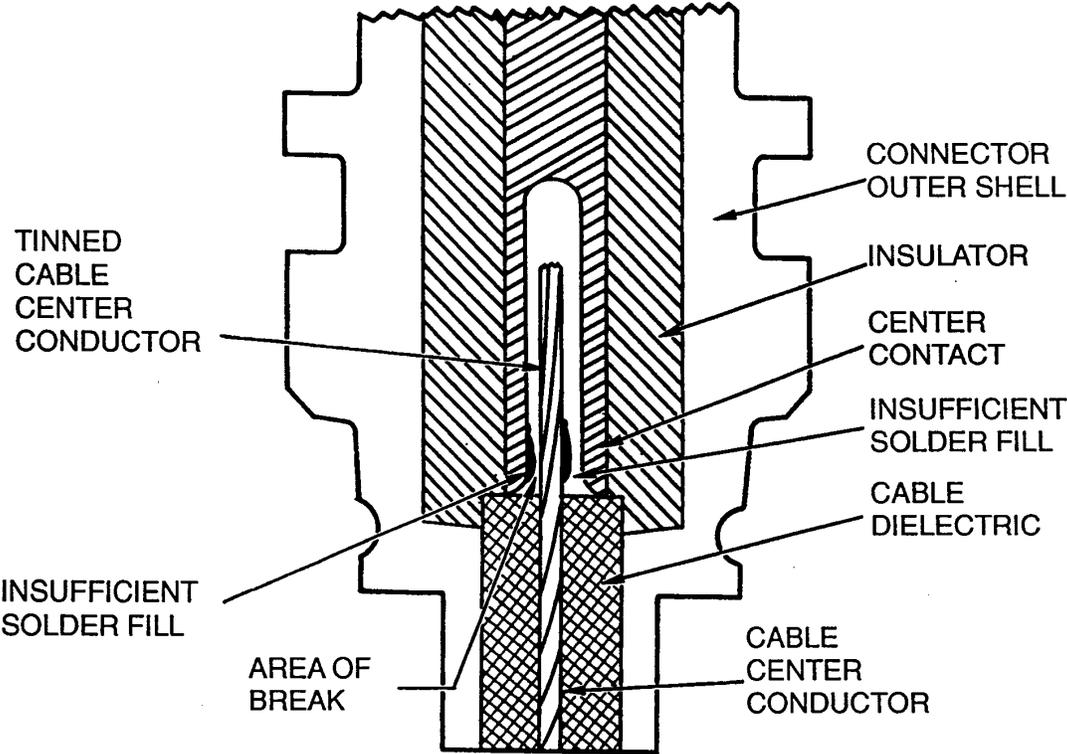
Figure B-2. Broken Solder Joint Caused by Insufficient Solder Fill

**Inadequate Center Conductor to Center Contact Solder Joint.** Certain manufacturers recommend that the center conductor be tinned, and that this tinned conductor be placed in the center contact. Then, the solder joint between the center conductor and center contact is made by reflowing the tinning in the center contact. Invariably, this makes an insufficient solder joint (see Figure B-2). A sufficient solder joint is made by placing a small length of rosin core solder in the contact wire well, e.g., 3.17mm (0.125 inch) length, 0.38 mm (0.015 inch) diameter. The center conductor is inserted into the wire well and the contact is heated to melt the solder and position the contact on the center conductor.

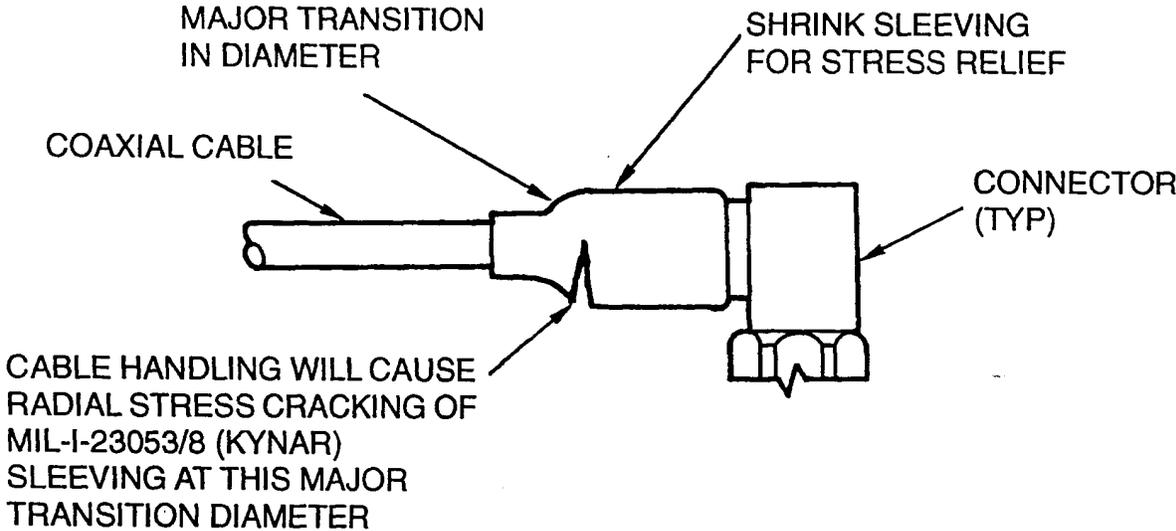
Figure B-3. Problem Point for Kynar Stress Relief Slewing

**Breakage of Stress-Relief Sleeving.** In assemblies where shrinkable sleeving is used to provide stress relief from a connector ferrule to the cable, there is often a major transition in diameter as shown in Figure B-3. If MIL-I-23053/8 sleeving is used for stress relief, it often cracks at the large diameter of the transition. The use of MIL-I-23053/8 sleeving for these applications should be avoided.
