14.4.3 Intermittent Lock of Universal Handling Tool In Suprathermal Ion Detector Fitting

14.5.1 Television Control Unit Clutch Slippage

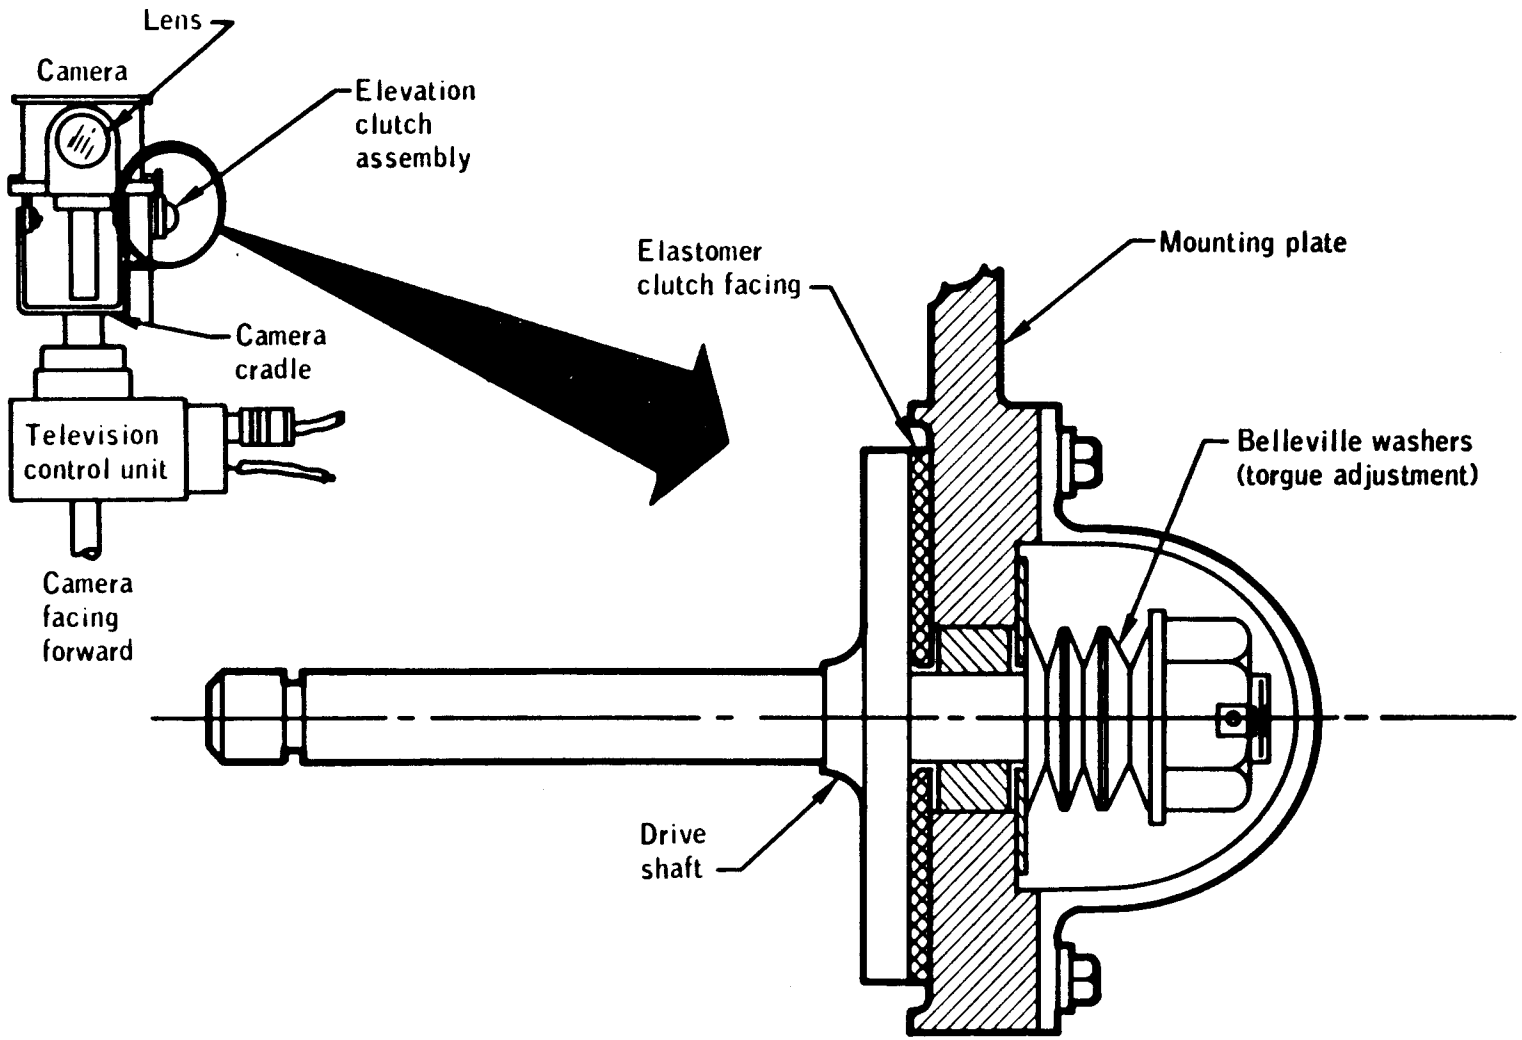
Figure 14-47.- Camera elevation control clutch.

During the second extravehicular activity, the camera could not be elevated as the unit approached the upper or lower limits of angular travel. The condition further deteriorated during the third extravehicular activity.

Elevation control is provided to the camera cradle through a friction clutch (fig. 14-47) which allows manual override of the ground-commanded camera positioning. The camera-cradle pivot point is approximately 3 inches below the center of gravity of the cradle with the camera mounted. As the camera moves away from the horizontal position, the unbalanced moment becomes progressively greater, and a higher torque load must be supported by the clutch mechanism.

The elastomer clutch-facing material provided the required stable friction properties in the specification and qualification test temperature range (122° F, maximum). However, the maximum temperature on the television control unit during the third extravehicular activity has been calculated as approximately 180° F. Materials specifications show that the compressive strength of the elastomer degrades rapidly at this temperature, and ground tests with flight unit 4 verify severely degraded performance with time at elevated temperature.

The clutch is being changed to a metal-to-metal spring ring design in place of the elastomer disc. The clutch torque for Apollo 15 was set at 16 inch-pounds for ease of manual adjustment. For greater stability on Apollo 16, the new clutch is being built with a torque of 30 inch-pounds, which is still comfortable for manual positioning and is within design limits of the system, including the gear train (35 inch-pounds).
